MASONRY AS A DUCTILE MATERIAL: TRADITIONAL AND CONTEMPORARY  
CONSTRUCTION PRACTICES UTILIZING UNREINFORCED  
MASONRY IN SEISMIC AREAS

Randolph Langenbach

University of California, Berkeley  
Berkeley, California  
U.S.A.

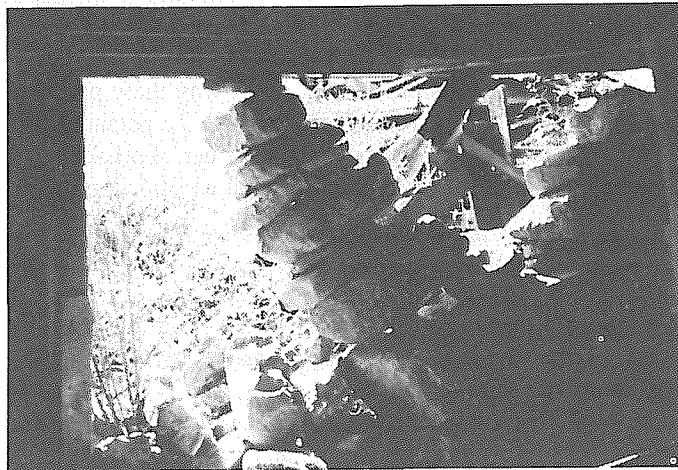
1. HARRISVILLE, N.H., stone pier of a barn demonstrating the ability of masonry to undergo lateral displacement without collapse when under load.

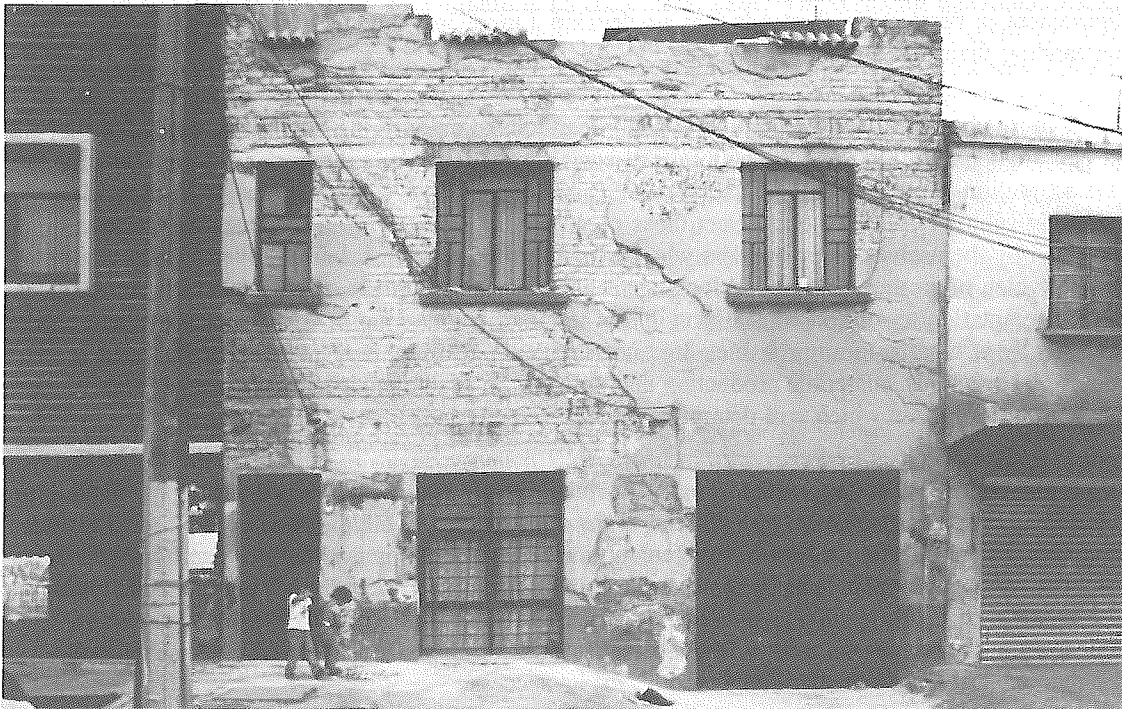
Unlike those buildings where the masonry is deliberately held back to avoid the damage from the "equivalent diagonal compression strut", there is no such effort here. The resulting integrated system actually appears to have performed better because it comes closer to achieving the "monolithic" quality originally attributed to reinforced concrete in the 1911 report *Earthquake-proof Construction* quoted at the beginning of the article. Normally these walls would not be strong enough to carry the extremely large loads demanded of them, so some energy absorption must be occurring within the brick wall itself without destructive cracking, and without the shearing off of the columns by the equivalent strut. The hypothesis here is that the cracking which does occur is invisible because it is a minor cracking and compression across the entire surface, and it is limited to the mortar joints, rather than occurring as destructive cracking at the center of the wall. This invisible cracking can be observed more clearly when the masonry wall is covered with stucco. The shedding of the stucco in the earthquake is evidence of the flexing and cracking of the wall across a wide area. If the wall is still intact, the evidence of the movement of the wall, i.e. the evidence of its "ductile" behavior, lies in the shedding of this brittle stucco surface (illustration # 2).

2. MEXICO CITY, the distribution of shear stress in a masonry wall is shown by the shedding of the stucco in this small building subjected to extreme pressure from the movement of its taller neighbor.

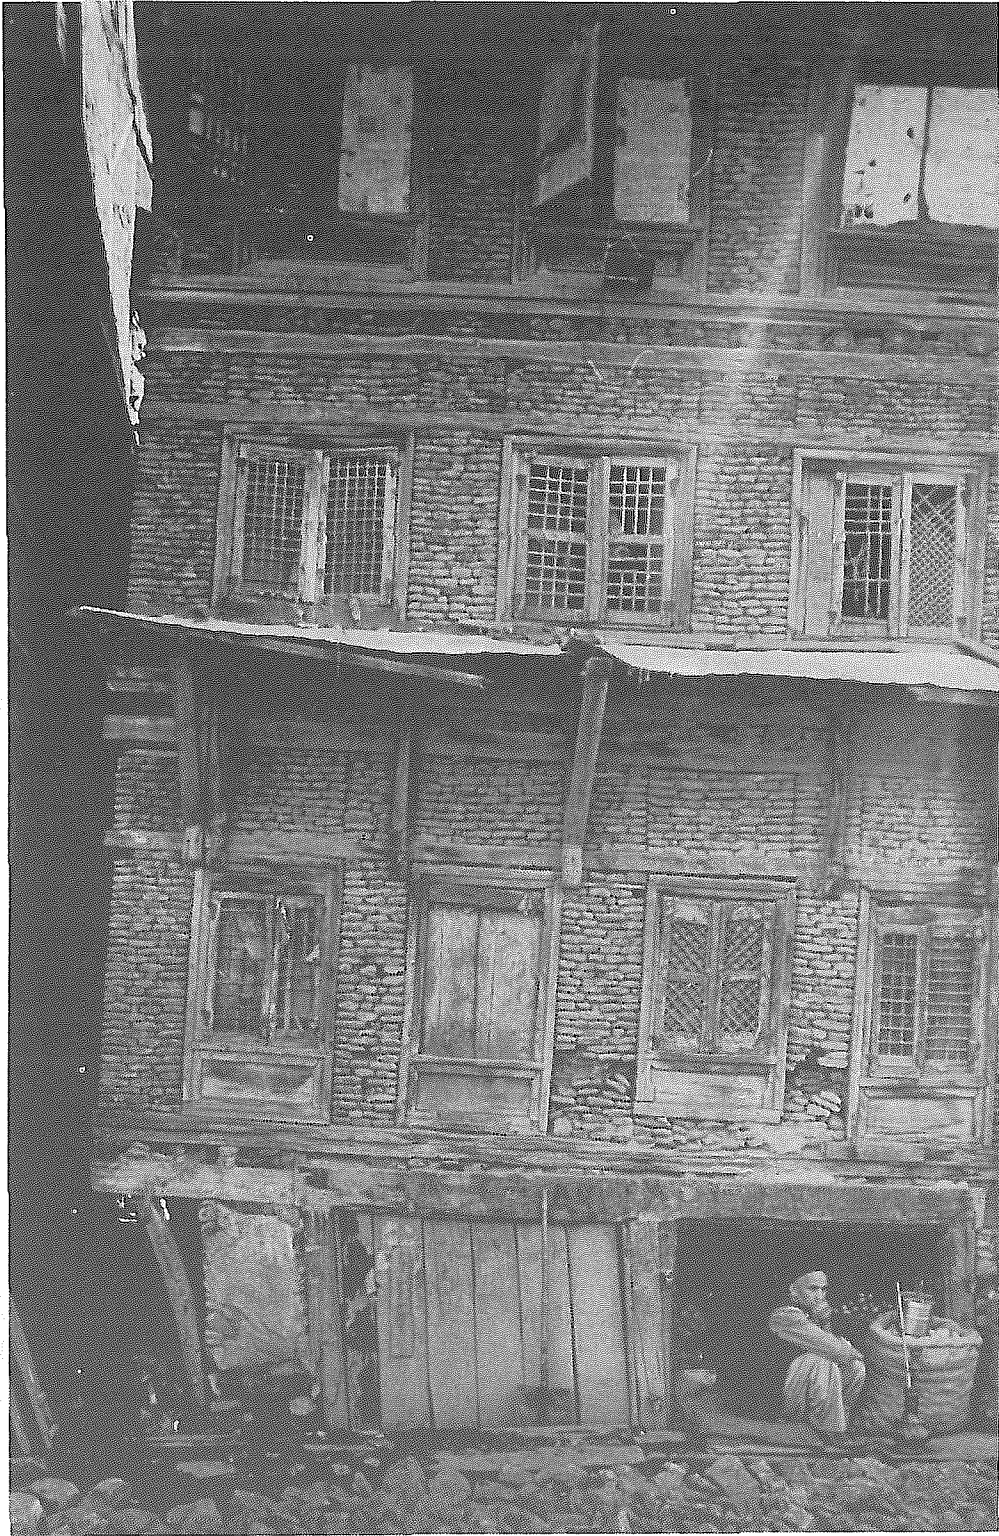
3. SRINAGAR, KASHMIR, INDIA, 18th. century "Dhajji-Dwari" building which has remained standing despite the effects of age and several major earthquakes.

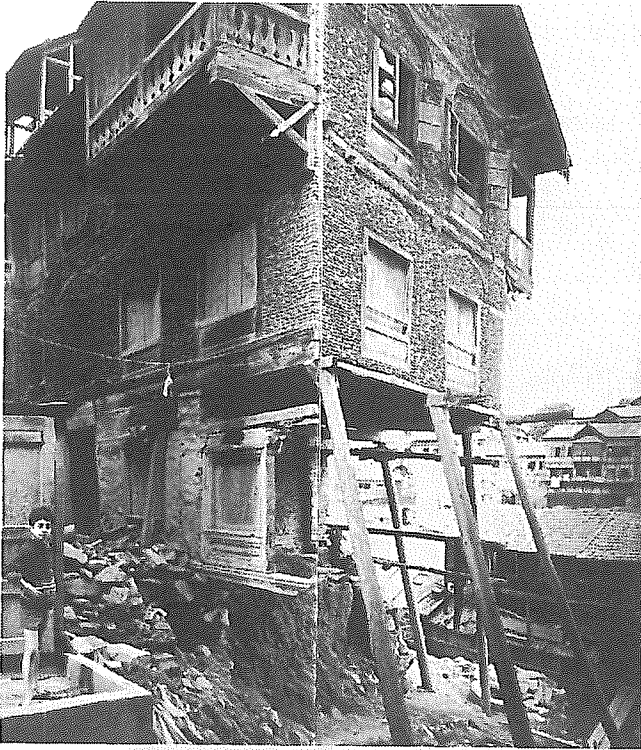
4. SRINAGAR, KASHMIR, INDIA, "Dhaji-Dwari" building undergoing repair demonstrating the through-wall bearing of the masonry onto the wood runners, and the comparative lightness of the masonry walls.

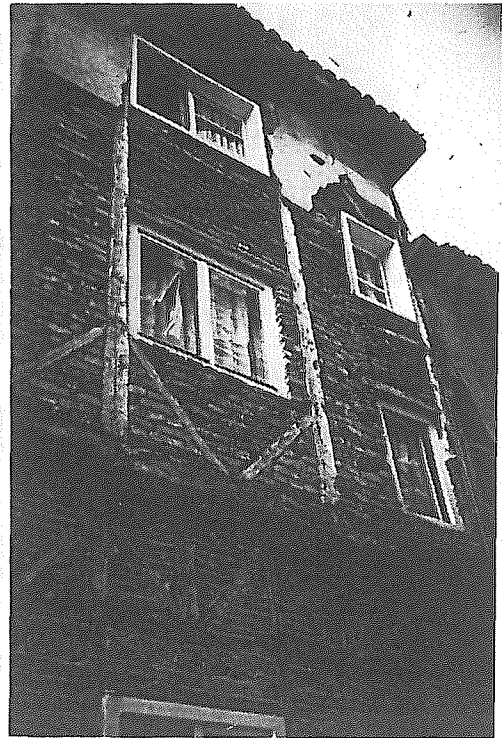
5. YUGOSLAVIA, Timber frame with brick infill construction.

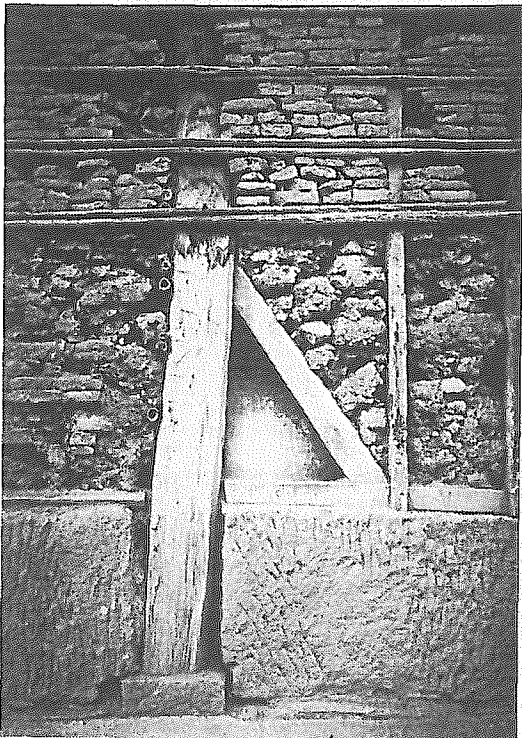
6. NICARAGUA, Detail showing "Taquezal" construction without the usual covering of stucco.

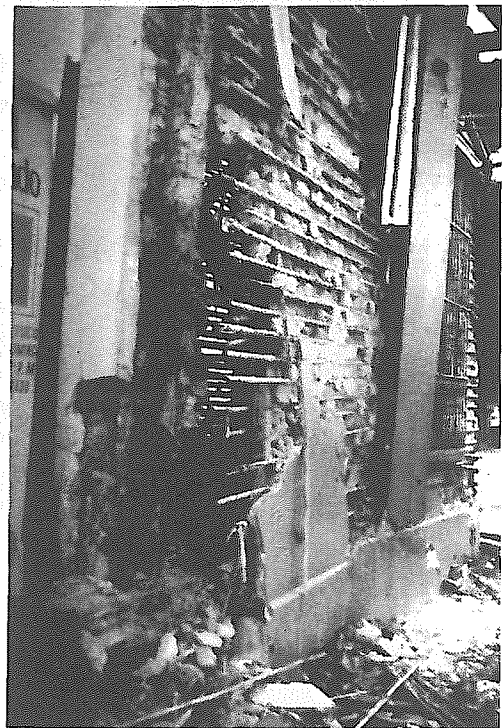
What is interesting here though is the fact that the primary cause of failure of this class of buildings might not have been directly the result of a defect in the system itself, but rather, a problem in the long term stability of the structures affected by environmental factors other than the earthquake. When the Taquezal buildings failed in the 1972 earthquake, the stresses apparently exceeded the strength of the wood frame's ability to restrain the masonry, and the structures collapsed. Often the rotting and termite damage caused the structure to fail first at the bottom.

7. SAN SALVADOR, a "Bahareque" building damaged by the 1986 Earthquake showing how the failure began at the rotten base of the timber frame.

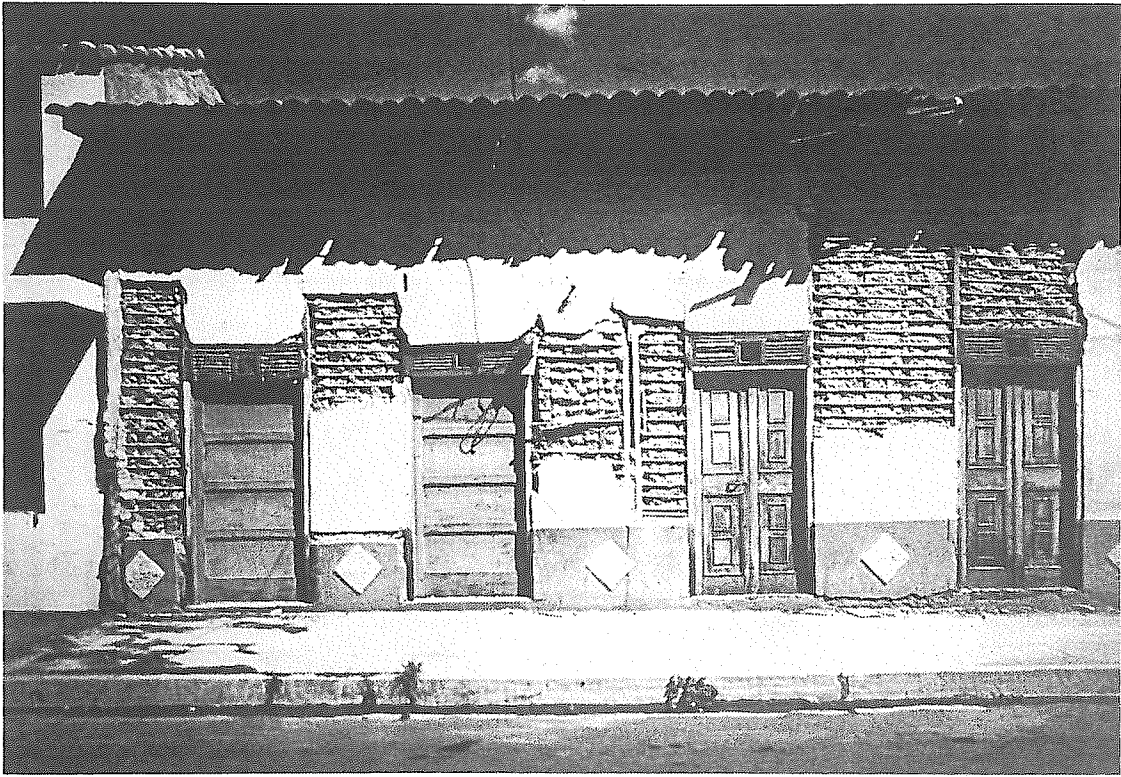
plastered on the exterior in order to give a more substantial effect (illustration # 8). In the 1931 earthquake in Managua, Freeman notes that practically all of the plaster was shaken off of the Tarquezal buildings. This also was observed to be the case in San Salvador in October, 1986. The fact that during the earthquake it was dislodged from practically the entire surface of the walls can be interpreted as a function of the distribution of the earthquake stress throughout the wall, rather than its concentration in one localized area. Wherever the earthquake shaking has caused a slight shifting and cracking between the masonry units, the brittle plaster on the surface was thrown off. The shedding of the plaster, therefore, draws attention to the fact that the earthquake stress is absorbed throughout the wall, so that no one major destructive crack occurs.

8. SAN SALVADOR, "Bahareque" building showing the shedding of stucco caused by the 1986 Earthquake.

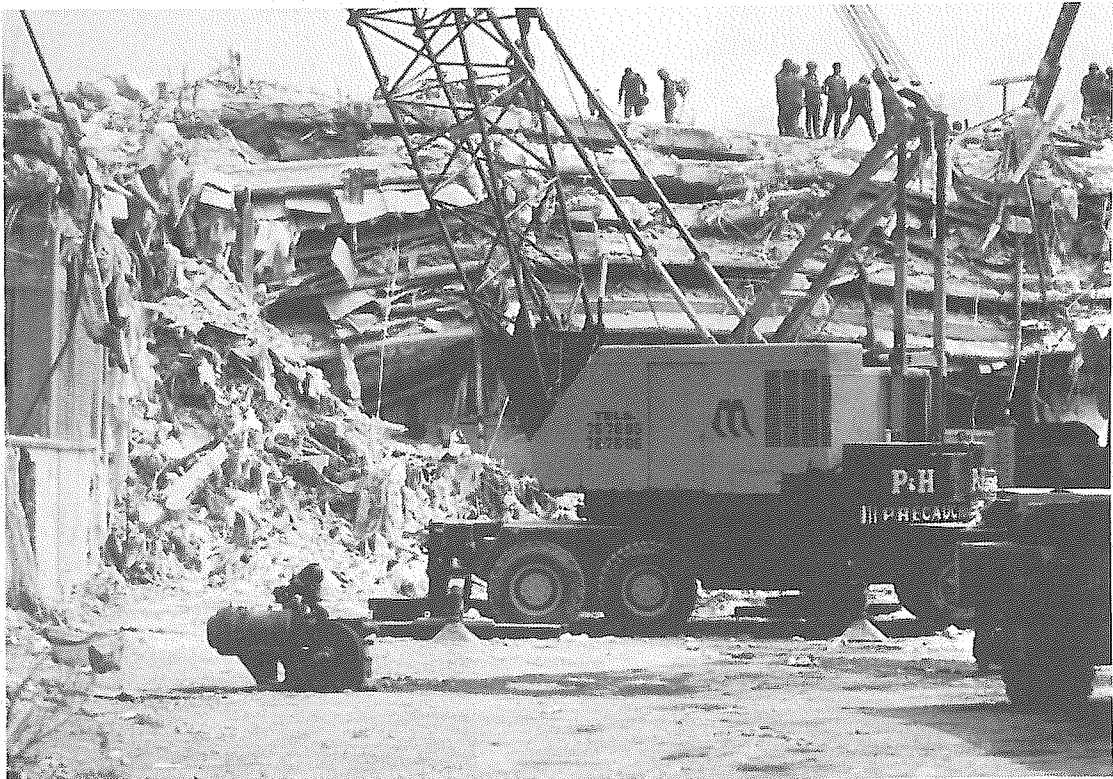
9. MEXICO CITY, pancake collapse of a reinforced concrete column and waffle structure.

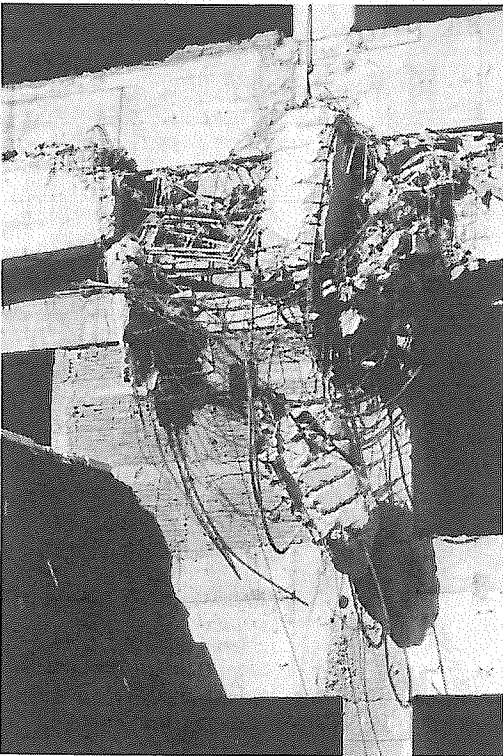
10. MEXICO CITY, detail of a collapsed column of the new Banco de Mexico building showing evidence of poor quality concrete.

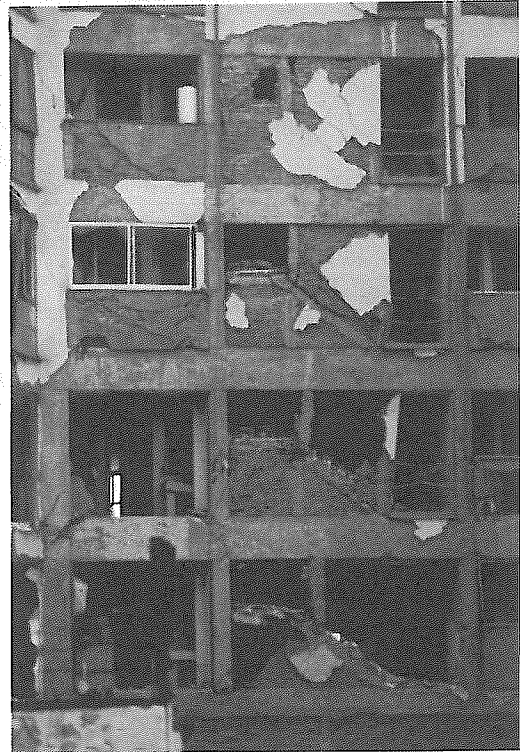
One of the problems which has been confronted with these walls in earthquakes is the fact that they are inherently very stiff and brittle. If the lateral loads are great, and the building frame is flexible because of a lack of specially designed shear walls, the deflection of the frame throws all of the lateral force onto these infill walls which were never intended to carry it. As a result, diagonal shear cracks will develop. If the shock is great enough, these walls can be shattered. The failure of the walls across one floor of a building can lead to the creation of an unintended "soft story", resulting in the collapse of the structure in subsequent cycles (illustration # 11).

Another problem caused by the action of the infill walls within a reinforced concrete moment resisting frame is the development of the "equivalent diagonal compression strut". When the frame deflects, it will bear upon the wall on its upper corner, forcing the wall to begin to develop diagonal shear cracks. The diagonal cracks do not, however, necessarily cause the wall to fall away. Instead, the masonry is restrained within the bay under massive pressure from the deflected frame. All of this pressure is delivered to the top of the column just below the intersection with the beam [1]. The resulting stresses can be sufficient to cause the column to fail in shear, again leading to the progressive collapse of the structure as the loads become greater as they shift to each successive column in a chain (an example of this damage can be seen in illustration # 11).

11. MEXICO CITY, reinforced concrete frame building showing the blowing out of the unreinforced brick infill walls and damage to the structural frame.

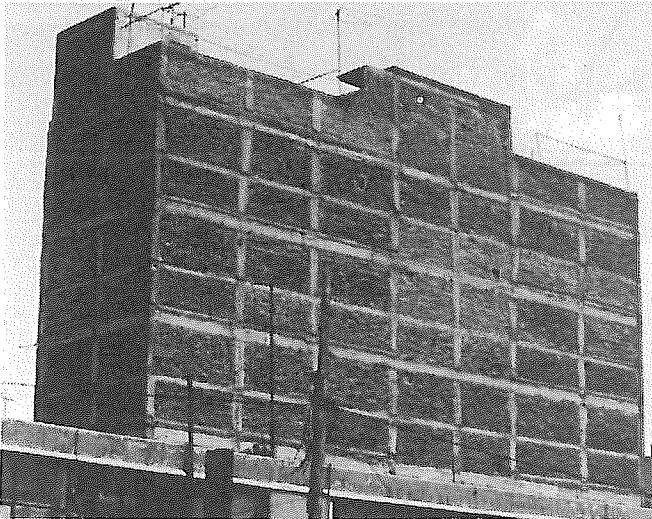
This difference was made apparent by certain examples investigated in Mexico City after the 1985 earthquake. In this earthquake, it is possible to test this hypothesis by comparing the results of the earthquake on different buildings, all of recent vintage, and all using some form of composite concrete and masonry construction. One example is a commercial building located only one block from the well documented Juarez Hospital Building, which collapsed, killing about 800 people (illustration # 12).

12. MEXICO CITY, commercial building near Juarez Hospital showing reinforced concrete

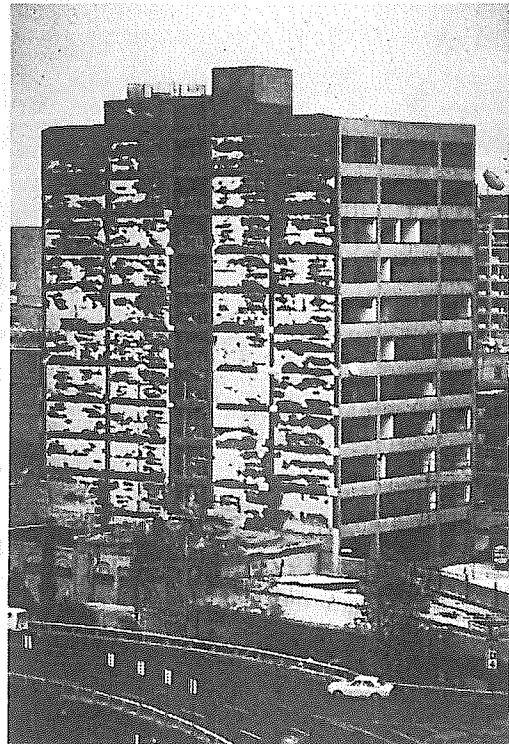
13. MEXICO CITY, eleven story building showing the absorption of shear stresses in the infill walls with the resulting shedding of the stucco.
