TRADITIONAL MASONRY AND CONTEMPORARY REINFORCED CONCRETE FRAME
WITH INFILL WALL CONSTRUCTION IN SEISMIC AREAS

Randolph Langenbach

University of California, Berkeley

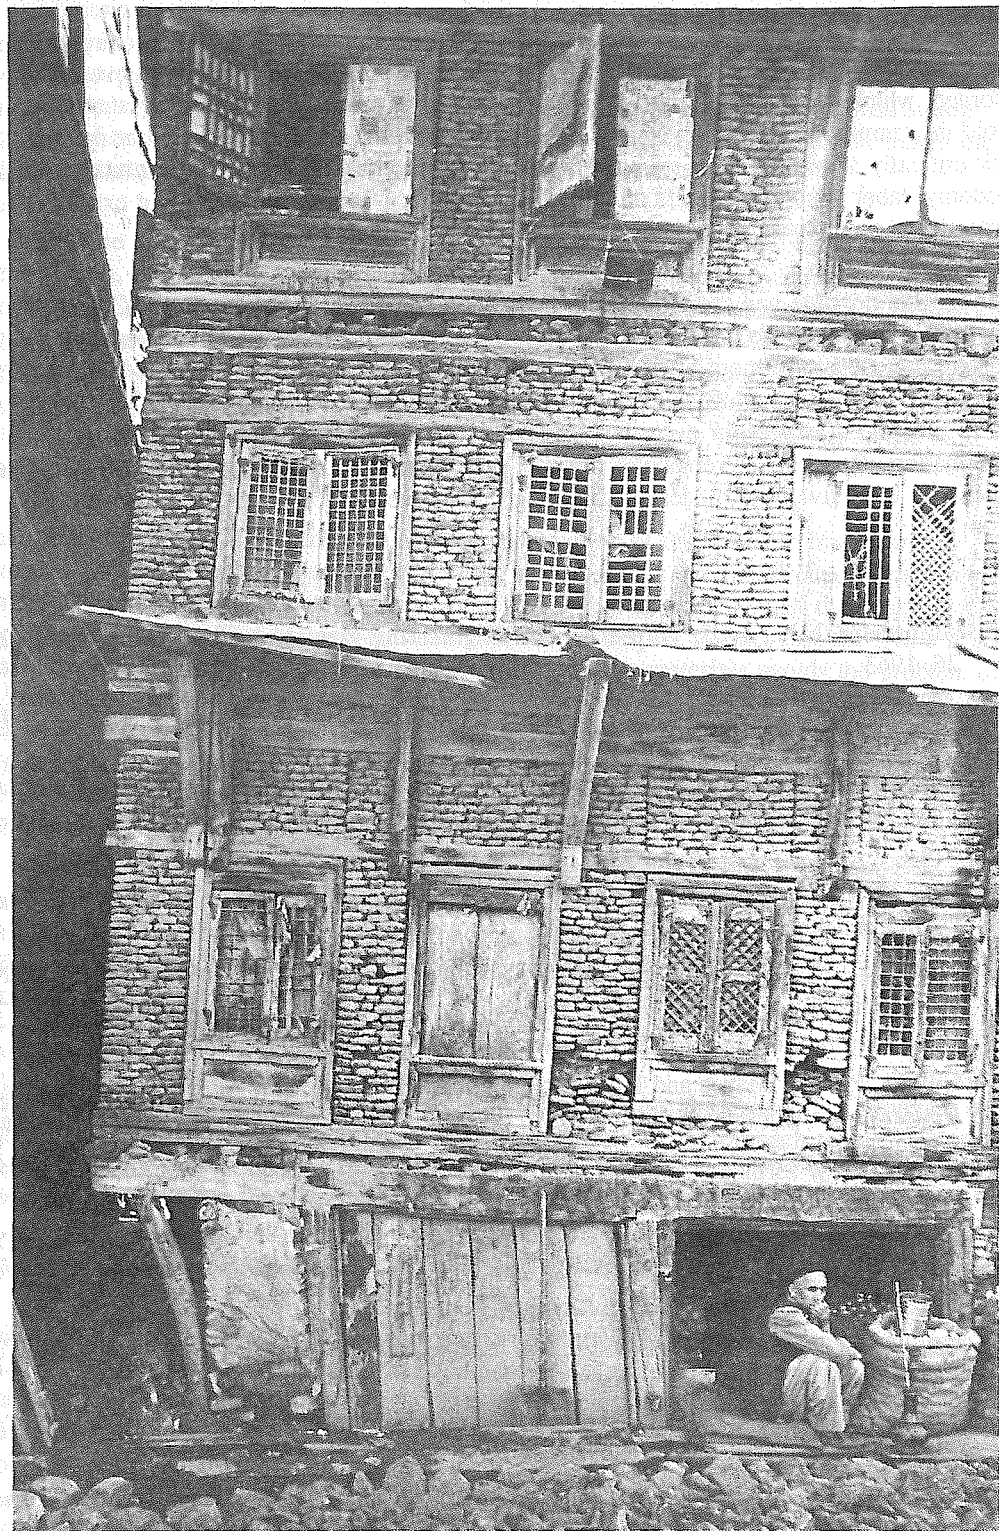
1. SRINAGAR, KASHMIR, INDIA, 18th. Century building illustrating Dhajji-Dwari construction affected by earthquakes.

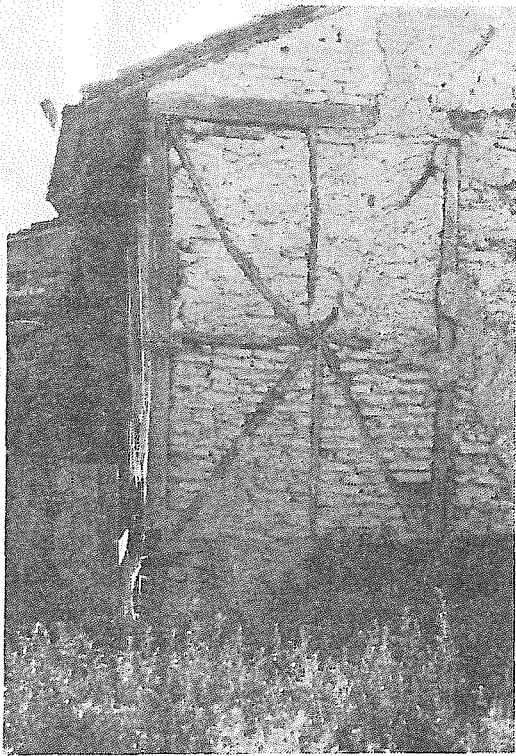
rapidly disappearing, are an important last trace of the old city. They are constructed of timber with infill of adobe or fired brick. This infill is only 1/2 brick thick in a two story building (illustration # 2). In one survey of the damage caused by the 1963 Skopje Earthquake, a London engineer, N.N. Ambraseys reports that the "old adobe construction, particularly those with timber bracing, resisted the shock with some damage, but behaved far better than the brick or the hybrid construction."

2. SKOPJE, YUGOSLAVIA, timber frame with brick infill construction.

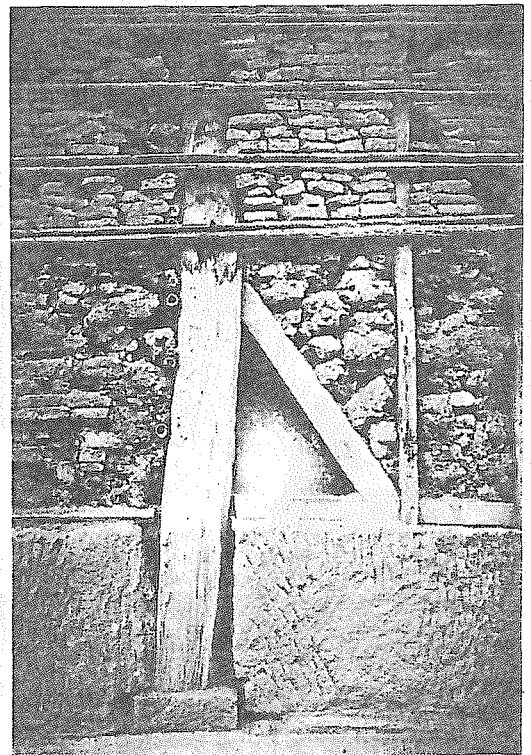
A different variation on the infilled timber frame system is common in several countries in Central America. This system, which reportedly was introduced from Spain during the colonial period, is known in Nicaragua as "Taquezal", or "pocket" system, and in the neighboring El Salvador as "Bahareque". In Taquezal or Bahareque construction, the timber frame consists of a row of studs, approximately 2 feet on center. These studs, which are approximately 51 x 102 mm are set within a heavy timber frame. The timber frame consists of hardwood posts, often made of unsawn logs, at the corners and at points in the walls approximately every seven feet. Wood lath or bamboo is then nailed across the studs to form a kind of basket, and the resulting pockets are filled with the loose material, either small stones ("Taquezal con piedra"), or balls of mud ("Taquezal con barro terra".) The wall is then usually plastered with a final layer of mud or lime plaster (illustration # 3).[3,6]

3. NICARAGUA, detail showing "Taquezal" construction without surface stucco.

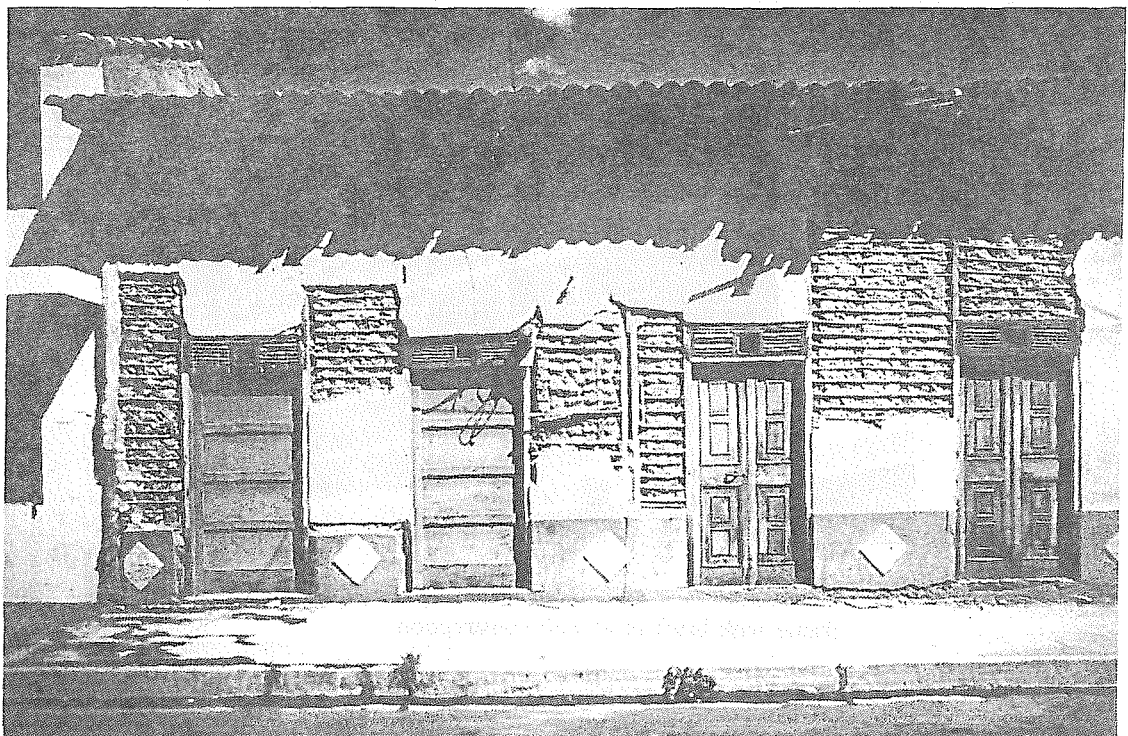
4. SAN SALVADOR, building showing loss of stucco from October 1986, earthquake.

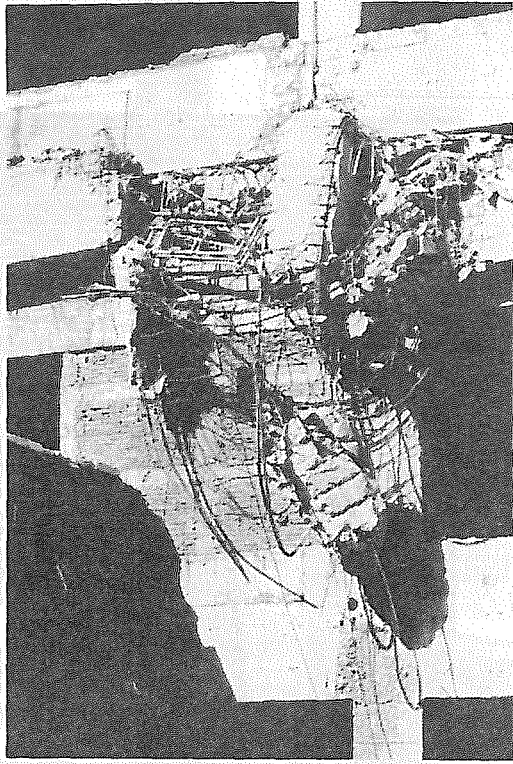
5. MEXICO CITY, detail of collapsed column, Banco de Mexico building, showing evidence of poor quality concrete.

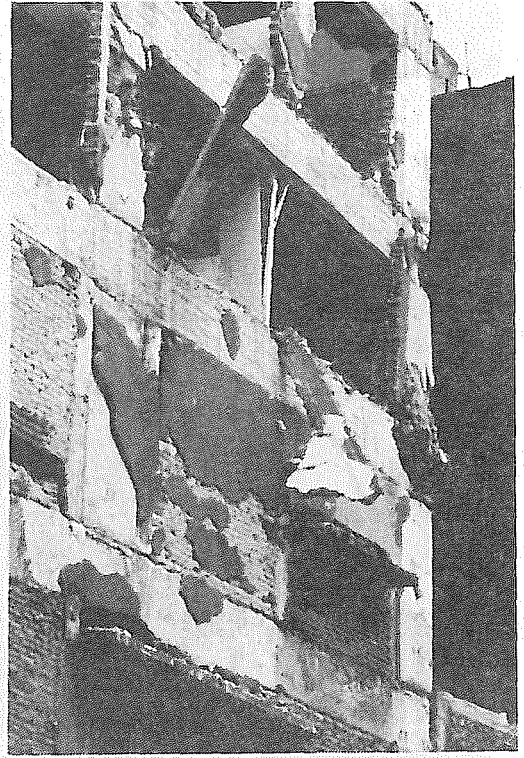
One of the problems which has been confronted with these walls in earthquakes is the fact that they are inherently very stiff and brittle. If the lateral loads are great, and the building frame is flexible because of a lack of specially designed shear walls, the deflection of the frame throws all of the lateral force onto these infill walls which were never intended to carry it. As a result, diagonal shear cracks will develop. If the shock is great enough, these walls can be shattered. The failure of the walls across one floor of a building can lead to the creation of an unintended "soft story", resulting in the collapse of the structure in subsequent cycles (illustration # 6).

Another problem caused by the action of the infill walls within a reinforced concrete moment resisting frame is the development of the "equivalent diagonal compression strut". When the frame deflects, it will bear upon the wall on its upper corner, forcing the wall to begin to develop diagonal shear cracks. The diagonal cracks do not, however, necessarily cause the wall to fall away. Instead, the masonry is restrained within the bay under massive pressure from the deflected frame. All of this pressure is delivered to the top of the column just below the intersection with the beam [2]. The resulting stresses can be sufficient to cause the column to fail in shear, again leading to the progressive collapse of the structure as the loads become greater as they shift to each successive column in a chain (an example of this damage can be seen in illustration # 6).

6. MEXICO CITY, detail of concrete building showing failure of column and collapse of the brick infill after the September 19, 1985 earthquake.

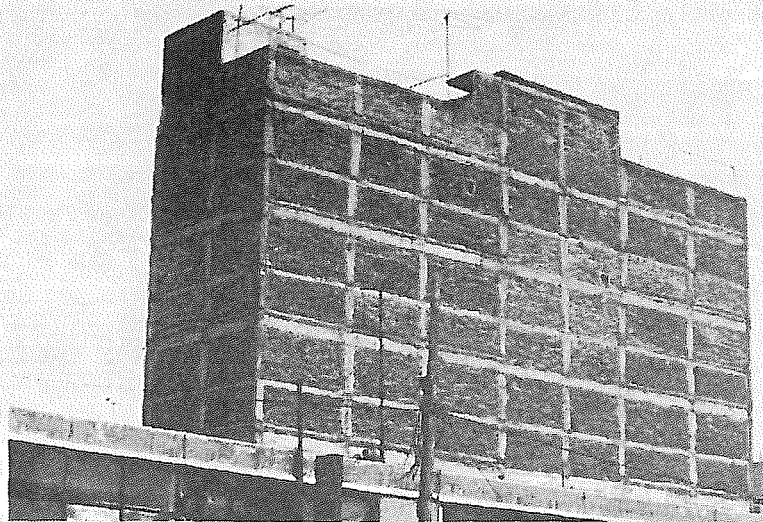
This difference was made apparent by certain examples investigated in Mexico City after the 1985 earthquake. In this earthquake, it is possible to test this hypothesis by comparing the results of the earthquake on different buildings, all of recent vintage, and all using some form of composite concrete and masonry construction. One example is a commercial building located only one block from the well documented Juarez Hospital Building, which collapsed, killing about 800 people (illustration # 7).

7. MEXICO CITY, commercial building showing concrete frame with brick infill wall construction.
