**SURVIVORS AMONGST THE RUBBLE:
Traditional Timber-laced Masonry Buildings that Survived the Great 1999
Earthquakes in Turkey and the 2001 Earthquake in India,
While Modern Buildings Fell**

Text and photographs
© Randolph Langenbach, 2002*

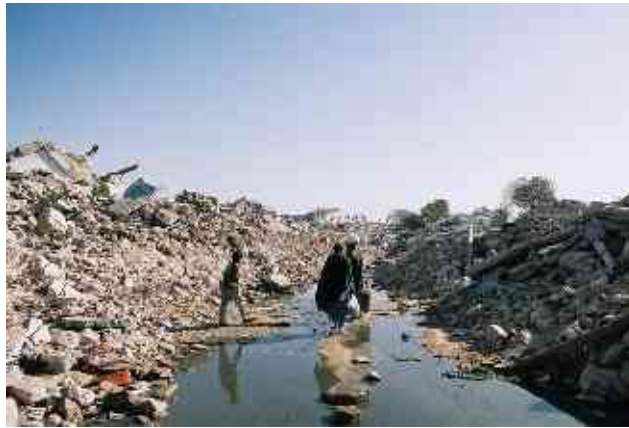
The Kocaeli and the Bhuj Earthquakes in Turkey and India were devastating disasters, with vast destruction of buildings and countless deaths and injuries in both urban and rural areas. One particular problem unique to urban areas was dramatically illustrated in the recent Bhuj Earthquake when, in the town of Anjar, several hundred school children participating in a Republic Day parade were killed while standing *outside* the buildings. This tragedy occurred because the walls of the surrounding buildings collapsed outward into the narrow street where they were standing, from which there was no escape.

Figure 1: View of Anjar City Center after the Bhuj Earthquake of January 26, 2001.

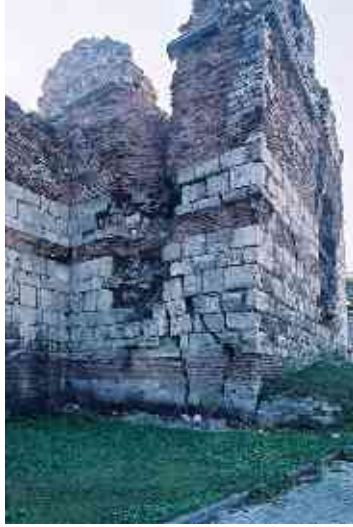
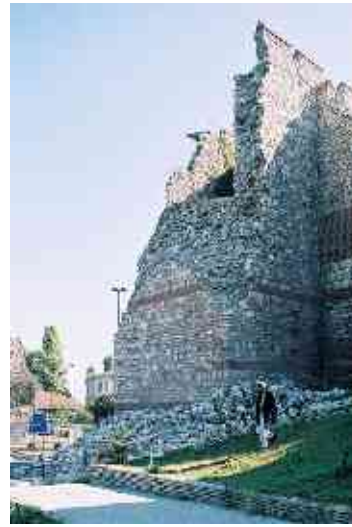
Laced Bearing Wall construction may have had its origins in ancient times as well, although it is not so identified in Vitruvius' work. An even earlier example has been identified at the Minoan "New Palace" of Knossos, dated 1450BC (Kienzle, 2002). It may also be loosely related to the utilization of horizontal bands of wide and flat Roman brick that was sometimes laid at intervals into walls composed of more random mortared masonry. At Pompeii, a number of the piers between storefronts were reconstructed with brick bands, and this construction may have been part of repairs of damage from an earthquake that occurred 17 years prior to the volcanic eruption that buried the city. This same type of construction can be found in Istanbul most notably in the medieval city walls, where the belts of red brick are an integral part of the architecture – so much so that when modern restorers reconstructed a section of the walls, they applied the brick band as a thin layer on the surface, rather than as a structural layer extending through the masonry. Interestingly, it was only this newly constructed section that collapsed when the tremors which radiated out from the distant August 17, 1999 Marmara earthquake reached Istanbul. The far more deteriorated portions of the wall where the brick bands remained in their original form remained standing.

Figure 5 & 6: Istanbul City walls showing brick banding in surviving historic section and collapsed reconstructed section with fake banding.

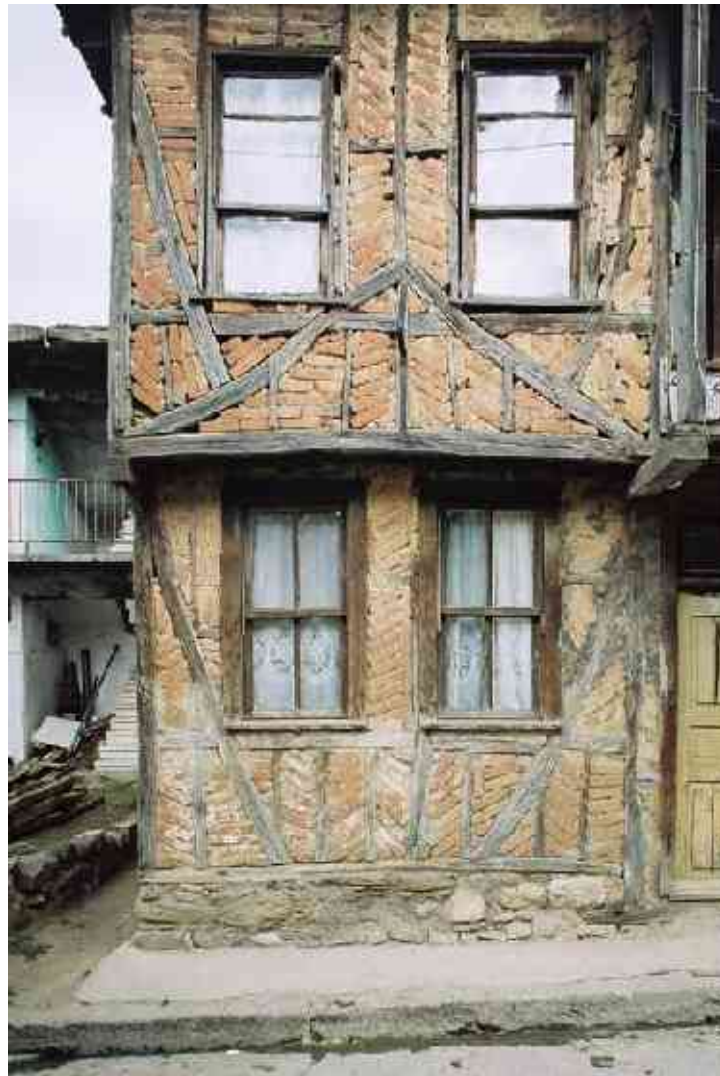
In one area surveyed in Adapazzari a single *hımış* house collapsed, killing an occupant – a rare occurrence of a death caused by the collapse of *hımış* construction. Decayed timbers could be seen in the ruins. It was the partially damaged traditional buildings here and in Gölcük provided evidence of how this type of construction responded to earthquake forces. Once each building was inspected, and the damaged area in each building identified, a pattern began to emerge. Of those inspected where structural damage was found, most of the damage was concentrated at areas around rotted timbers. Interviews with residents often revealed that the buildings with the most timber decay had been unoccupied for years. It appeared that decayed timber significantly degraded a buildings’ performance in earthquakes. In occupied houses, the most severe damage resulted mainly from alterations and modernization work that had corrupted the integrity of the original frames and walls.

Figure 11: *Hımış* house in Gölcük after earthquake constructed in 1955. There was only slight damage to the interior of this house.

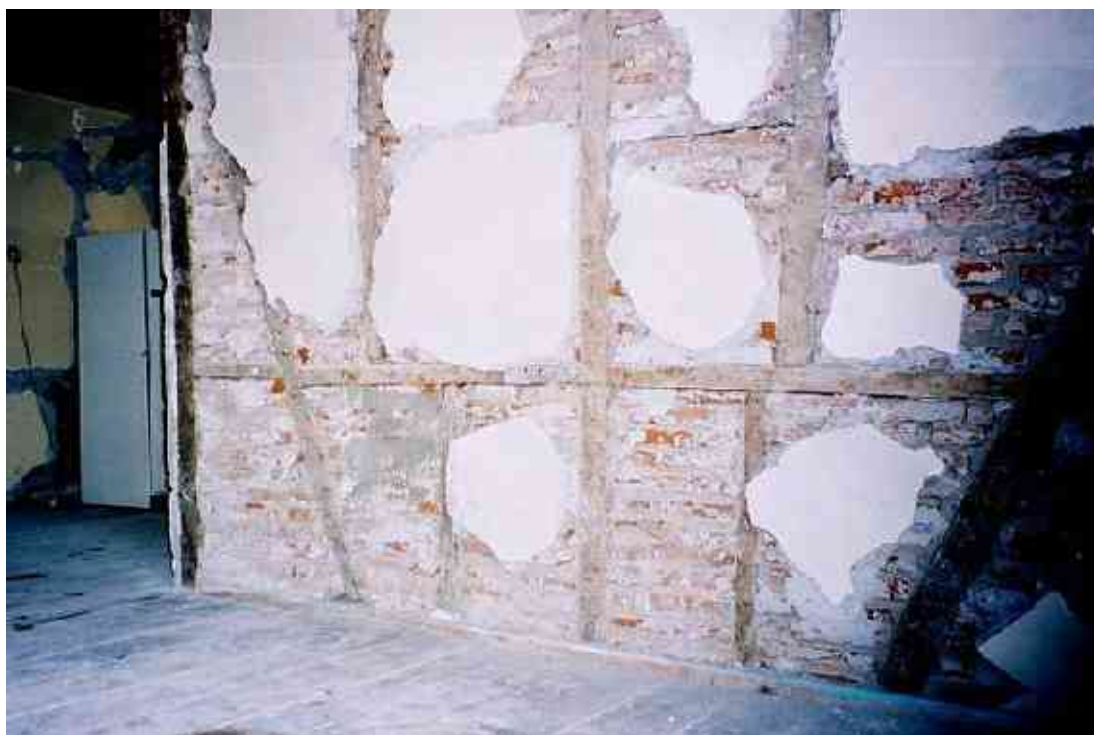
and the timber frame; that is, the straining and sliding of the masonry and timbers dissipated a significant amount of the energy of the earthquake. The only visible manifestation of this internal movement was the presence of cracks in the interior plaster along the walls and at the corners of the rooms, revealing the pattern of the timbers imbedded in the masonry underneath. This level of damage was evident in every house. On the exterior, unless the house was stuccoed, damage was impossible to see. The bricks themselves were only infrequently displaced sufficiently for a crack to be visible. The movement was primarily along the interface between the timbers and the brick panels rather than forming a crack within the panels themselves.

Figure 12: *Hımış* interior wall in Düzce after earthquake.

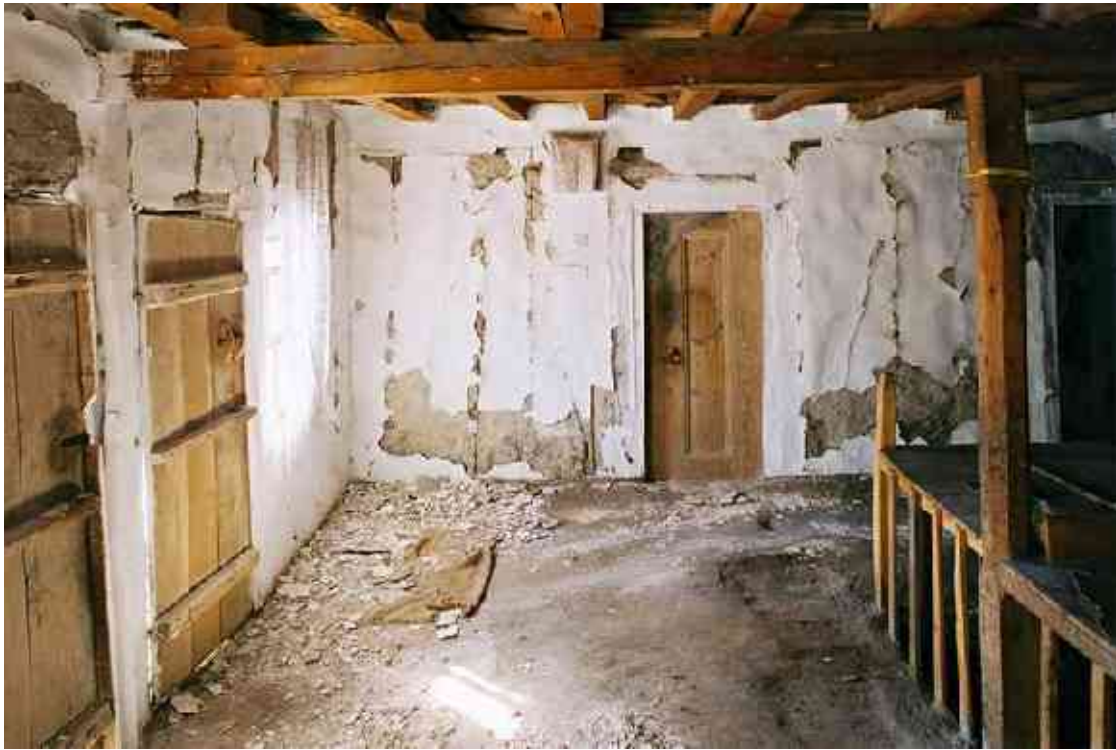
Figure 13: Interior of *hımiş* house in Orta after earthquake showing damage to mud and lime plaster over infill walls.

In this earthquake, many *hımiş* houses did suffer widespread cracking and shedding of plaster and stucco, and a few had damage to the infill masonry. This level of damage was hard to explain when compared to that found in the infill-frame houses subjected to the full brunt of the Marmara earthquake, where the shaking was stronger and continued for a longer period. The *hımiş* houses in Gölcük and Adapazari had about the same level of damage as the Orta houses. This stands in sharp contrast to the performance of the reinforced concrete buildings. While in Orta the reinforced concrete buildings were only lightly damaged, in the Marmara and Düzce earthquake area vast numbers of them suffered heavy damage or collapse.

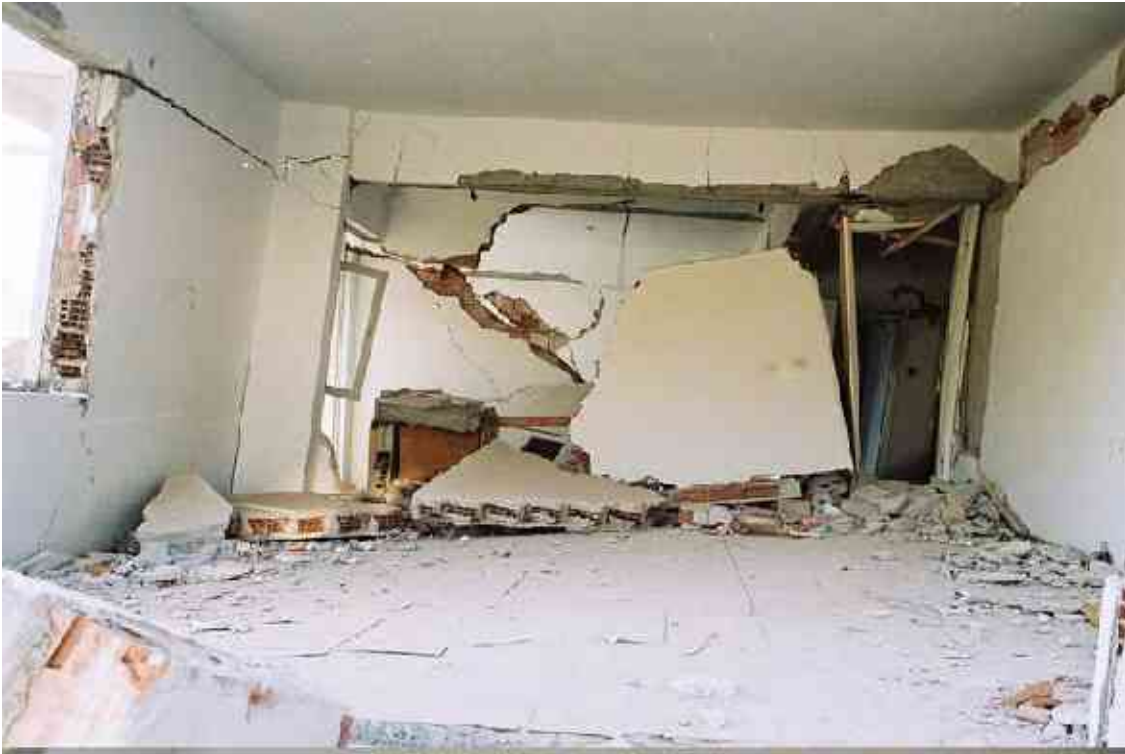
Rarely is the infill considered in the engineering design process as part of the lateral resisting system, and it is often ignored in calculations. In spite of this, the masonry infill does play a significant role that sometimes can help to save a building that has weakened joints. More often, however, it can contribute to the collapse of a building because its rapid degradation in specific areas can transfer concentrated loads onto localized parts of the frame, which are then overwhelmed. As can be seen in Figure 14, these infill walls can readily collapse completely when an earthquake distorts the building's frame. Sometimes, to avoid damage to the surrounding reinforced concrete frame from the “diagonal strut” effect, where the stiff infill causes a corner column to break, leading to collapse, the infill material is sometimes deliberately separated from the frame.

Figure 14: Collapsed interior infill wall in reinforced concrete building in Gölcük

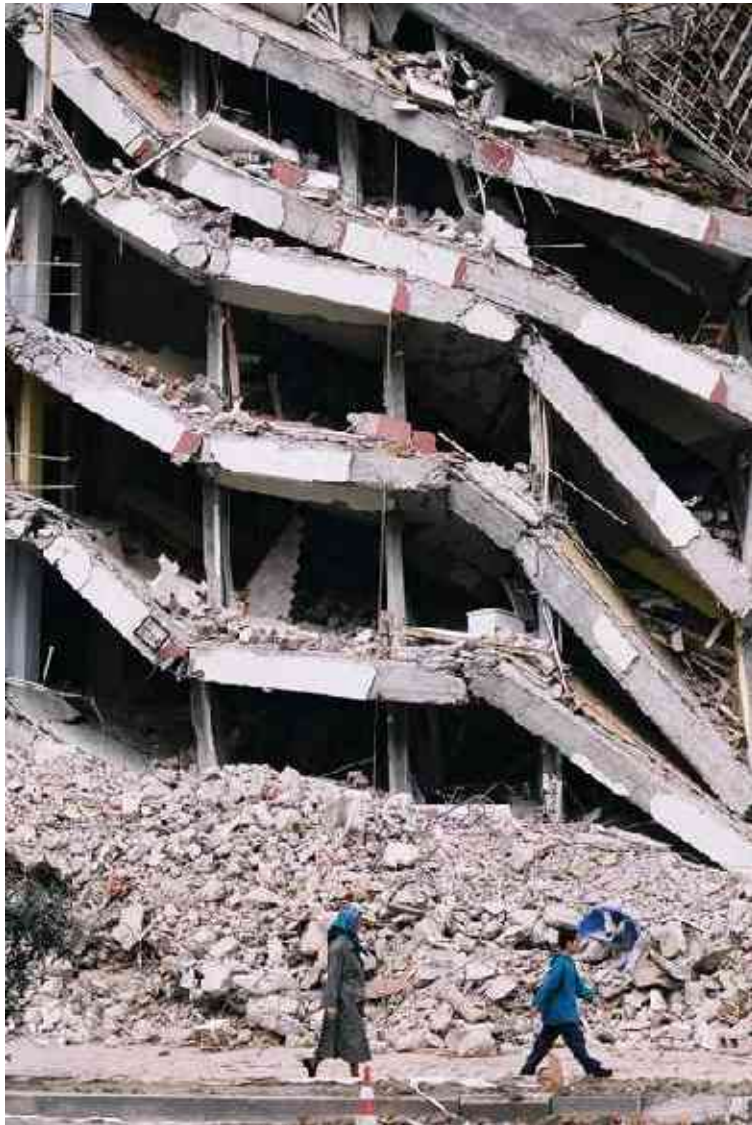
Figure 15: Collapsed Reinforced concrete building in Gölcük.
