**SURVEY REPORT ON NORTHERN KASHMIR EARTHQUAKE OF  
OCTOBER 8, 2005  
FROM THE INDIAN KASHMIR SIDE OF THE LINE OF CONTROL**

**By Randolph Langenbach**

Building Conservation Consultant, Oakland, California

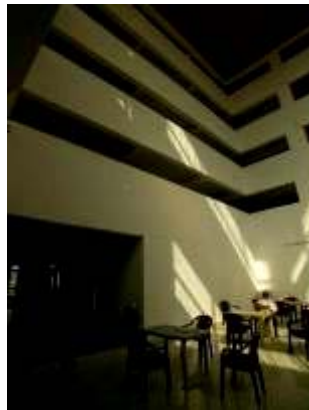
described the shaking as having lasted for two minutes. Because he was on the third floor at an end of the building remote from the stairs, and he described the swaying of the trees which he could only have witnessed from the ground at the opposite end of the building, the lengthy duration is plausible. In spite of the shaking that was experienced, the only damage that I was able to find in Srinagar itself was seen in the Heemal Hotel, next to Dal Lake, where a slight crack at ground floor level could be seen between the RC frame and masonry infill. [Figures 4&5]

**Figure 4: Interior of five story Heemal Hotel showing location of crack in figure 5.**

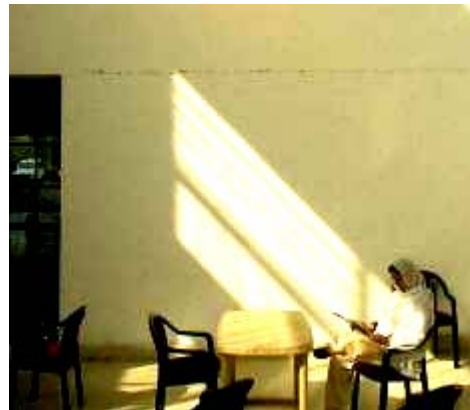
**Figure 4: This crack shows how minor the earthquake damage is, because it is only the propagation through the surface plaster of the interface between infill and the RC frame.**

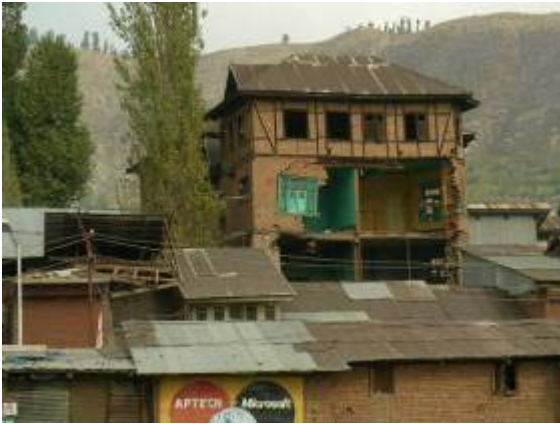
river. The damage consisted of the collapse of the front load bearing masonry wall up to the level of the top story of Dhajji Dewari construction, which remained in place. [Figures 9 & 10]

**Figure 9:** Large house in Baramula showing collapse of URM wall, leaving Dhajji Dewari construction wall in place above.

The remarkable bridging effect of the surviving walls at the top of the structure was a condition seen also in a number of photographs posted from media reports of the earthquake. The Dhajji Dewari construction – frequently used for the upper floors of masonry buildings, has proved to be remarkably resilient in this earthquake, even when all support from the walls below has fallen away.

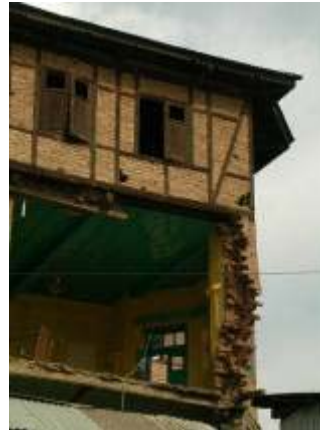
**Figure 10:** Detail of collapsed wall in building shown in Figure 9.

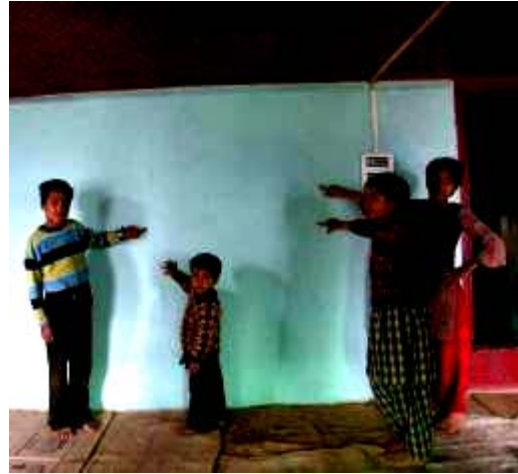
We had time to be invited into one home in the historic center. In the interior of this house, the evidence of earthquake damage was limited to hairline cracks in the plaster over Dhajjis Dewari walls where the infill masonry walls contacted the timber. Larger cracks could be found on the inside face of the exterior and party walls with the neighboring house at the corner of the stairway. None of these cracks indicated a threat

to the stability of the building, but the occupants expressed a degree of concern as they are unfamiliar with what the cracks signify. [Figure 13]

Figure 13: Interior of ca. 1900 house in Baramula showing cracks where the people are pointing. The cracks are limited to plaster cracks around the Dhajji Dewari infill panels.

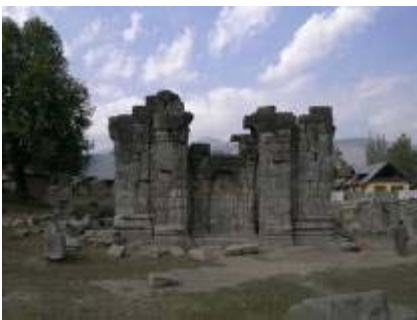
**Fatehgarh:** The village of Fatehgarh is 7 KM from Baramula and is the location of the Shiva Temple, a 9<sup>th</sup> or 10<sup>th</sup> Century archeological site. At this site, the ASI staff explained that the earthquake had made some existing dislocations of the large ashlar blocks larger, and, in one location, one large and one small block fell. [Figures 14-16] Because the temple is an incomplete ruin, the individual sections of stonework are free to vibrate independently, so such damage would not be unexpected. The fact that the damage was not greater, together with the low level of damage in the village, indicates that the shaking at this location was not severe.

Figure 14: Shiva Temple, Fatehgarh. Stones in Fig.15 show some shifting from earthquake.

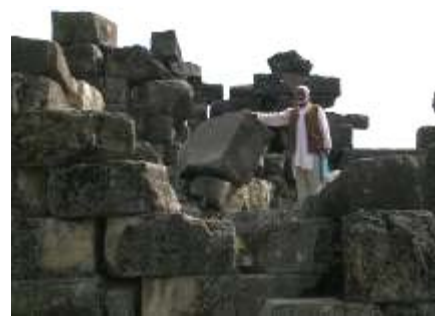
Figure 16: This large stone block under the man's hand is the only block to fall off the wall in the earthquake.

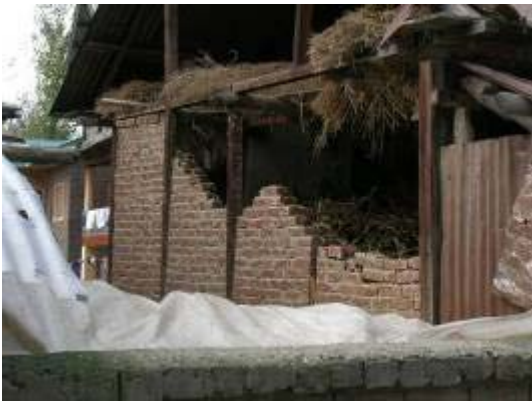
Across the way from the temple is a small mosque of recent origin. Damage visible on the interior was limited to cracks above the windows. One barn seen in the village had lost some of the masonry from between the wood studs of its Dhajji Dewari upper gable,

and in the location where the timber was missing there was evidence that the timber had been weakened because of heavy infestation by insects. [Figure 16] Another house in this village was found to have vertical cracks revealing the empanelling of the masonry construction that is characteristic of traditional bearing wall construction in Kashmir, known as *Taq*. In this form of construction, rather than walls of uniform thickness of bonded masonry, the masonry is constructed as a series of thick piers, and with thinner walls in between that are not bonded to the piers. In this form, the masonry is all held together usually with horizontal timbers above and below the windows, and at the floor levels. The damage caused by the earthquake vibrations in this house serves to reveal this feature of the masonry construction, which may have been devised to allow for differential settlement on soft soil sites, avoiding the development of X cracks. (Figure 17)

Figure 16: Dhajji Dewari wall in barn that partially collapsed because of insect infested timbers.

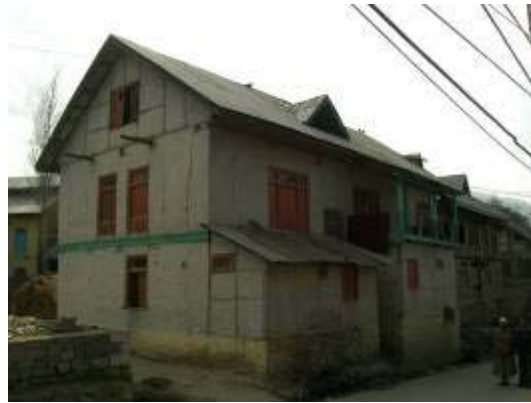
Figure 17: Taq construction house where movement from the earthquake reveals where the masonry panels are disconnected from the piers.

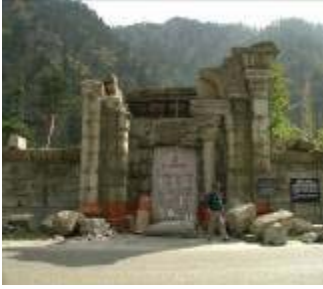
**Buniyar Temple:** The Buniyar Temple (ca. 9<sup>th</sup>-12<sup>th</sup> Century Hindu Temple), is located 23 km from Uri and 22km from Baramula. It is now surrounded by an Indian Army base, and the army shares responsibility for it with ASI. This was the first of the archeological monuments seen during this survey to have suffered significant damage. The top arch and lintel of the main gateway collapsed, and the large stone blocks from this were still lying at the base outside the wall of the compound. One of the causes for this may have been the compression failure of the round column to the left of the doorway, which can be seen lying in front of the door with the broken shaft visible. A similar diagonal break can be seen in the still standing column on the interior of the gateway that is now leaning dangerously outward, held only by the weight of the shifted large stone lintel above. This column and lintel were the only items seen in the ASI monuments of an immediate life safety risk. This element should be shored, and dismantled to avoid eventual collapse that will destroy the stones. [Figures 18 & 19]

Figure 18: Buniyar Temple gate showing fallen stones from the collapsed column and top lintel.

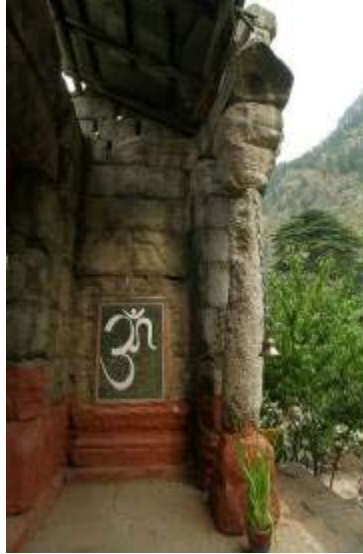
Figure 19: Leaning column. Bell chain shows vertical line.

It appeared on examination that the stone of this monument has suffered from deterioration from weathering. The stone appears to be a kind of weathered conglomerate that has developed mineral crusts that are easily broken off, carrying away the original dressed surface with the crust. [Figure 20] Inspection of the cracked and leaning column on the inside of the gateway indicat

es that the stone has lost a considerable portion of its dimension at the base of the round shaft from such deterioration, and that the remaining stone is weak and friable.

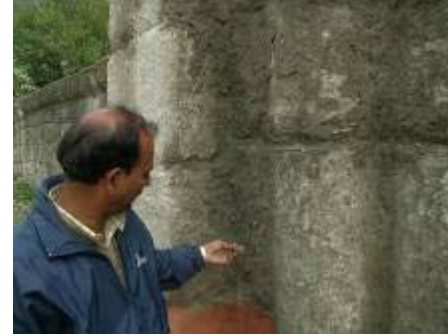
Figure 20: Stone encrusted with mineral byproducts of deterioration.

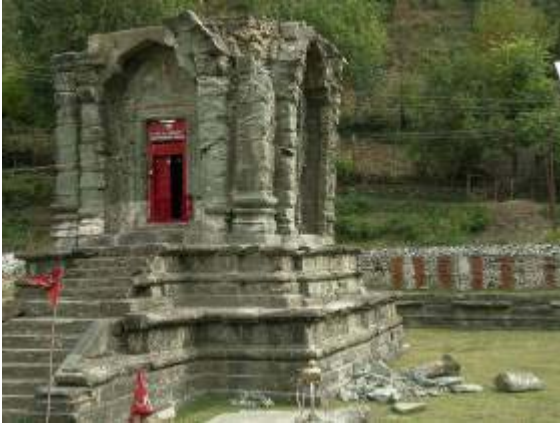
The earthquake caused some stones to fall from the right side of the main sanctuary and caused the separation of many of the stones at the top of the structure. The section of concrete block did manage to stay together as one piece, but the stones around the edge

of the roof were disturbed, with large cracks having opened up from the spreading of the stones, few of which were adequately mortared together. The existence of what appeared to be a modern reinforced concrete roof may have contributed to the damage to the masonry, but the roof itself remained intact. [Figure 21 & 22]

Figure 21: Detha Mandir Temple showing stones thrown off from the top of the wall. It appears that unconsolidated and deteriorated stone work surrounded a later reinforced concrete roof, which is set back from the edge of the structure. Differences in the vibrations between the roof and surrounding stonework may have contributed to the damage.

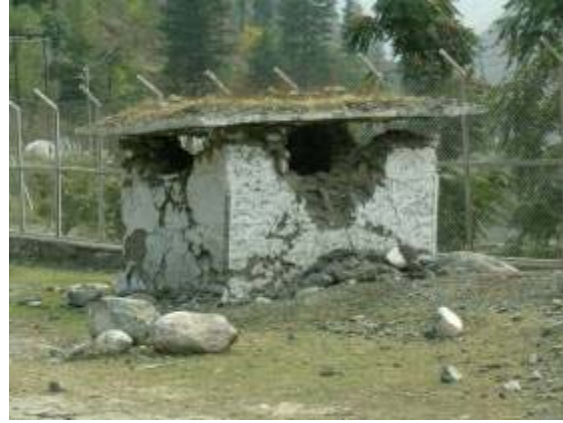
Figure 22: A small military structure near to the Detha Mandir Temple provides an example of damage associated with rigid concrete roofs on rubble masonry walls. A nearby similar structure with a timber and heavy sod roof remained completely intact.

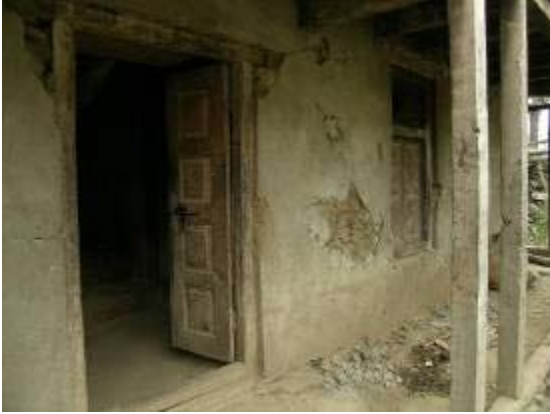
**Timber-laced masonry house:** Opposite this temple we visited the family living in one dwelling, and we inspected the damage to the two and a half story house. It was of relatively recent construction. This structure was a masonry bearing wall structure with interior partitions of Dhajji Dewari construction. The earthquake revealed that there was timber lacing in the exterior bearing walls - at least on the ground floor. The exterior had been stuccoed with concrete stucco. There were many cracks in the structure, but it had held together well. The movement served to reveal the Dhajji Dewari by opening up a crack around each of the panels through the paint and plaster, but the walls themselves were not reduced in capacity. The government had provided a tent for the family, in which the family stayed immediately after the earthquake, but they soon moved back into the dwelling, and no repairs had been undertaken. The damage to the structure did not appear to have reduced its capacity significantly, although cracks were to be seen in all of the rooms of the house. [Figures 23 & 24]

**Figure 23:** The earthquake caused stresses in the ground floor wall to cause the shedding of the concrete stucco, but the horizontal timber lacing helped hold the wall from cracking and collapsing.

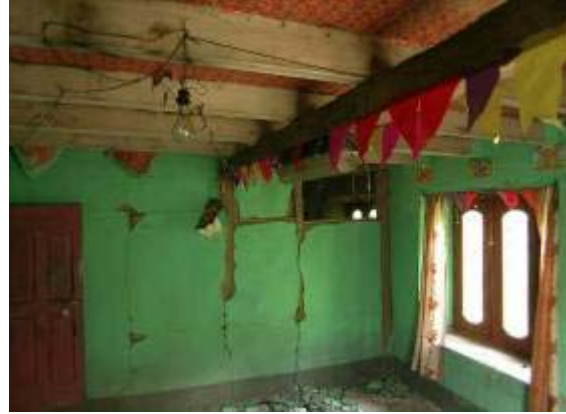
**Figure 24:** The interior of the same house shows how the plaster cracks reveal the location of the Dhajji Dewari construction infill panels.

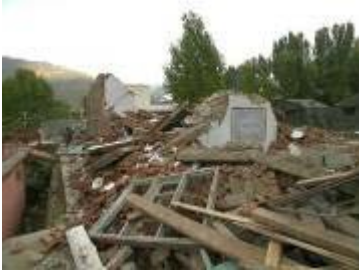
The government complex was inaugurated in 1982 for the Jammu and Kashmir State Government. Many of the buildings in the government complex were destroyed or heavily damaged. The most conspicuous among these was the school - which was totally destroyed, leaving only the walls with the blackboards and one short section of the wall of the building standing. The walls of the school were of rubble stone and fired brick in cement-lime mortar, and the floors and roof were timber. There were no ties, and the joists and beams of the floors did not penetrate the walls. In the wreckage there was evidence that the structure had a concrete bond beam, which lay broken on the top of the pile. (It is unknown how much further demolition was carried out after the earthquake.) It appeared from the one section still standing that the joists ran parallel to the building, which meant that the long exterior walls may have been largely free standing without attachment to the floor system. [Figure 25]

**Figure 25: Totally collapsed unreinforced masonry school building in Uri Government Complex.**

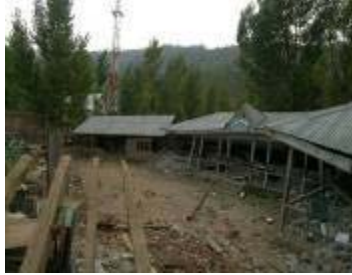
**Figure 26: Collapsed School buildings in Uri Government Complex.**

Two other smaller structures that were a part of the school were also destroyed. One was totally collapsed, with only the roof remaining intact resting on the fallen walls, and the other partially collapsed. Figures 26 & 27] These buildings lacked the kind of timber lacing found in traditional construction - and also used as we had seen in the house near to the Detha Mandir Temple [Figure 23 & 24], which had been constructed around the same time as this school. It appears also that most of the other government complex buildings were masonry with thin reinforced concrete floor slabs, rather than with timber joists and wooden floors. In this case, the flexible timber floors combined with the lack of ties and the short depth of the timber joists into the walls, as well as the complete lack of attachment of the floors to the walls parallel to the joists, may explain the complete collapse of this structure, while most of the other structures were only partially collapsed.

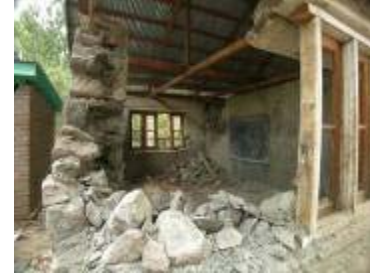
**Figure 27: Detail of rubble masonry construction of school building seen on left in Figure 26.**

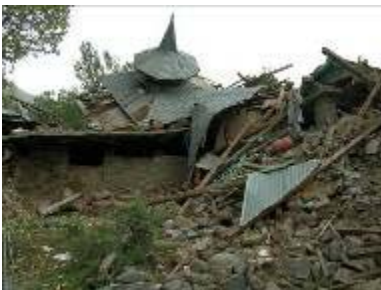
The standard form of construction in many of the other buildings in the government complex was (1) ground floor walls of rubble stone, (2) upper floor walls of brick, (3) floors of two-way RC slabs, (4) roofs of light timber covered with sheet metal. Some buildings had stone to the roof, and others had brick from the foundation to the roof. The brick walls generally fared better than the stone walls. A mosque near the school was also demolished so completely as to make it impossible to discern its original shape and configuration. It appeared to have been masonry with a reinforced concrete slab and wooden roof. Figure 28]

**Figure 28: Collapsed Mosque in Uri Government complex.**

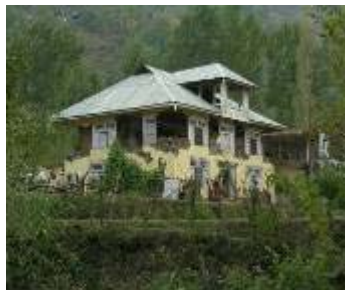
**Figure 29: Collapsed rubble masonry building in Uri Government complex.**

The other structures in the complex surrounding the collapsed mosque were mostly residential structures. Those structures that were constructed of brick from the foundation up most often manifested damage at the ground story level in the form of diagonal tension “X” cracks. Some of these structures were close to collapse. In contrast to these buildings, those structures that had rubble stone construction extending to the top of the walls tended to collapse from the top down. There were several buildings that were still standing, but the stone walls had fallen away, leaving the roof held up by the interior partitions and the wooden window frames. None of these walls manifested diagonal tension cracks. Instead, the masonry appeared to have crumbled in place. From what could be seen in our short visit, there was no evidence of deliberate bonding of the walls either with stone bond courses, or by any other means, and the mortar was very poor or non-existent. The mortar appeared to have contained cement, but it appeared that the cement had failed to fully hydrate from premature drying out, as the mortar was brittle but the collapsed stones were largely clean and free of mortar. [Figures 29 & 30]

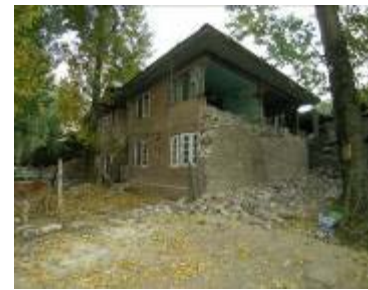
**Figure 30: Brick building with rubble stone end walls in Uri Government complex.**

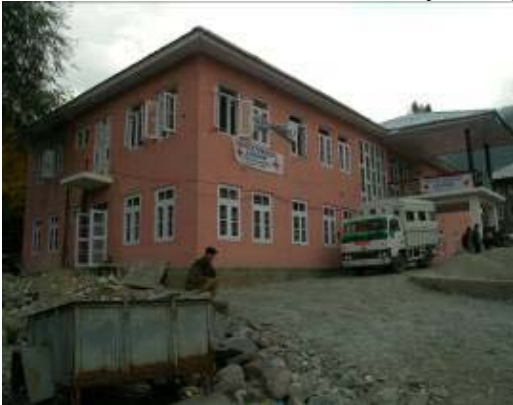
There were two structures in the complex that did surprisingly well, in light of the almost universal poor performance of the others. One of these, which was fortunately the medical clinic, was still in operation. [Figure 31] The other had formed a part of the clinic, but because of the collapse of the walls around its stair tower, it was out of operation. [Figure 32] Time limits prevented close examination of these facilities on the interior. From the exterior, however, it was evident that the functioning clinic was constructed entirely of brick with concrete floors, rather than with rubble stone at the ground floor level. It appeared to be of more recent vintage than the other structures in the complex, and of better construction. The smaller clinic building, which suffered the collapse of its stair tower walls, had stone at the ground floor level and brick above, but in this case, the stone walls remained intact, except where they extended out to form the base of the stair tower, where they collapsed.

Figure 31: This Medical Clinic in Uri Government complex was not significantly damaged, and is still in use.

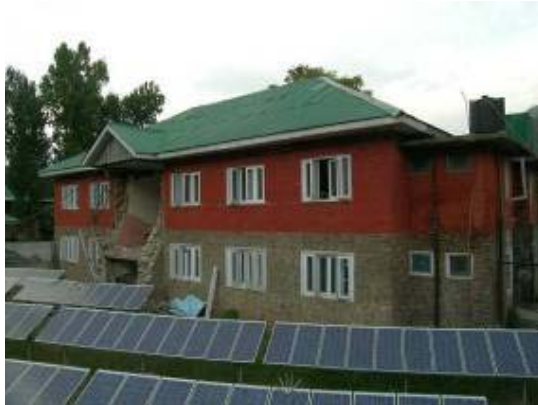
Figure 32: Adjacent annex to medical clinic was only slightly damaged except for the collapse of the walls of the stairway, which rendered it unusable.

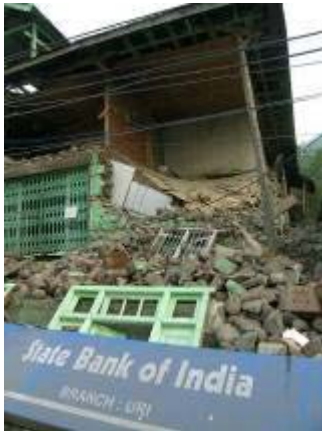
What was notable was that in Uri, although the damage was heavy and pervasive, it was insufficient to shut down the normal life and business of the town. Many of the shops and offices were functioning, even in buildings that had sustained damage. [Figure 35] The kind of damage that had disrupted what would have been thought to be the more substantial buildings of the Government complex was rare in the market town. Walls were cracked and breached in some buildings, with some collapses, but most buildings were either totally of timber, or had Dhajji Dewari walls that remained intact. [Figure 36] Those buildings of rubble stone without timber lacing suffered similar failures to those in the government complex. In many of these, the stone was laid in mud mortar without bond courses. [Figure 33 & 37]

Figure 33 (left): State Bank Building collapsed in Uri.

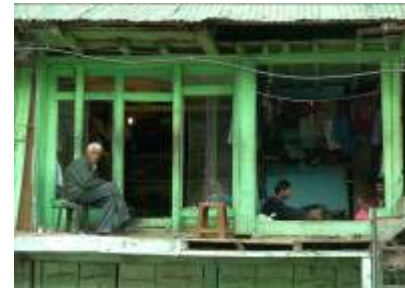
Figure 35: In Uri, this and many other shops were open and in active use in wooden buildings, or even some partially damaged masonry buildings.

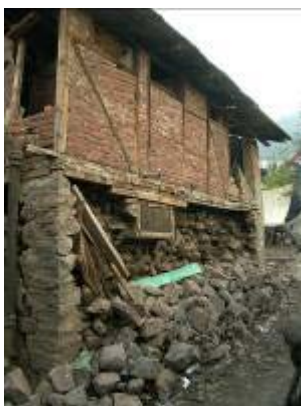
Figure 36: Intact Dhajji Dewari wall above collapsed rubble masonry wall.

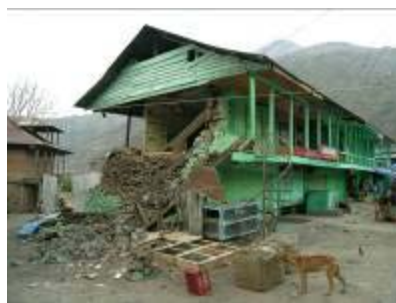
Figure 37: Rubble masonry building with all walls collapsed but front where balcony and timber door frames held the stone together.

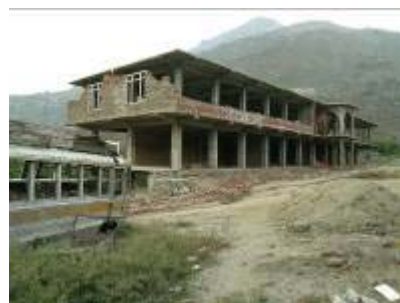
There were several reinforced concrete buildings that were under construction at the time of the earthquake, and these survived intact. In one instance, where the infill masonry was being installed, some of this infill fell over, but the frame remained standing undamaged (unless closer inspection, which I could not undertake in the time available, reveals cracks in the beam column joints). [Figure 38]

Figure 38: Reinforced Concrete structure under construction at time of earthquake. Undamaged, except for out-of-plane collapse of some infill masonry.
