**SURVEY REPORT ON NORTHERN KASHMIR EARTHQUAKE OF  
OCTOBER 8, 2005  
FROM THE INDIAN KASHMIR SIDE OF THE LINE OF CONTROL**

**By Randolph Langenbach**

This report is from observations made from a trip into the Indian side of Kashmir from October 24 to 29, 2005, including a trip into the damage district as far as Uri on October 25. This survey is limited to observations made along state highway 1A from Srinagar to Baramula and Uri. This survey of the damage was facilitated by the Archaeological Survey of India, and included visits to four historical monuments and archeological sites on this route that are under their jurisdiction. The trip to the damage district also included visits to the historic city of Baramula, to Uri, and several villages in the same region.

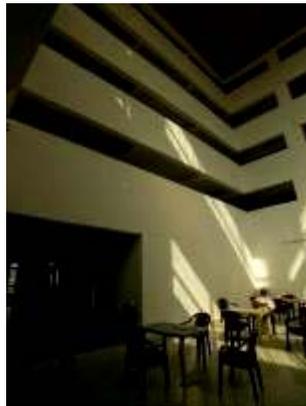
described the shaking as having lasted for two minutes. Because he was on the third floor at an end of the building remote from the stairs, and he described the swaying of the trees which he could only have witnessed from the ground at the opposite end of the building, the lengthy duration is plausible. In spite of the shaking that was experienced, the only damage that I was able to find in Srinagar itself was seen in the Heemal Hotel, next to Dal Lake, where a slight crack at ground floor level could be seen between the RC frame and masonry infill. [Figures 4&5]

**Figure 4: Interior of five story Heemal Hotel showing location of crack in figure 5.**

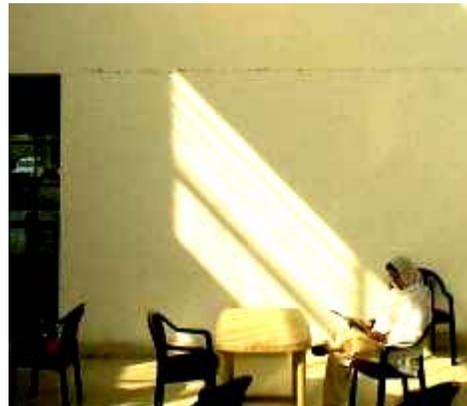
**Figure 4: This crack shows how minor the earthquake damage is, because it is only the propagation through the surface plaster of the interface between infill and the RC frame.**

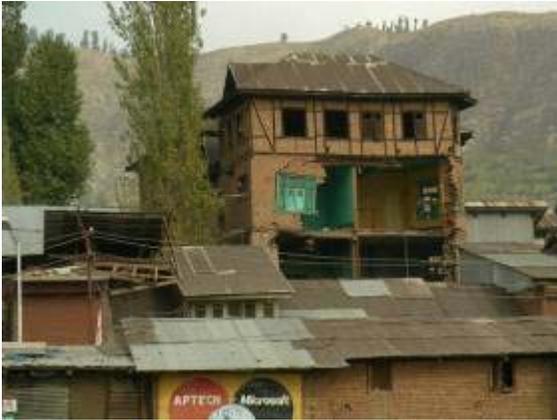
river. The damage consisted of the collapse of the front load bearing masonry wall up to the level of the top story of Dhajji Dewari construction, which remained in place. [Figures 9 & 10]

**Figure 9:** Large house in Baramula showing collapse of URM wall, leaving Dhajji Dewari construction wall in place above.

The remarkable bridging effect of the surviving walls at the top of the structure was a condition seen also in a number of photographs posted from media reports of the earthquake. The Dhajji Dewari construction – frequently used for the upper floors of masonry buildings, has proved to be remarkably resilient in this earthquake, even when all support from the walls below has fallen away.

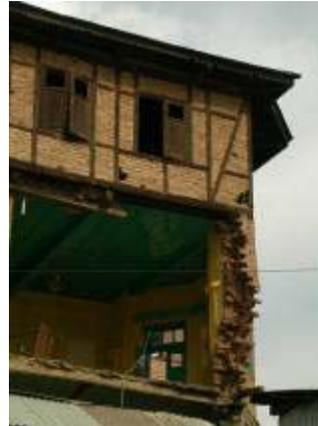
**Figure 10:** Detail of collapsed wall in building shown in Figure 9.

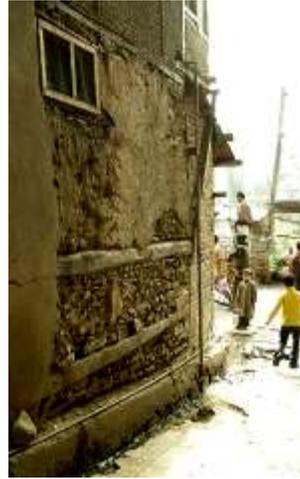
Figure 12: Timber lacing in URM wall of house in Baramula.

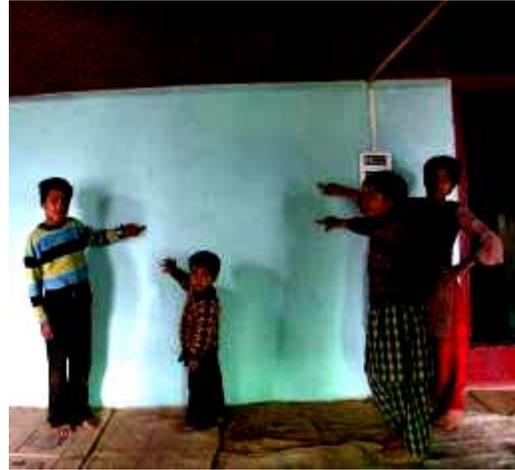
We had time to be invited into one home in the historic center. In the interior of this house, the evidence of earthquake damage was limited to hairline cracks in the plaster over Dhajjis Dewari walls where the infill masonry walls contacted the timber. Larger cracks could be found on the inside face of the exterior and party walls with the neighboring house at the corner of the stairway. None of these cracks indicated a threat

to the stability of the building, but the occupants expressed a degree of concern as they are unfamiliar with what the cracks signify. [Figure 13]

Figure 13: Interior of ca. 1900 house in Baramula showing cracks where the people are pointing. The cracks are limited to plaster cracks around the Dhajji Dewari infill panels.

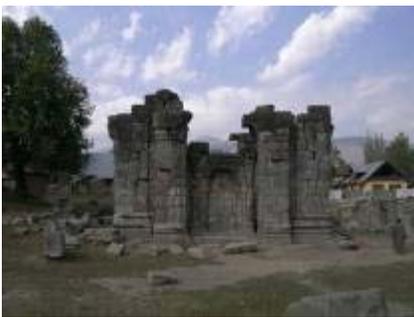
**Fatehgarh:** The village of Fatehgarh is 7 KM from Baramula and is the location of the Shiva Temple, a 9<sup>th</sup> or 10<sup>th</sup> Century archeological site. At this site, the ASI staff explained that the earthquake had made some existing dislocations of the large ashlar blocks larger, and, in one location, one large and one small block fell. [Figures 14-16] Because the temple is an incomplete ruin, the individual sections of stonework are free to vibrate independently, so such damage would not be unexpected. The fact that the damage was not greater, together with the low level of damage in the village, indicates that the shaking at this location was not severe.

Figure 14: Shiva Temple, Fatehgarh. Stones in Fig.15 show some shifting from earthquake.

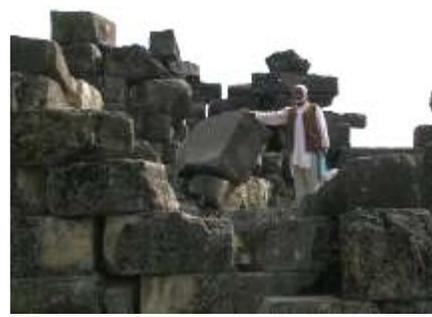
Figure 16: This large stone block under the man's hand is the only block to fall off the wall in the earthquake.

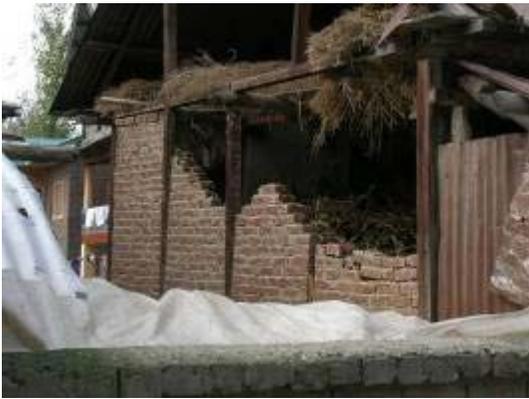
and in the location where the timber was missing there was evidence that the timber had been weakened because of heavy infestation by insects. [Figure 16] Another house in this village was found to have vertical cracks revealing the empanelling of the masonry construction that is characteristic of traditional bearing wall construction in Kashmir, known as *Taq*. In this form of construction, rather than walls of uniform thickness of bonded masonry, the masonry is constructed as a series of thick piers, and with thinner walls in between that are not bonded to the piers. In this form, the masonry is all held together usually with horizontal timbers above and below the windows, and at the floor levels. The damage caused by the earthquake vibrations in this house serves to reveal this feature of the masonry construction, which may have been devised to allow for differential settlement on soft soil sites, avoiding the development of X cracks. (Figure 17)

Figure 16: Dhajji Dewari wall in barn that partially collapsed because of insect infested timbers.

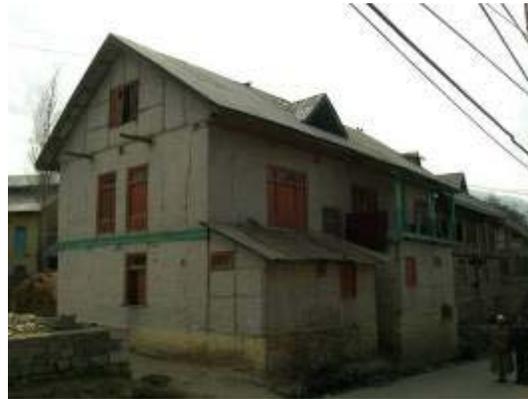
Figure 17: Taq construction house where movement from the earthquake reveals where the masonry panels are disconnected from the piers.

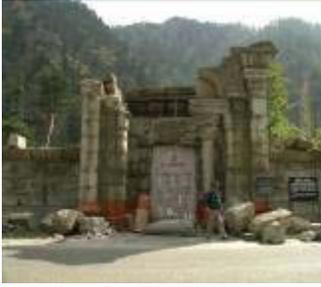
**Buniyar Temple:** The Buniyar Temple (ca. 9<sup>th</sup>-12<sup>th</sup> Century Hindu Temple), is located 23 km from Uri and 22km from Baramula. It is now surrounded by an Indian Army base, and the army shares responsibility for it with ASI. This was the first of the archeological monuments seen during this survey to have suffered significant damage. The top arch and lintel of the main gateway collapsed, and the large stone blocks from this were still lying at the base outside the wall of the compound. One of the causes for this may have been the compression failure of the round column to the left of the doorway, which can be seen lying in front of the door with the broken shaft visible. A similar diagonal break can be seen in the still standing column on the interior of the gateway that is now leaning dangerously outward, held only by the weight of the shifted large stone lintel above. This column and lintel were the only items seen in the ASI monuments of an immediate life safety risk. This element should be shored, and dismantled to avoid eventual collapse that will destroy the stones. [Figures 18 & 19]

Figure 18: Buniyar Temple gate showing fallen stones from the collapsed column and top lintel.

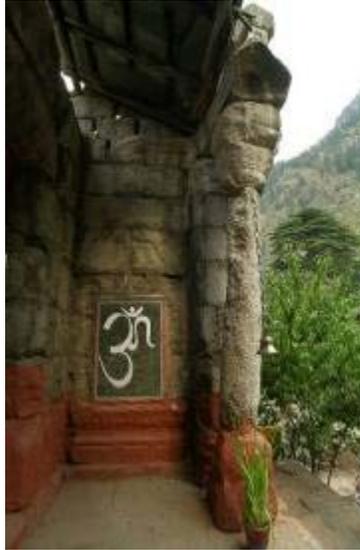
Figure 19: Leaning column. Bell chain shows vertical line.

It appeared on examination that the stone of this monument has suffered from deterioration from weathering. The stone appears to be a kind of weathered conglomerate that has developed mineral crusts that are easily broken off, carrying away the original dressed surface with the crust. [Figure 20] Inspection of the cracked and leaning column on the inside of the gateway indicat

es that the stone has lost a considerable portion of its dimension at the base of the round shaft from such deterioration, and that the remaining stone is weak and friable.

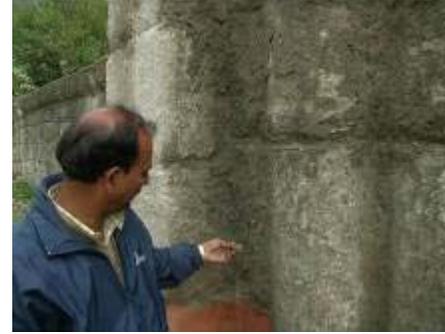
Figure 20: Stone encrusted with mineral byproducts of deterioration.

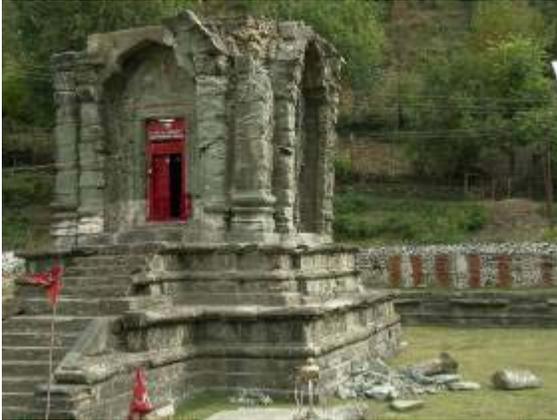
The earthquake caused some stones to fall from the right side of the main sanctuary and caused the separation of many of the stones at the top of the structure. The section of concrete block did manage to stay together as one piece, but the stones around the edge

of the roof were disturbed, with large cracks having opened up from the spreading of the stones, few of which were adequately mortared together. The existence of what appeared to be a modern reinforced concrete roof may have contributed to the damage to the masonry, but the roof itself remained intact. [Figure 21 & 22]

**Figure 21:** Detha Mandir Temple showing stones thrown off from the top of the wall. It appears that unconsolidated and deteriorated stone work surrounded a later reinforced concrete roof, which is set back from the edge of the structure. Differences in the vibrations between the roof and surrounding stonework may have contributed to the damage.

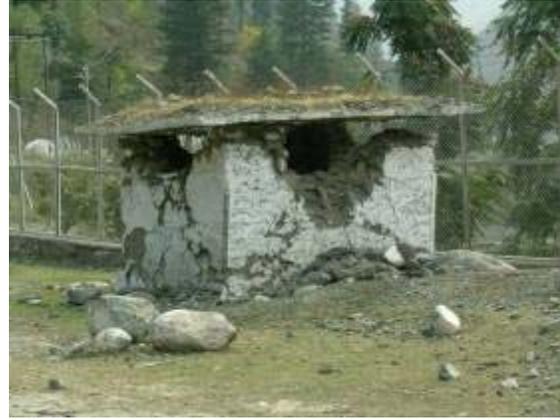
**Figure 22:** A small military structure near to the Detha Mandir Temple provides an example of damage associated with rigid concrete roofs on rubble masonry walls. A nearby similar structure with a timber and heavy sod roof remained completely intact.

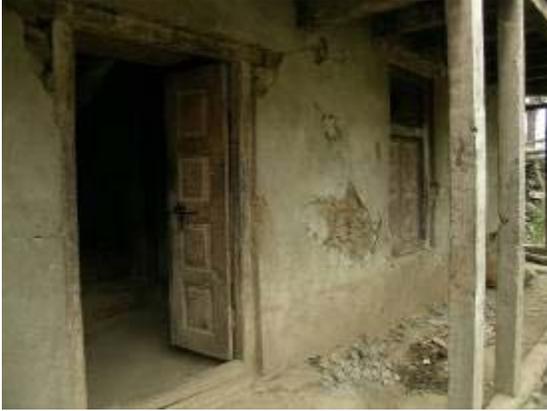
**Timber-laced masonry house:** Opposite this temple we visited the family living in one dwelling, and we inspected the damage to the two and a half story house. It was of relatively recent construction. This structure was a masonry bearing wall structure with interior partitions of Dhajji Dewari construction. The earthquake revealed that there was timber lacing in the exterior bearing walls - at least on the ground floor. The exterior had been stuccoed with concrete stucco. There were many cracks in the structure, but it had held together well. The movement served to reveal the Dhajji Dewari by opening up a crack around each of the panels through the paint and plaster, but the walls themselves were not reduced in capacity. The government had provided a tent for the family, in which the family stayed immediately after the earthquake, but they soon moved back into the dwelling, and no repairs had been undertaken. The damage to the structure did not appear to have reduced its capacity significantly, although cracks were to be seen in all of the rooms of the house. [Figures 23 & 24]

**Figure 23:** The earthquake caused stresses in the ground floor wall to cause the shedding of the concrete stucco, but the horizontal timber lacing helped hold the wall from cracking and collapsing.

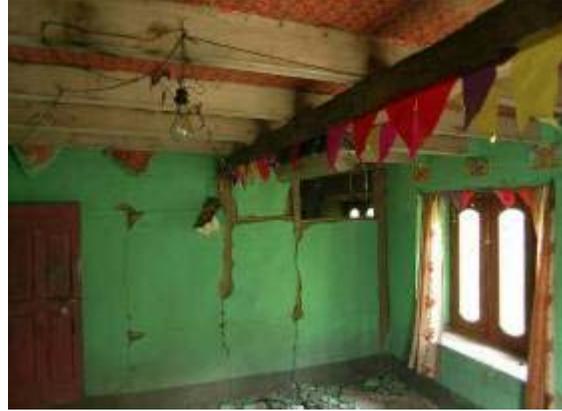
**Figure 24:** The interior of the same house shows how the plaster cracks reveal the location of the Dhajji Dewari construction infill panels.

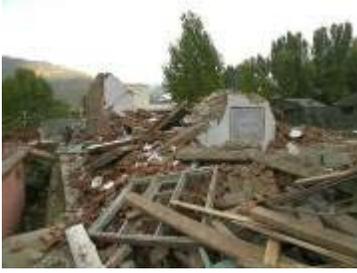
The government complex was inaugurated in 1982 for the Jammu and Kashmir State Government. Many of the buildings in the government complex were destroyed or heavily damaged. The most conspicuous among these was the school - which was totally destroyed, leaving only the walls with the blackboards and one short section of the wall of the building standing. The walls of the school were of rubble stone and fired brick in cement-lime mortar, and the floors and roof were timber. There were no ties, and the joists and beams of the floors did not penetrate the walls. In the wreckage there was evidence that the structure had a concrete bond beam, which lay broken on the top of the pile. (It is unknown how much further demolition was carried out after the earthquake.) It appeared from the one section still standing that the joists ran parallel to the building, which meant that the long exterior walls may have been largely free standing without attachment to the floor system. [Figure 25]

**Figure 25: Totally collapsed unreinforced masonry school building in Uri Government Complex.**

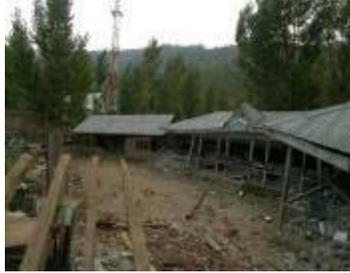
**Figure 26: Collapsed School buildings in Uri Government Complex.**

Two other smaller structures that were a part of the school were also destroyed. One was totally collapsed, with only the roof remaining intact resting on the fallen walls, and the other partially collapsed. Figures 26 & 27] These buildings lacked the kind of timber lacing found in traditional construction - and also used as we had seen in the house near to the Detha Mandir Temple [Figure 23 & 24], which had been constructed around the same time as this school. It appears also that most of the other government complex buildings were masonry with thin reinforced concrete floor slabs, rather than with timber joists and wooden floors. In this case, the flexible timber floors combined with the lack of ties and the short depth of the timber joists into the walls, as well as the complete lack of attachment of the floors to the walls parallel to the joists, may explain the complete collapse of this structure, while most of the other structures were only partially collapsed.

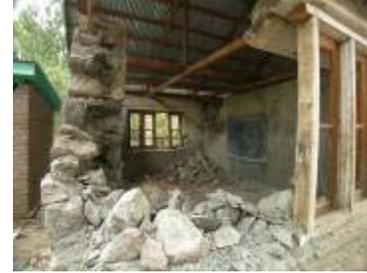
**Figure 27: Detail of rubble masonry construction of school building seen on left in Figure 26.**

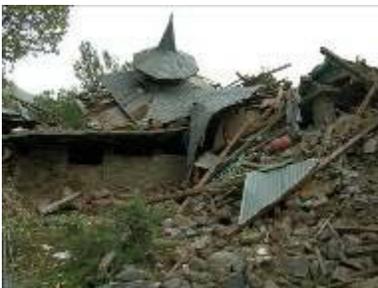
The standard form of construction in many of the other buildings in the government complex was (1) ground floor walls of rubble stone, (2) upper floor walls of brick, (3) floors of two-way RC slabs, (4) roofs of light timber covered with sheet metal. Some buildings had stone to the roof, and others had brick from the foundation to the roof. The brick walls generally fared better than the stone walls. A mosque near the school was also demolished so completely as to make it impossible to discern its original shape and configuration. It appeared to have been masonry with a reinforced concrete slab and wooden roof. Figure 28]

**Figure 28: Collapsed Mosque in Uri Government complex.**

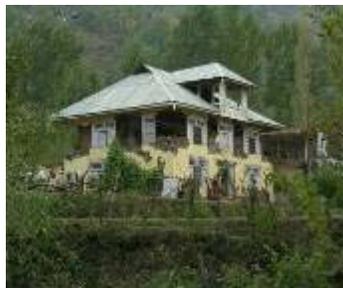
**Figure 29: Collapsed rubble stone upper story walls in Uri Government complex.**

The other structures in the complex surrounding the collapsed mosque were mostly residential structures. Those structures that were constructed of brick from the foundation up most often manifested damage at the ground story level in the form of diagonal tension “X” cracks. Some of these structures were close to collapse. In contrast to these buildings, those structures that had rubble stone construction extending to the top of the walls tended to collapse from the top down. There were several buildings that were still standing, but the stone walls had fallen away, leaving the roof held up by the interior partitions and the wooden window frames. None of these walls manifested diagonal tension cracks. Instead, the masonry appeared to have crumbled in place. From what could be seen in our short visit, there was no evidence of deliberate bonding of the walls either with stone bond courses, or by any other means, and the mortar was very poor or non-existent. The mortar appeared to have contained cement, but it appeared that the cement had failed to fully hydrate from premature drying out, as the mortar was brittle but the collapsed stones were largely clean and free of mortar. [Figures 29 & 30]

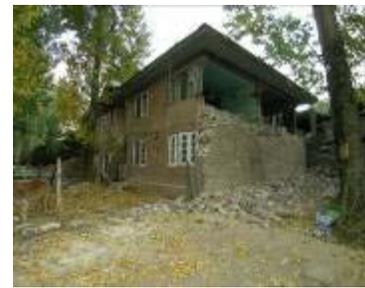
**Figure 30: Brick building with rubble stone end walls in Uri Government complex.**

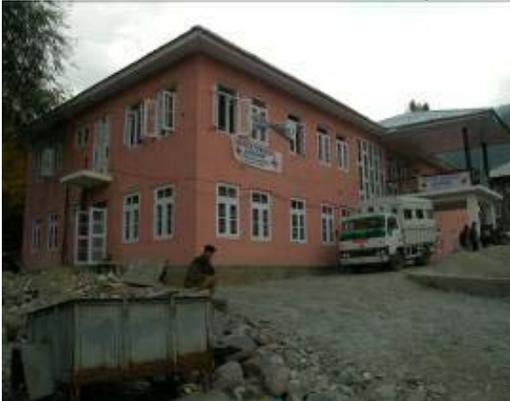
There were two structures in the complex that did surprisingly well, in light of the almost universal poor performance of the others. One of these, which was fortunately the medical clinic, was still in operation. [Figure 31] The other had formed a part of the clinic, but because of the collapse of the walls around its stair tower, it was out of operation. [Figure 32] Time limits prevented close examination of these facilities on the interior. From the exterior, however, it was evident that the functioning clinic was constructed entirely of brick with concrete floors, rather than with rubble stone at the ground floor level. It appeared to be of more recent vintage than the other structures in the complex, and of better construction. The smaller clinic building, which suffered the collapse of its stair tower walls, had stone at the ground floor level and brick above, but in this case, the stone walls remained intact, except where they extended out to form the base of the stair tower, where they collapsed.

Figure 31: This Medical Clinic in Uri Government complex was not significantly damaged, and is still in use.

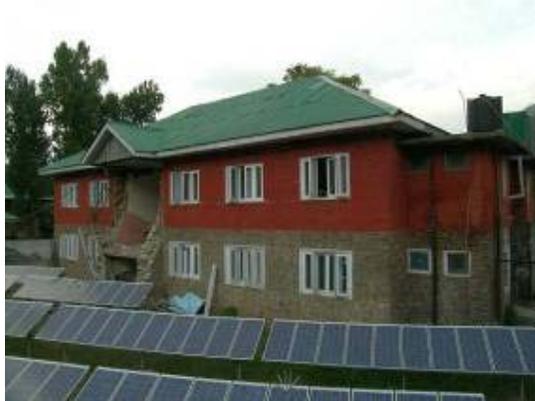
Figure 32: Adjacent annex to medical clinic was only slightly damaged except for the collapse of the walls of the stairway, which rendered it unusable.

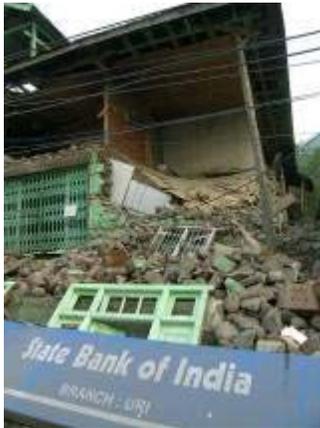
What was notable was that in Uri, although the damage was heavy and pervasive, it was insufficient to shut down the normal life and business of the town. Many of the shops and offices were functioning, even in buildings that had sustained damage. [Figure 35] The kind of damage that had disrupted what would have been thought to be the more substantial buildings of the Government complex was rare in the market town. Walls were cracked and breached in some buildings, with some collapses, but most buildings were either totally of timber, or had Dhajji Dewari walls that remained intact. [Figure 36] Those buildings of rubble stone without timber lacing suffered similar failures to those in the government complex. In many of these, the stone was laid in mud mortar without bond courses. [Figure 33 & 37]

Figure 33 (left): State Bank Building collapsed in Uri.

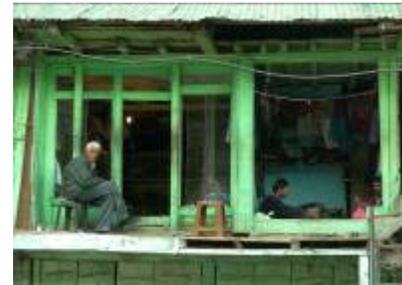
Figure 35: In Uri, this and many other shops were open and in active use in wooden buildings, or even some partially damaged masonry buildings.

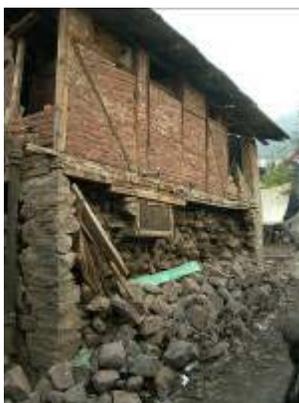
Figure 36: Intact Dhajji Dewari wall above collapsed rubble masonry wall.

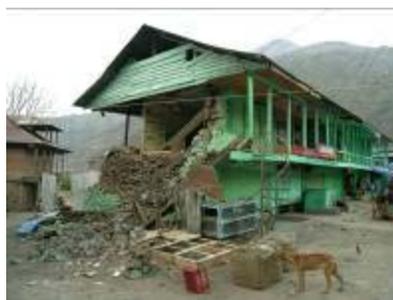
Figure 37: Rubble masonry building with all walls collapsed but front where balcony and timber door frames held the stone together.

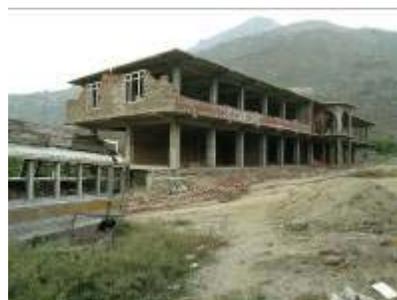
There were several reinforced concrete buildings that were under construction at the time of the earthquake, and these survived intact. In one instance, where the infill masonry was being installed, some of this infill fell over, but the frame remained standing undamaged (unless closer inspection, which I could not undertake in the time available, reveals cracks in the beam column joints). [Figure 38]

Figure 38: Reinforced Concrete structure under construction at time of earthquake. Undamaged, except for out-of-plane collapse of some infill masonry.
