Rubble Stone Walls and Reinforced Concrete Frames: Heritage Structures Reveal the Hidden Truth about Risk and Resilience during the Haiti Earthquake

Randolph Langenbach

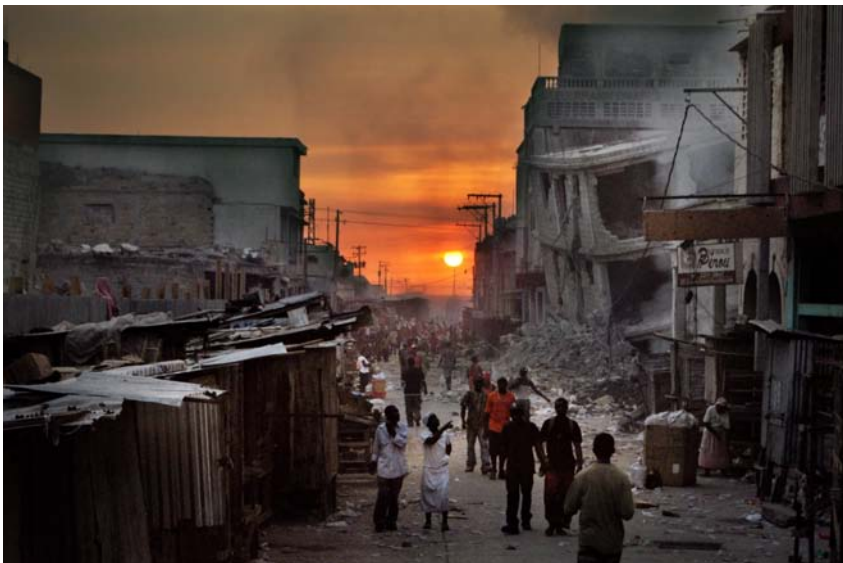
Figure 1. Like a scene from Dante's *Inferno*, central Port-au-Prince, 4 months after the earthquake.

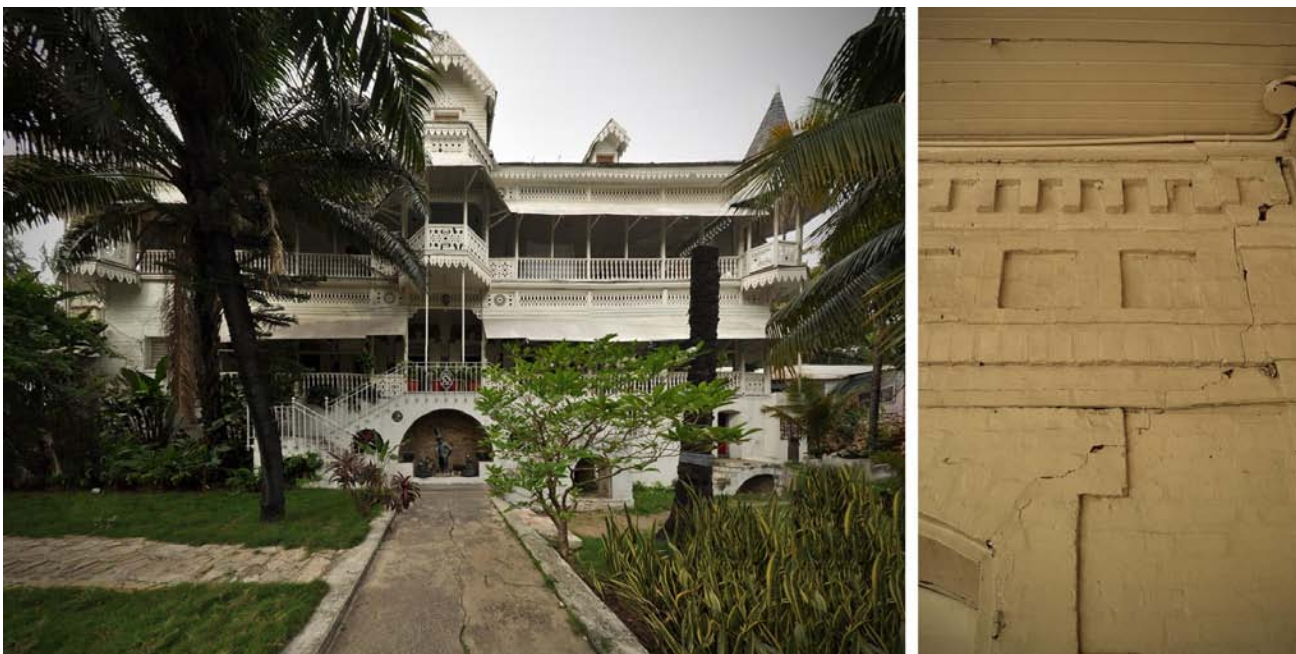
Figure 3. The unreinforced brick masonry Hotel Oloffson, Port-au-Prince after the earthquake.

But then, how does one reconcile the still-standing houses with walls of rubble stone, or the practically undamaged Oloffson Hotel with an MMI-IX or X? The reaction of many when told of this is to say that the sites may have experienced less shaking than those areas that were devastated – a not unreasonable response. In fact, a detailed geological study was conducted by a team from the University of Texas, Austin shows the soil strata under the downtown area to be more responsive to seismic vibrations. However, just up the slope behind the Oloffson a modern nine-story reinforced concrete hotel building pancaked. The chances of a difference in seismic shaking in such close proximity being the reason for such a difference in building performance seems very remote, although the difference in height and stiffness of the buildings may have contributed to the difference in performance. Similarly, throughout the Gingerbread district, which is to the east of the area identified by UT as being the most vulnerable to seismic resonance, the intermingling of the surviving Gingerbread houses with many buildings of more recent construction – usually of RC or concrete block with RC floors, many of which collapsed – made it unconvincing to explain differences in the extent of damages and collapse by underlying soil differences alone.

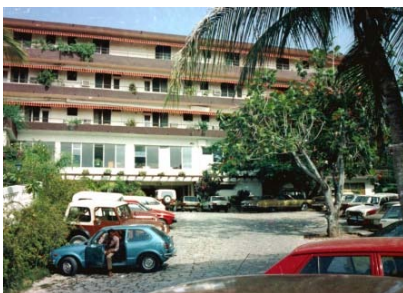
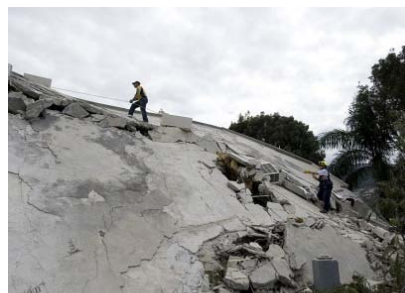
Two buildings that may have influenced the setting of a high MMI were the pancake collapses of the five star Hotel Montana, and the former five star hotel used by the UN to house its staff in Haiti (Figures 4 & 5). The Hotel Montana had been heavily used by visiting US governmental officials. These two collapses alone killed the head of the UN mission together with much of its staff, as well as a number of US and European dignitaries. Knowledge of these events spread fast, including to the US Geological Survey (USGS) which within hours of the earthquake began publishing their famous shakemaps that, in addition to instrument data where it existed, included subjective data based on analysis of the initial news reports and over the phone interviews.

Figure 4. Five star collapses in Petionville: left: Hotel Montana before, and center after the earthquake (Google images).

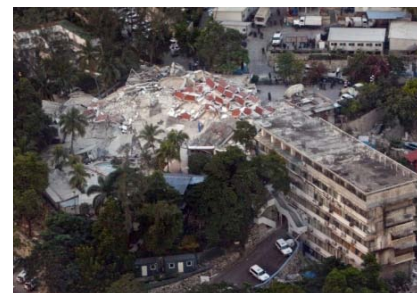
Figure 5. UN Headquarters after the earthquake (Google images).

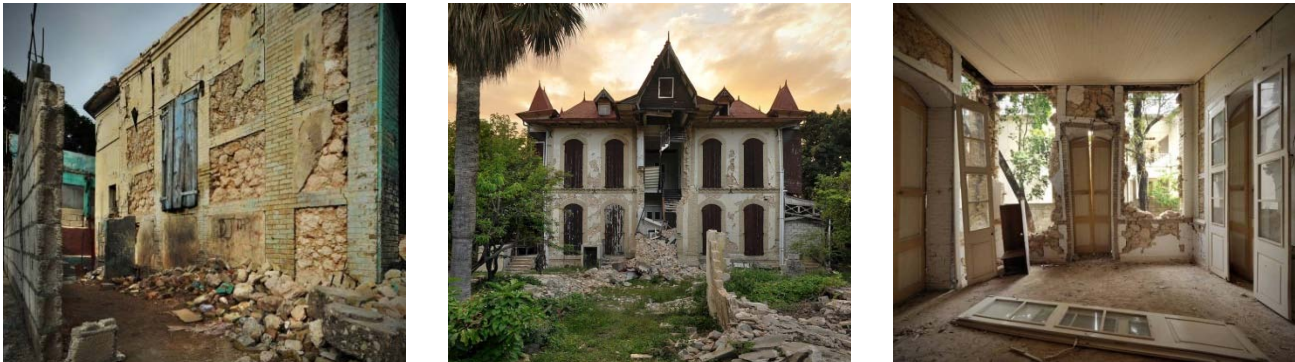
In almost all cases, the timber framing elements were compromised by termite damage and/or fungal decay – which was in a few cases very extensive. Despite the almost universal lack of maintenance and commonly found decay, it was rare to find even a partial collapse at any of these houses, regardless of construction type. In the buildings with rubble stone, in quite a few instances, the rubble stone sections of the walls showed different gradations of damage from the shedding of exterior stucco to the partial or total falling out of a stone panel – leaving the building still standing on the brick piers which surrounded the rubble sections of the walls.

Figure 6. Brick and empanelled round-rock rubble stone construction, as is typically found in many of the Port-au-Prince “Gingerbread” Houses from the late 19th century, showing different levels of damage from onset, to collapse of the rubble panels. Center: The 2 ½ story Villa Castel Fleuri Mansion was of rubble stone between brick piers and window surrounds, and only the staircase projection collapsed. The onset of inelastic deformation of the rubble stone panels is visible where the surface stucco has come off. Right: The Dufort House still standing on its brick piers after the collapse of the rubble stone panels. This house is now being restored by FOKAL. Many reinforced concrete buildings nearby collapsed.

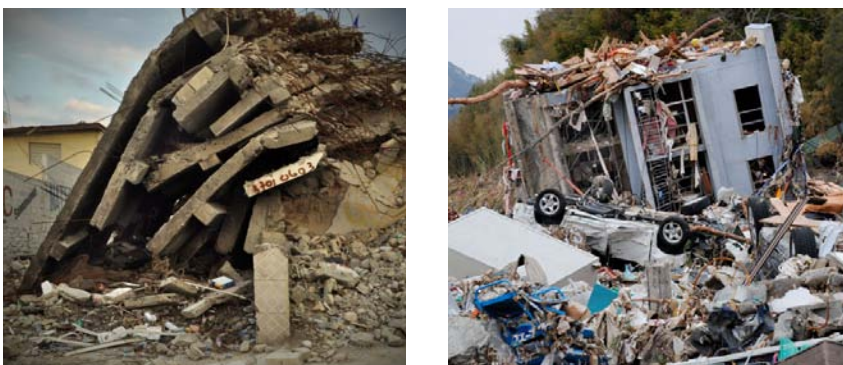
Figure 7. Left: Pancake collapse of a reinforced concrete building that was located in the Gingerbread District of Port-au-Prince. Right: As a remarkable example of the inherent strength and resilience of a well-constructed reinforced concrete building, this one in Rikuzentakata, Japan was swept onto its side and carried upstream by the March 10, 2011 earthquake and tsunami without being crushed or collapsed (AFP/Getty).

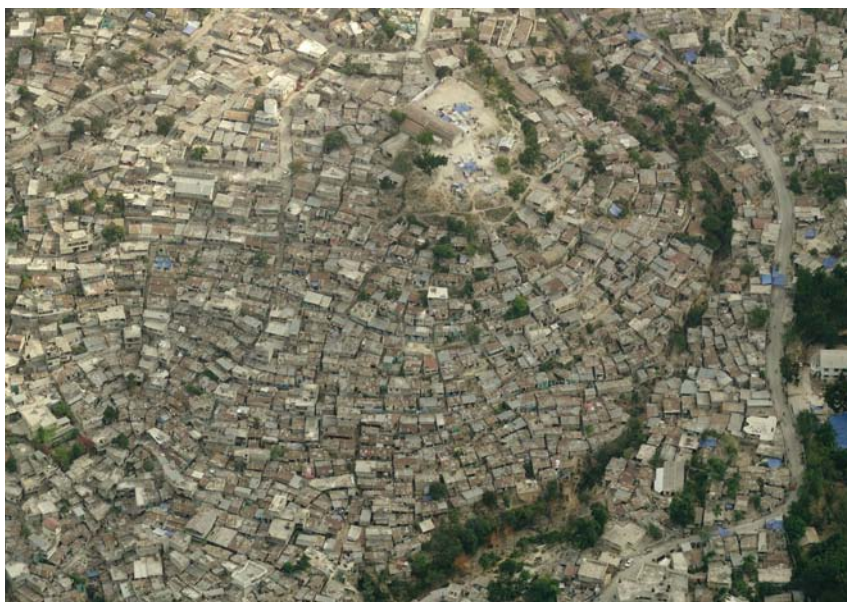
Figure 8. View of 4 Carrefour Feuilles area bidonville, close to the city center, Port-au-Prince (© Pictometry).

ance of the tightly packed cluster of homes that spread over the hills showed little damage visible from the air within the high resolution of the Pictometry images (Figures 8 & 9).

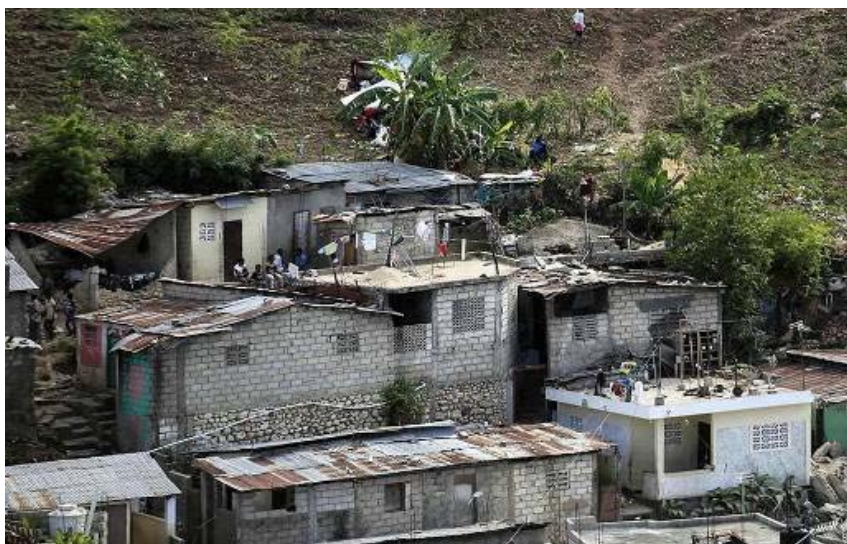
Figure 9. View of 4 Carrefour Feuilles area bidonville, close to the city center, Port-au-Prince showing the unsophisticated rough construction of informal settlement dwellings, with incomplete frames, round-rock rubble stone retaining walls, and unreinforced concrete block construction – that nevertheless did not collapse (Source: Carlos Barria-Reuters).

Does this defy the improbability that poor people without training on land they do not own would use higher quality materials, better engineering, and better construction quality control than that found in the formal, contractor-built, and even sometimes engineered structures downtown and in Pétionville? The answer to this question is *no*. The quality of the design, construction and even the materials used in the informal settlements was in fact quite poor as one would expect – they just did not often collapse (Figure 9).

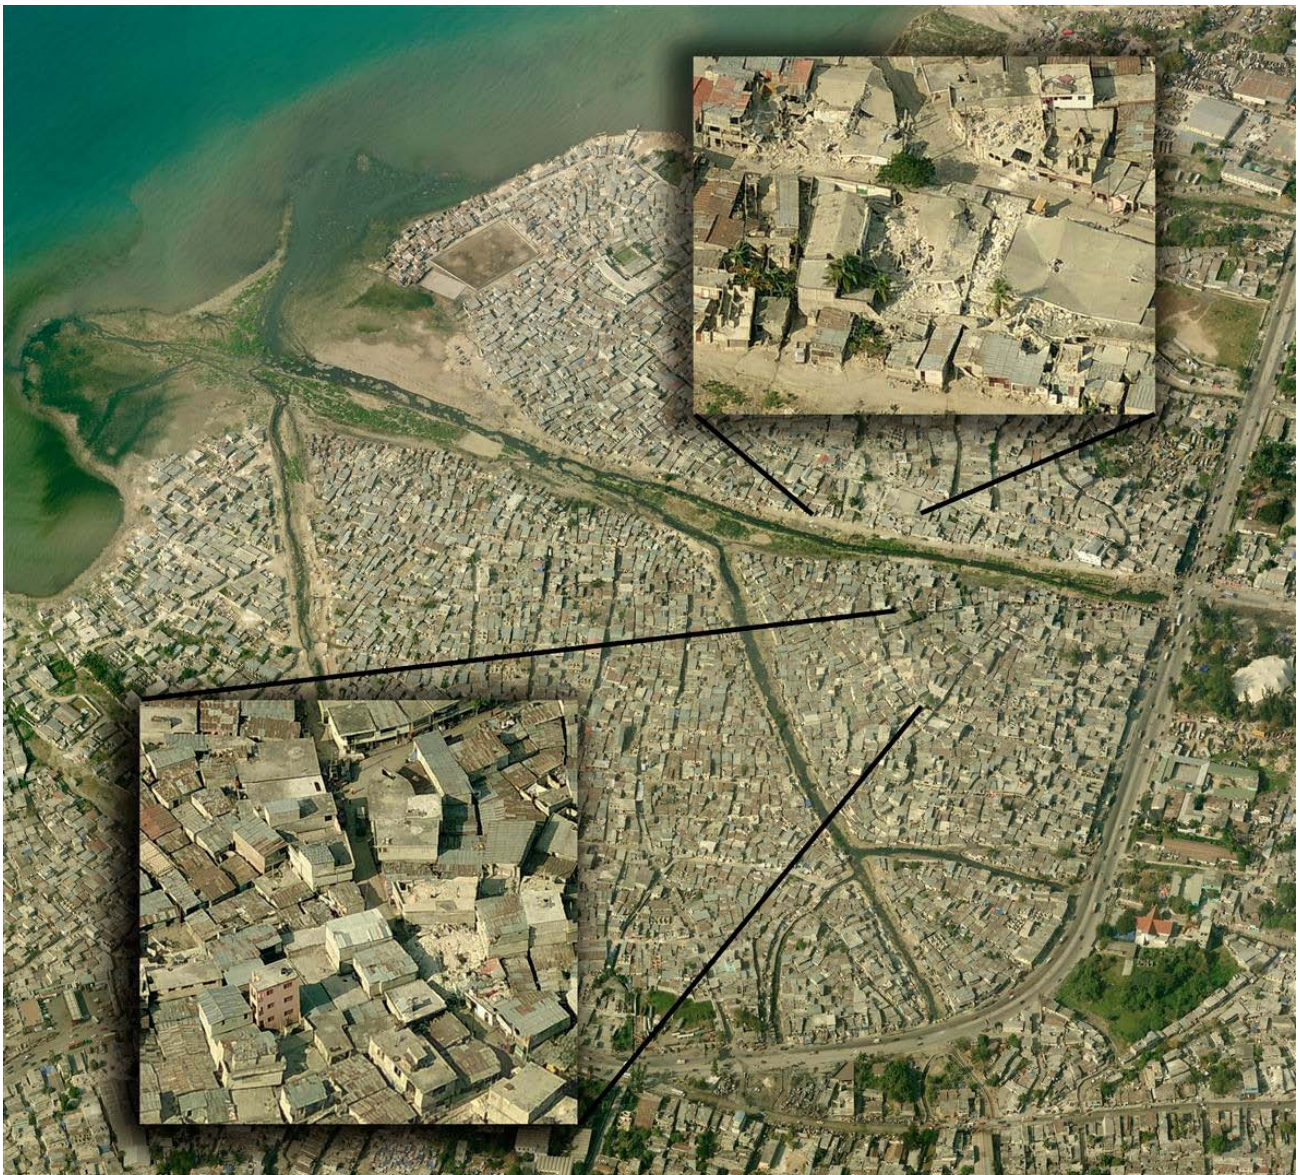
Figure 10. City Eternel an informal settlement on an alluvial fan next to downtown Port-au-Prince, with insets (left) showing 2, 3, and 4 story buildings still standing without visible damage, and only evidence of one collapsed building in the view, and (right) evidence of the collapse of RC frame structures, including an open air market structure among other buildings.

Number (3), known as *Cite Eternal*, was even more remarkable for a number of reasons in addition to being closer to the epicenter (Figure 10). One would normally expect that an alluvial soil site like this would be particularly vulnerable – especially for taller buildings, but three and four story structures appeared in the imagery to not show visible damage, although there may be damage invisible from the air. Also interesting was to find that several buildings around a large central market structure that were of more formal construction of reinforced concrete frame with infill walls collapsed. The rest of the settlement consisted of construction that was more common to informal buildings, which could only be loosely described as confined masonry or simply concrete block construction.

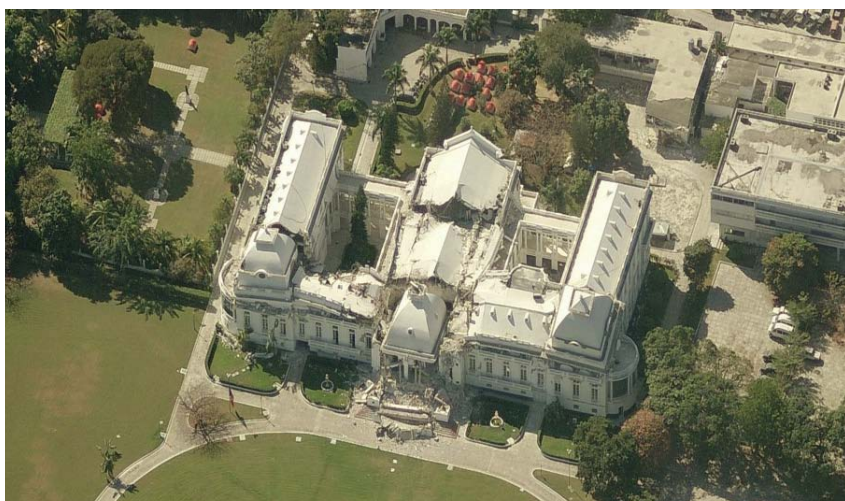
Figure 11. National Palace in Port-au-Prince after the earthquake and partial demolition, revealing the reinforced concrete frame infilled with rubble stone (© Pictometry).

In Haiti, the two iconic symbols of the destruction wrought by this earthquake were the National Palace (Figure 11, 12) and the National Cathedral. Both were reinforced concrete. The cause of the collapse of these two structures, as well as many other 100+ year old churches, was the corrosion of the rebars after a century of exposure to moisture in the tropical environment. Yet only a few blocks away from both, and resting on the very soil identified as subject to the highest shaking, is another structure that few have seen and which has rarely been in the news, but which stands as a remarkable monument to resilience when almost every building around it collapsed – the Saint Louis de Gonzague Chapel (Figure 13). It was as high and about half the length of the cathedral, and about 20 years older – but little damage was visible on the exterior. The structure was of brick masonry with an iron or steel frame. Not only has it not rusted out, despite its age, it has remained standing, even as all of the school buildings around it, some of concrete, and others of timber, collapsed. Much still needs to be known about this church, but perhaps when we are looking at this structure we are looking at the future, and not just at the past. Embodied in this magnificent survivor may be at least one idea of how we can build durable and safe buildings in earthquake areas that can remain standing after an earthquake a century later.

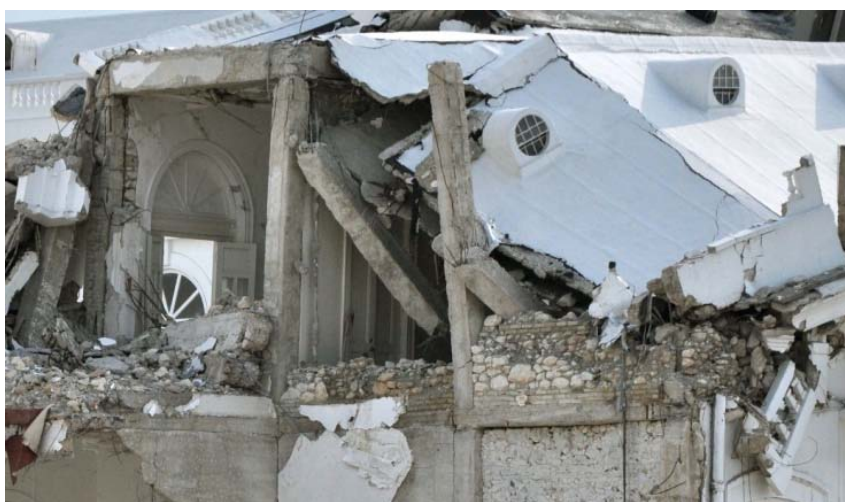
12. Detail view showing the reinforced concrete frame with round rock rubble stone infill of the 1916 structure exposed during the demolition of the ruins of the National Palace.

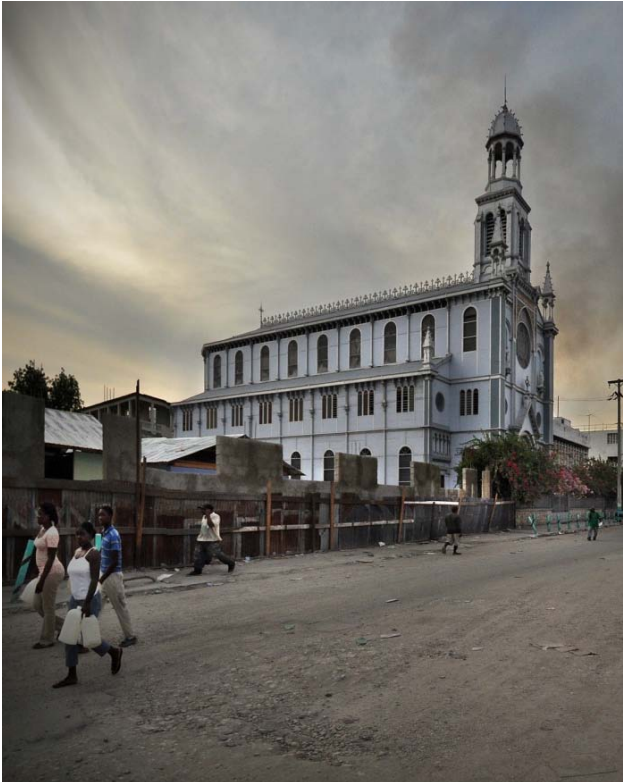
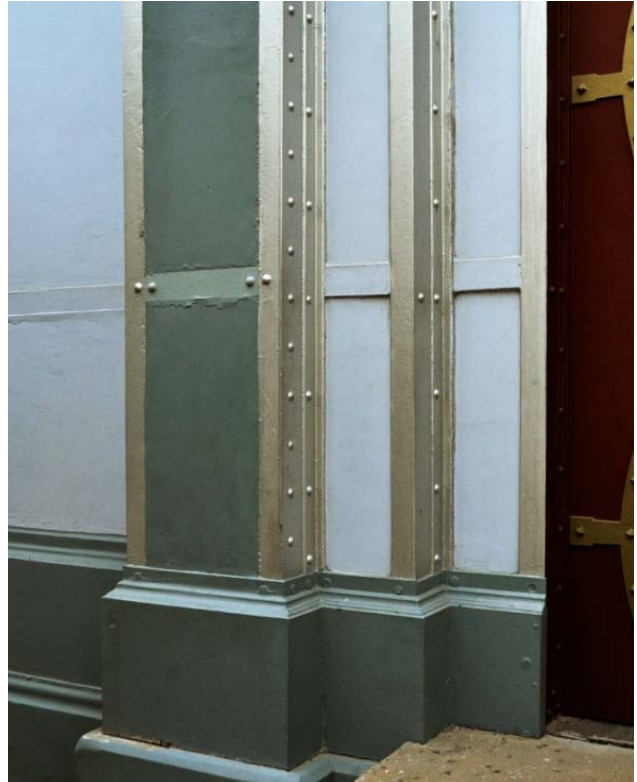
13. Saint Louis de Gonzague Chapel ca. 1890 in central Port-au-Prince showing external lightweight steel frame on masonry walls.
