**SURVIVORS AMONGST THE RUBBLE:
Traditional Timber-laced Masonry Buildings that Survived the Great 1999
Earthquakes in Turkey and the 2001 Earthquake in India,
While Modern Buildings Fell**

Text and photographs
© Randolph Langenbach, 2002*

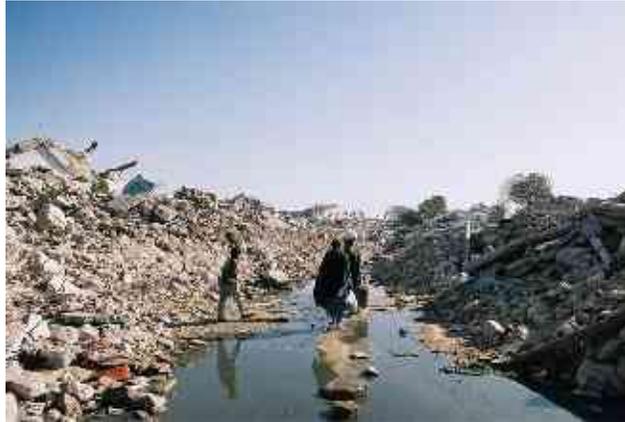
Figure 1: View of Anjar City Center after the Bhuj Earthquake of January 26, 2001.

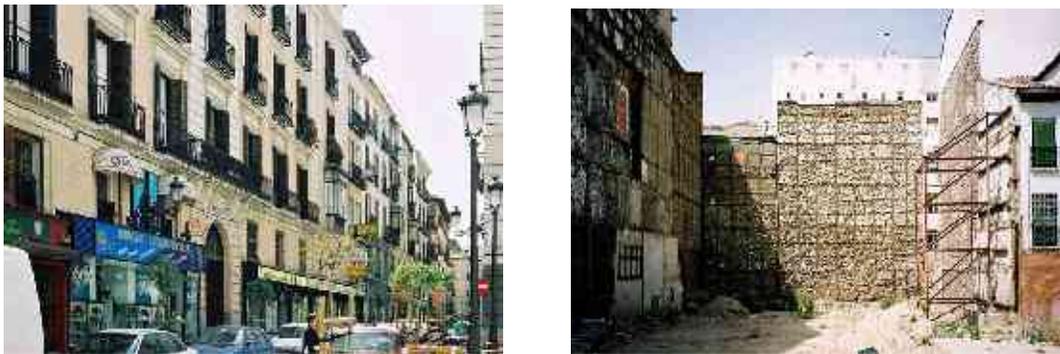
Figure 2 a&b: Timber and masonry infill-frame construction near the Plaza Major in Madrid – hidden in the facades, but revealed by demolition behind.

Timber-laced construction can also be found in both Spain and Portugal. In Madrid, many of the buildings in the historic central area around the Plaza Major which appear today as solid masonry buildings underneath a layer of stucco are, in fact, composed of walls of timber with brick or rubble stone masonry infill (Figure 2). Many of the buildings in Lisbon that were rebuilt after the great Lisbon earthquake of 1755 were constructed with heavy timber frames imbedded in the masonry, in this case a deliberate response to the earthquake risk. In fact, the Lisbon example may have been based on observations of earlier timber-laced buildings that may have done comparatively well in the earthquake, thus encouraging its more elaborate use for earthquake hazard mitigation during the reconstruction.

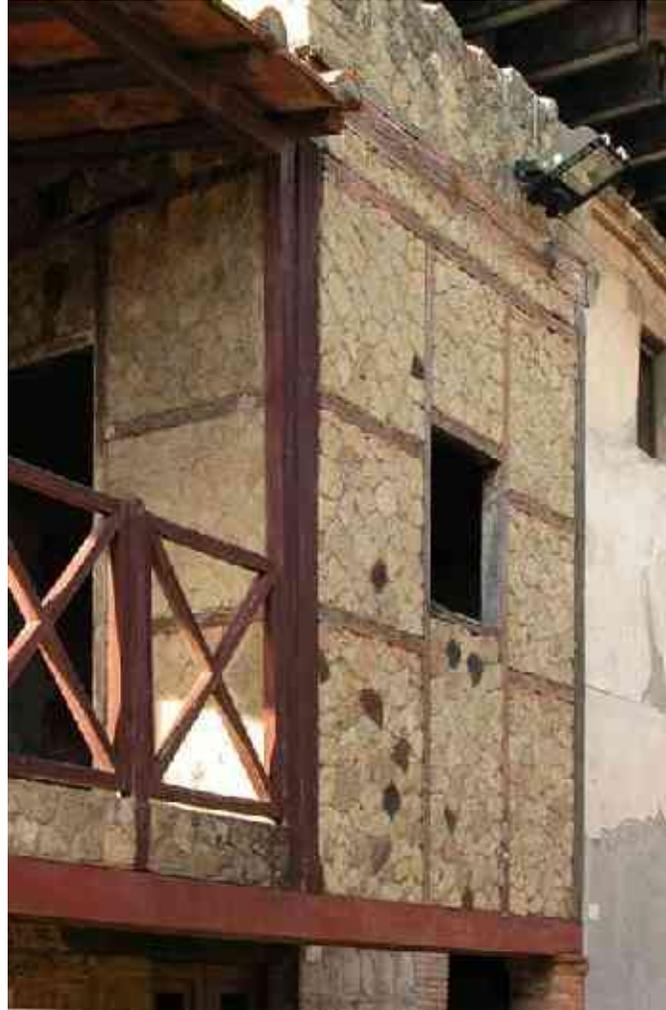
Figure 3: Pre-79AD Infill-frame construction found and restored at Herculaneum.

Because it is rare for the wooden armature of these sorts of buildings to survive as archeological ruins, the chance of finding ancient examples of the infill-frame construction type is low, but the unique burial under volcanic mudflows, and the modern-day archeological uncovering of the Roman town of Herculaneum in Italy has provided the unique opportunity to peer back through 2000 years and find early examples of this type of construction. (Figure 3)³

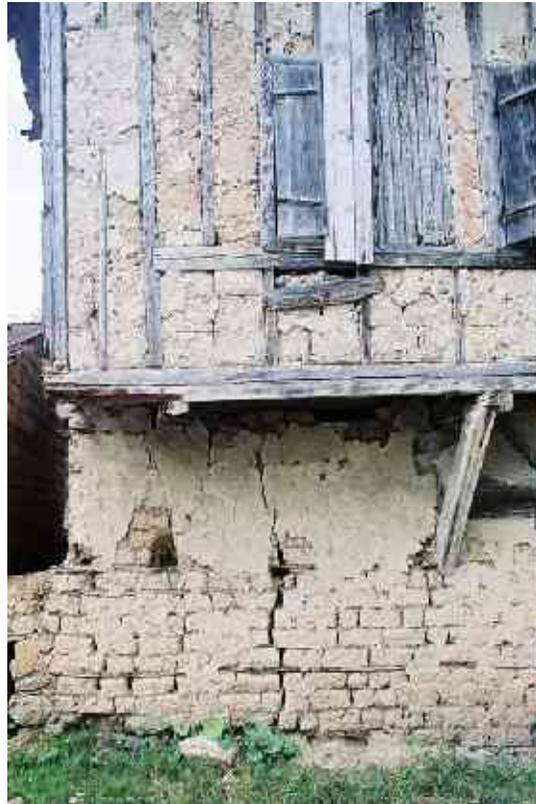
Figure 4: View of Infill-frame construction in the historic Ottoman town of Safranbolu, Turkey

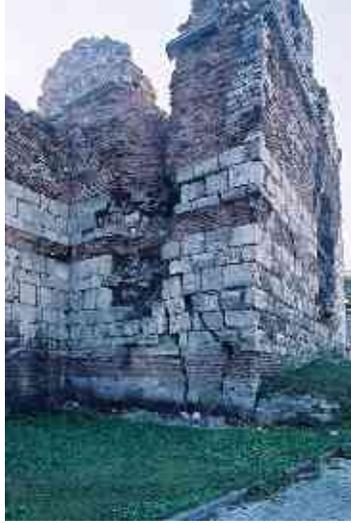
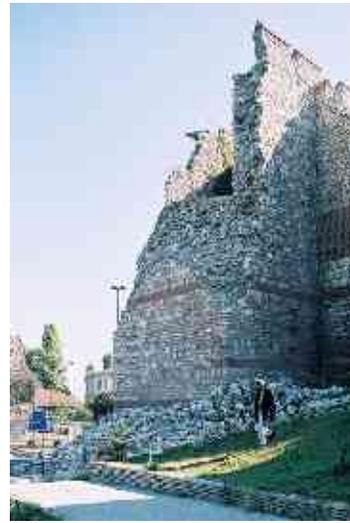
Figure 5 & 6: Istanbul City walls showing brick banding in surviving historic section and collapsed reconstructed section with fake banding.

Laced Bearing Wall construction may have had its origins in ancient times as well, although it is not so identified in Vitruvius' work. An even earlier example has been identified at the Minoan "New Palace" of Knossos, dated 1450BC (Kienzle, 2002). It may also be loosely related to the utilization of horizontal bands of wide and flat Roman brick that was sometimes laid at intervals into walls composed of more random mortared masonry. At Pompeii, a number of the piers between storefronts were reconstructed with brick bands, and this construction may have been part of repairs of damage from an earthquake that occurred 17 years prior to the volcanic eruption that buried the city. This same type of construction can be found in Istanbul most notably in the medieval city walls, where the belts of red brick are an integral part of the architecture – so much so that when modern restorers reconstructed a section of the walls, they applied the brick band as a thin layer on the surface, rather than as a structural layer extending through the masonry. Interestingly, it was only this newly constructed section that collapsed when the tremors which radiated out from the distant August 17, 1999 Marmara earthquake reached Istanbul. The far more deteriorated portions of the wall where the brick bands remained in their original form remained standing.

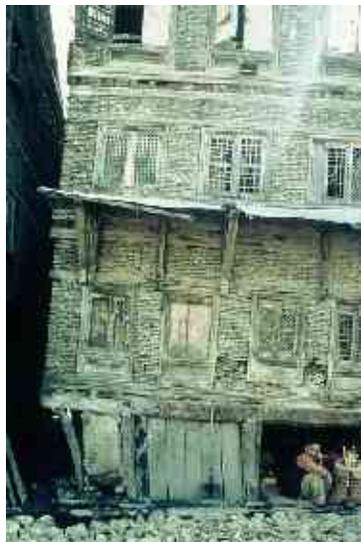
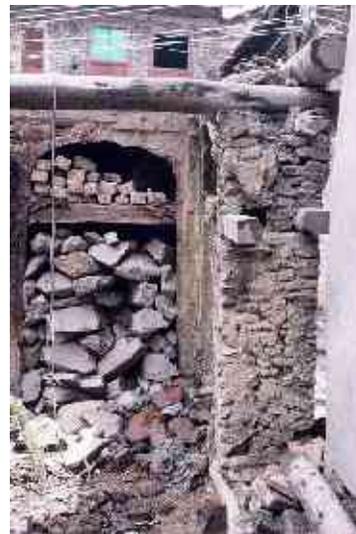
Figure 7 & 8: *Taq* construction in Srinagar, Kashmir and demolished section of wall showing timber lacing in wall section.

Some of the most elaborate examples of laced bearing wall construction can be found in Srinagar, Kashmir, where this type of construction, referred to as *Taq*, is the predominant historical vernacular type. Here the type evolved to allow building of structures onto soft waterlogged banks of the alpine lakebed in the Vale of Kashmir, where the heavy masonry structures were subjected to differential settlement. Here the heavy timber beams are laid in only horizontally, with the masonry carrying all of the vertical loads. The timber bands, which resemble ladders laid into the walls, run both above and below the window frames and at each floor level, where the joists extend through the wall and are secured to the wall by the timbers laid below and above them, which are themselves surmounted by the weight of the overburden of masonry of the floor above or the parapet under the roof.⁴

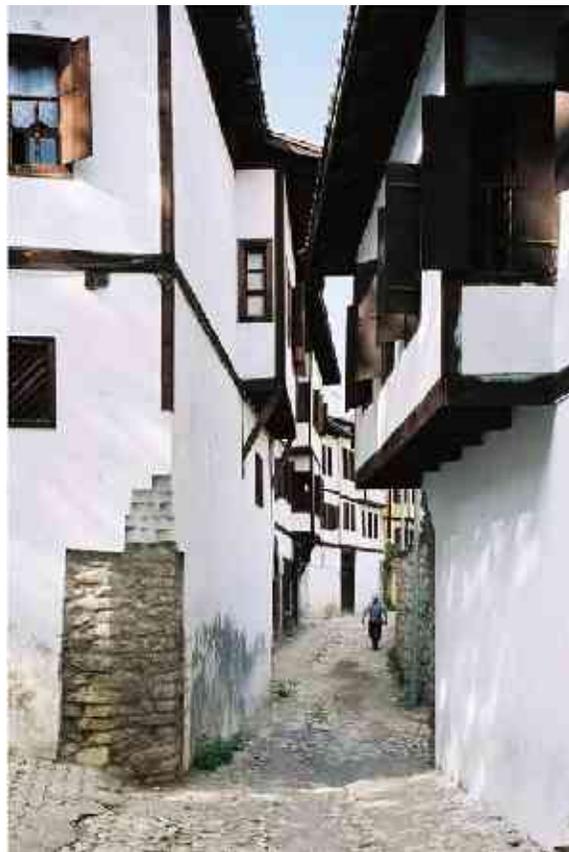
Figure 9: Traditional Ottoman style Turkish architecture in Safranbolu, Turkey.

In Turkey, and also in Greece, houses were often designed with the laced bearing wall construction on the ground floor level, and the infill-frame used for the upper stories. The thicker, often windowless, bearing walls served to enclose the storage or barn area of the structures, with the lighter more open infill walls above enclosing the living quarters. The Turkish Ottoman-style house, with its tiled roof and overhanging timber-and-brick bays above a heavy stone first floor wall, has become an icon known worldwide. Where they survive, the overhanging upper stories, or jetties, contribute to the visual vitality and delight of historic Turkish towns. The jetties strengthen the buildings because the joists that cantilever over the walls below hold those lower-story walls firmly in place with the help of the weight of the infill masonry overhanging upper story. This compressive force gives the heavy walls below added strength against lateral forces.

The upper story is almost always constructed with the infill-frame type of construction, with the frame infilled with a single-wythe of fired brick or stone masonry. This type of construction is referred to in Turkish as “*humuş*” (pronounced “humush”). This construction utilizes a weak mortar of mud or lime holding a single wythe of masonry into a timber framework of studs rarely more than two feet (60cm) apart. The studs are themselves tied at mid-story height by other timbers. Because the masonry is only one wythe in thickness, the walls are light enough to be supported on the cantilevered timbers.

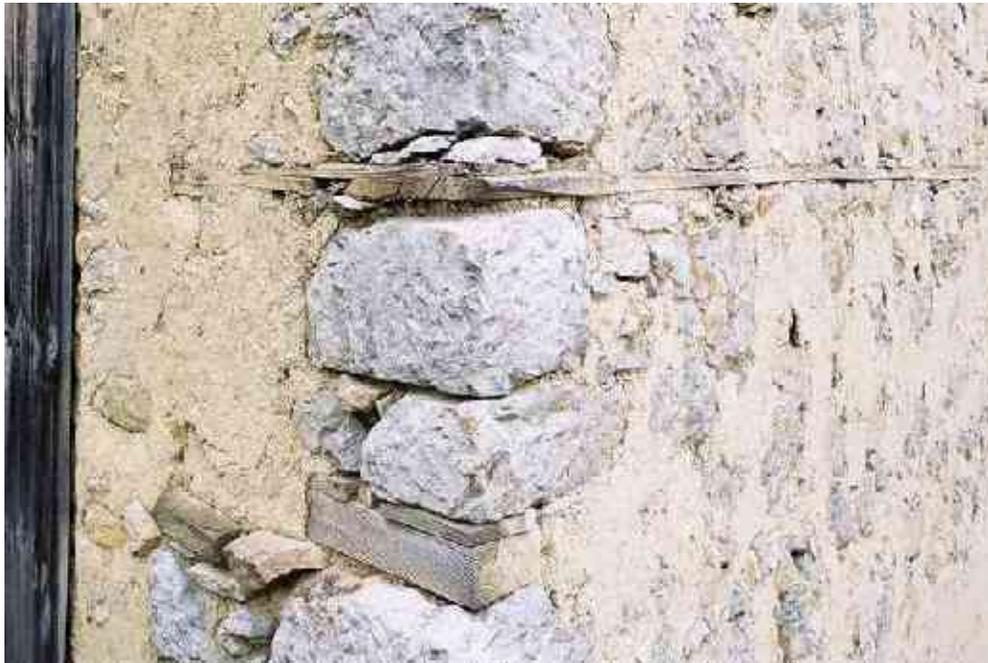
Figure 10: Laced bearing wall in Safranbolu, Turkey

For those houses where the *hımış* style rests on the heavy load bearing masonry base, the multi-wythe masonry bearing walls of the first story, are often laced with horizontal timbers, (in Turkish, the timbers are “*hatıl* (s) *hatıllar* (pl)”). In contrast to those used in Kashmir, these are often very thin timber boards laid into the wall at vertical intervals of about 3 feet (1m). They are placed so that they overlap at the corners. They thus serve to bind the stone layers together without interrupting the continuity of the masonry construction. In those regions most affected by the 1999 earthquakes, however, the bearing wall type was rare. There, the houses were of *hımış* construction from the ground up, thus the discussions of earthquake performance of the timber-laced construction as witnessed following the recent earthquakes in Turkey and in India will be focused primarily on this type.

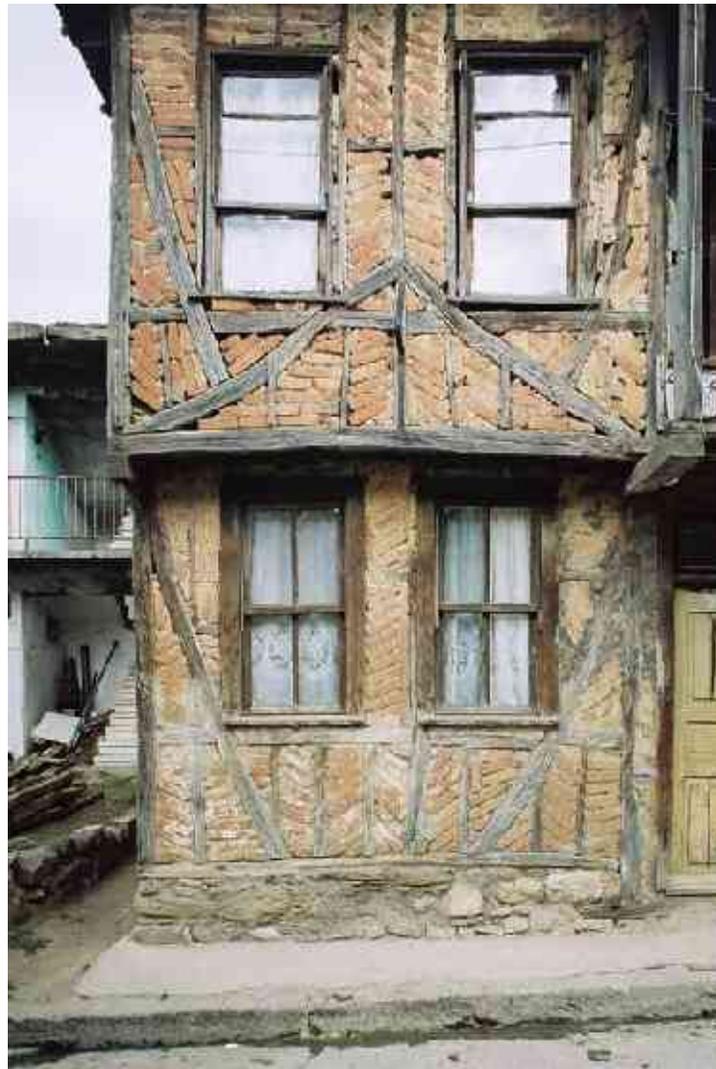
Figure 11: *Hımış* house in Gölcük after earthquake constructed in 1955. There was only slight damage to the interior of this house.

In one area surveyed in Adapazzari a single *hımış* house collapsed, killing an occupant – a rare occurrence of a death caused by the collapse of *hımış* construction. Decayed timbers could be seen in the ruins. It was the partially damaged traditional buildings here and in Gölcük provided evidence of how this type of construction responded to earthquake forces. Once each building was inspected, and the damaged area in each building identified, a pattern began to emerge. Of those inspected where structural damage was found, most of the damage was concentrated at areas around rotted timbers. Interviews with residents often revealed that the buildings with the most timber decay had been unoccupied for years. It appeared that decayed timber significantly degraded a buildings’ performance in earthquakes. In occupied houses, the most severe damage resulted mainly from alterations and modernization work that had corrupted the integrity of the original frames and walls.

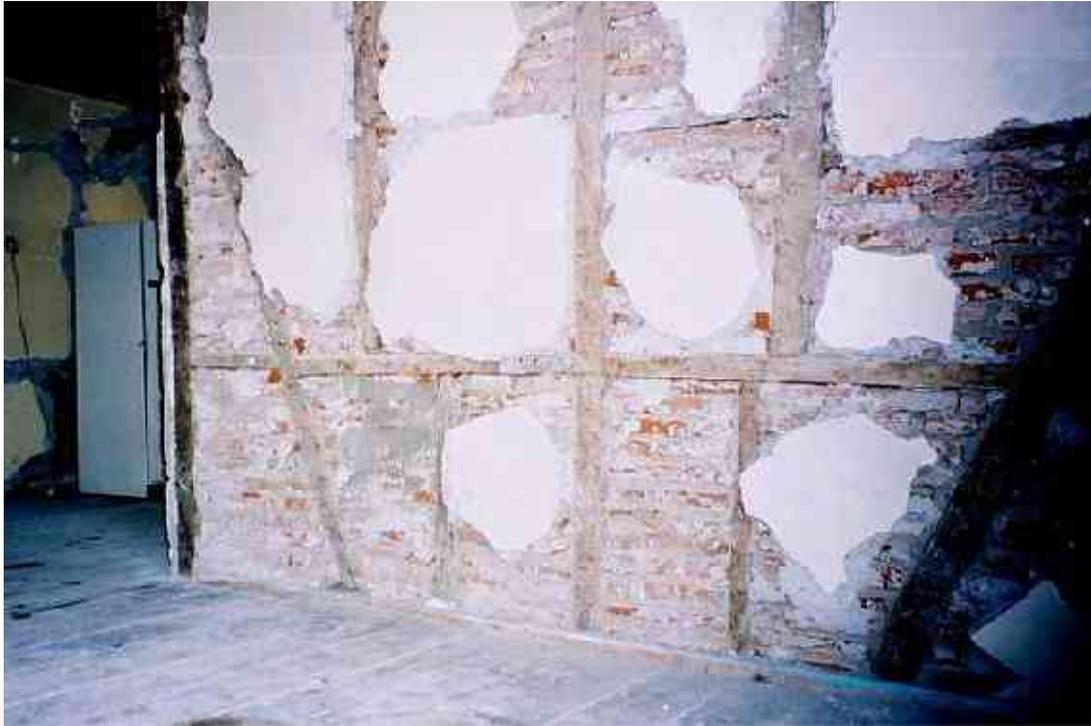
Figure 12: *Hımış* interior wall in Düzce after earthquake.

Inspecting the interiors of some of the houses provided a more complete understanding of the behavior of *hımış* as a structural system. It was evident that the infill masonry walls responded to the stress of the earthquake by “working” along the joints between the infilling

and the timber frame; that is, the straining and sliding of the masonry and timbers dissipated a significant amount of the energy of the earthquake. The only visible manifestation of this internal movement was the presence of cracks in the interior plaster along the walls and at the corners of the rooms, revealing the pattern of the timbers imbedded in the masonry underneath. This level of damage was evident in every house. On the exterior, unless the house was stuccoed, damage was impossible to see. The bricks themselves were only infrequently displaced sufficiently for a crack to be visible. The movement was primarily along the interface between the timbers and the brick panels rather than forming a crack within the panels themselves.

The typical *hımış* construction does not have mechanical ties between the timber and masonry to hold the infill masonry in place. As a result, in some cases, small sections of the infill were shaken out from between the studs near the top of the upper-story walls. Because of the existence of the timber studs, which subdivided the infill walls into small panels, the loss of portions or all of several panels did not appear to lead progressively to the destruction of the rest of the wall. Many walls were missing some of their infill, but evidence of ‘X’ shear cracks, so common in the infill in the modern reinforced concrete buildings, was non-existent in the *hımış* structures. The closely spaced studs reduced the likelihood of the propagation of ‘X’ cracks within any single panel. In addition, the subdivision of each structural bay with a tight network of vertical, horizontal, and diagonal timbers, rather than vertical studs alone, appeared to have been successful in reducing the possibility of the masonry falling out of the frames.

An important additional factor in the performance of the walls was the use of weak, rather than strong mortar together with bricks that are stronger than the mortar. The mud or weak lime mortar tended to encourage sliding along the masonry bedding planes instead of

cracking through the masonry units when the masonry panels deformed, reducing the contrast between rigid masonry panels and the flexible surrounding frames.

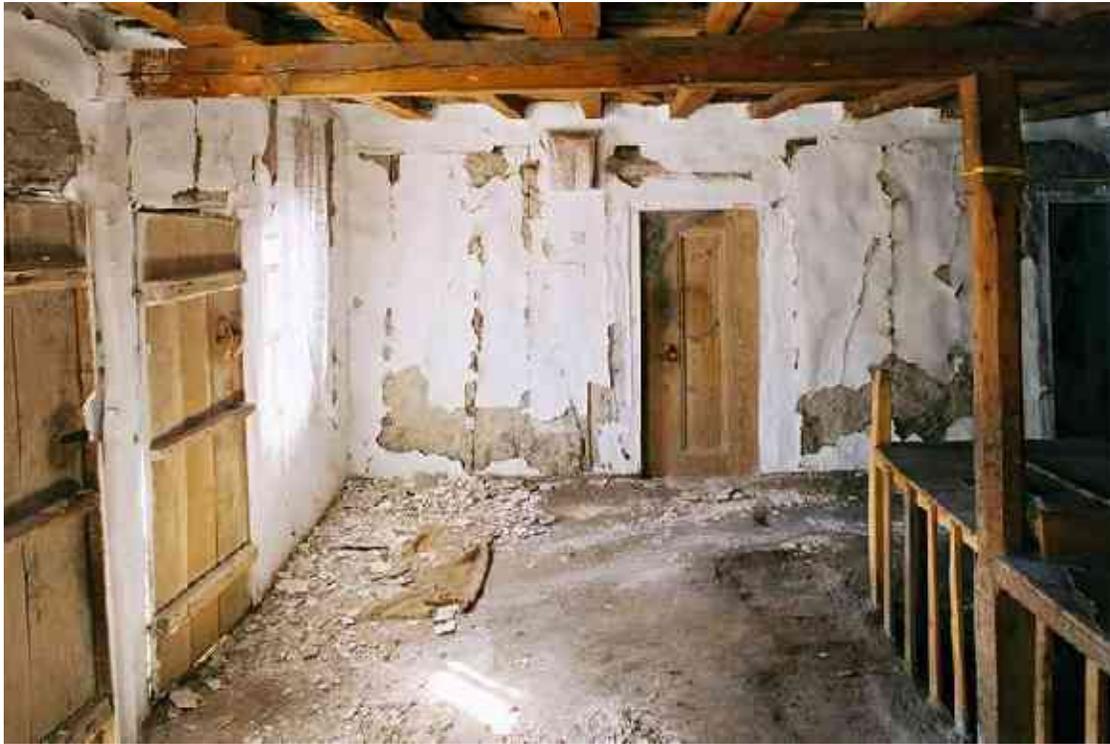
Figure 13: Interior of *hımiş* house in Orta after earthquake showing damage to mud and lime plaster over infill walls.

In this earthquake, many *hımiş* houses did suffer widespread cracking and shedding of plaster and stucco, and a few had damage to the infill masonry. This level of damage was hard to explain when compared to that found in the infill-frame houses subjected to the full brunt of the Marmara earthquake, where the shaking was stronger and continued for a longer period. The *hımiş* houses in Gölcük and Adapazari had about the same level of damage as the Orta houses. This stands in sharp contrast to the performance of the reinforced concrete buildings. While in Orta the reinforced concrete buildings were only lightly damaged, in the Marmara and Düzce earthquake area vast numbers of them suffered heavy damage or collapse.

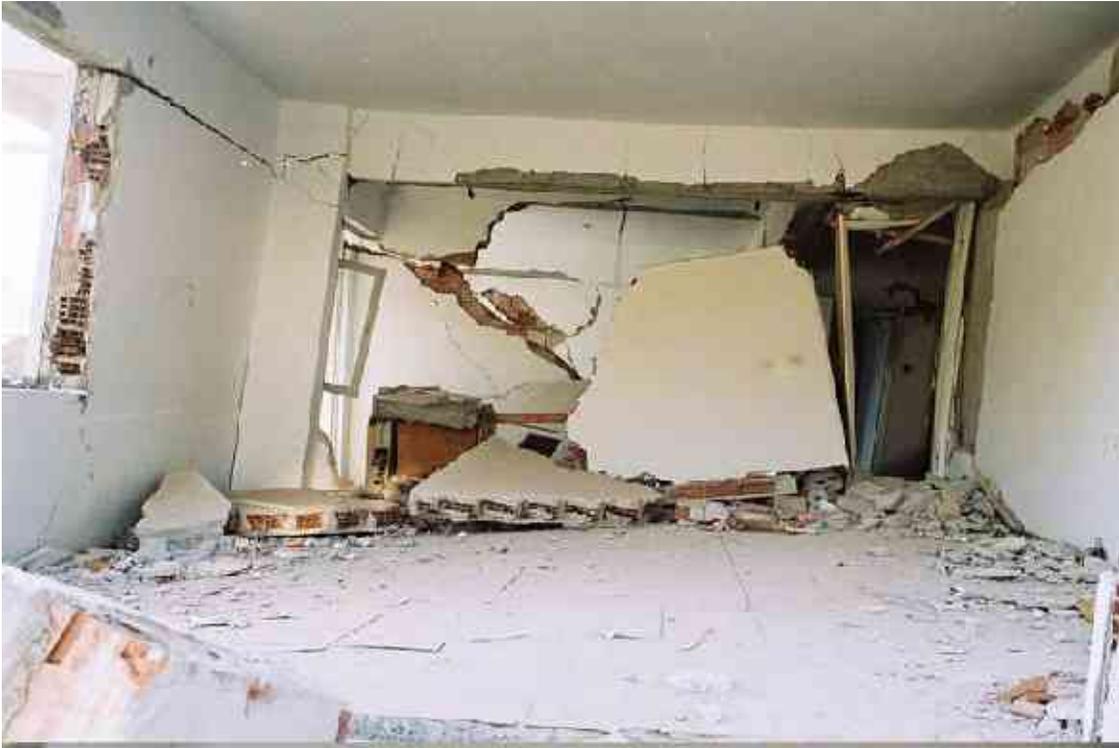
Figure 14: Collapsed interior infill wall in reinforced concrete building in Gölcük

The infill walls in modern reinforced concrete construction generally have strong mortar binding weak masonry units, and these masonry walls fill each structural bay without intervening studs. In Turkey, the most common infill for the interior partitions and exterior walls is a lightweight hollow clay block that has barely more strength than a dinner plate. In India, commonly it is a low temperature fired brick that performs better than the Turkish material, but none-the-less it can crumble easily.

Rarely is the infill considered in the engineering design process as part of the lateral resisting system, and it is often ignored in calculations. In spite of this, the masonry infill does play a significant role that sometimes can help to save a building that has weakened joints. More often, however, it can contribute to the collapse of a building because its rapid degradation in specific areas can transfer concentrated loads onto localized parts of the frame, which are then overwhelmed. As can be seen in Figure 14, these infill walls can readily collapse completely when an earthquake distorts the building's frame. Sometimes, to avoid damage to the surrounding reinforced concrete frame from the “diagonal strut” effect, where the stiff infill causes a corner column to break, leading to collapse, the infill material is sometimes deliberately separated from the frame.

While the infill in modern construction has often performed badly, the infill in traditional construction has performed well. What accounts for this apparent discrepancy? Two things may account for this: (1) the subdivision of the infill masonry into smaller panels with horizontal and vertical studs within a single bay of the building's structural frame, and (2) the use of weak mortar with strong masonry units in the traditional infill compared with what are often weak masonry units and cement-based strong mortar used in the modern infill walls.

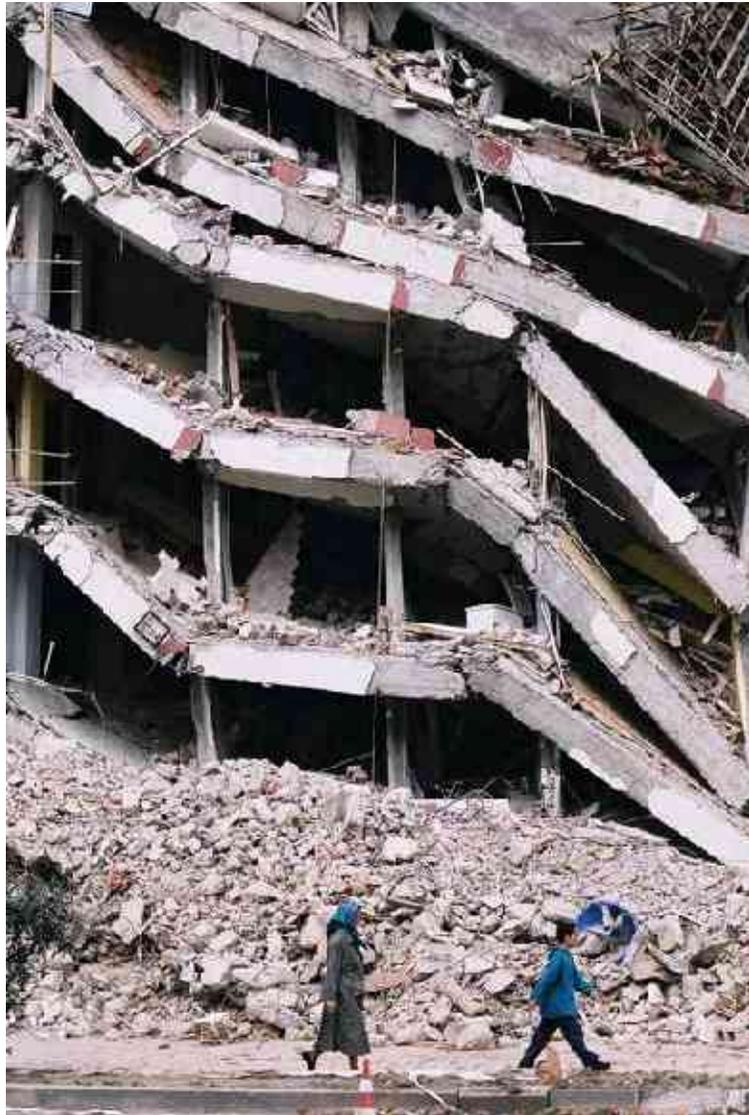
Figure 15: Collapsed Reinforced concrete building in Gölcük.
