EARTHQUAKE AND THE CITADEL

By Randolph Langenbach

From an edited transcript of a lecture given at the Library of Congress, December, 2004.

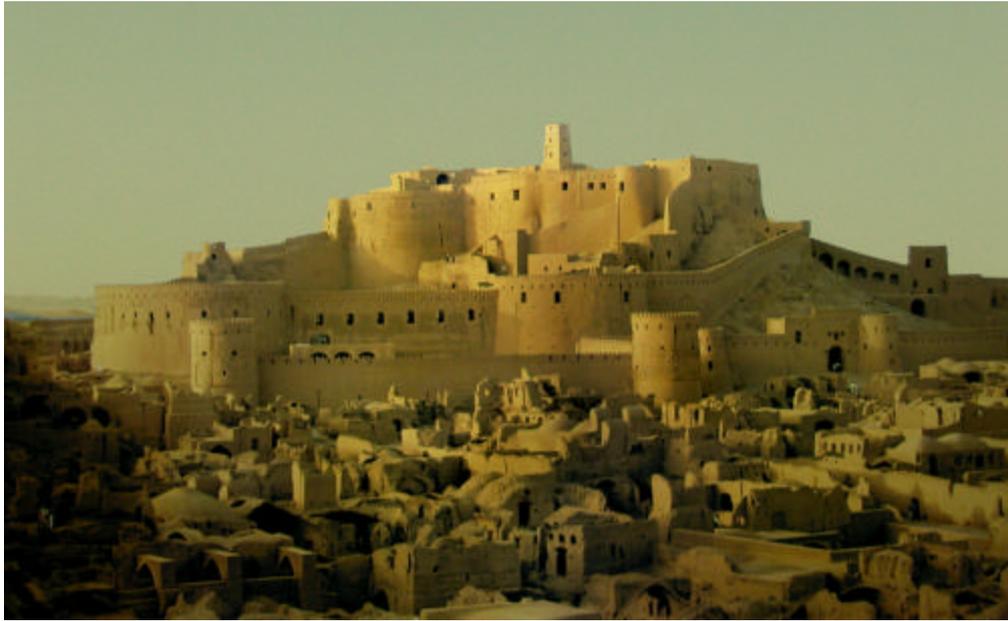
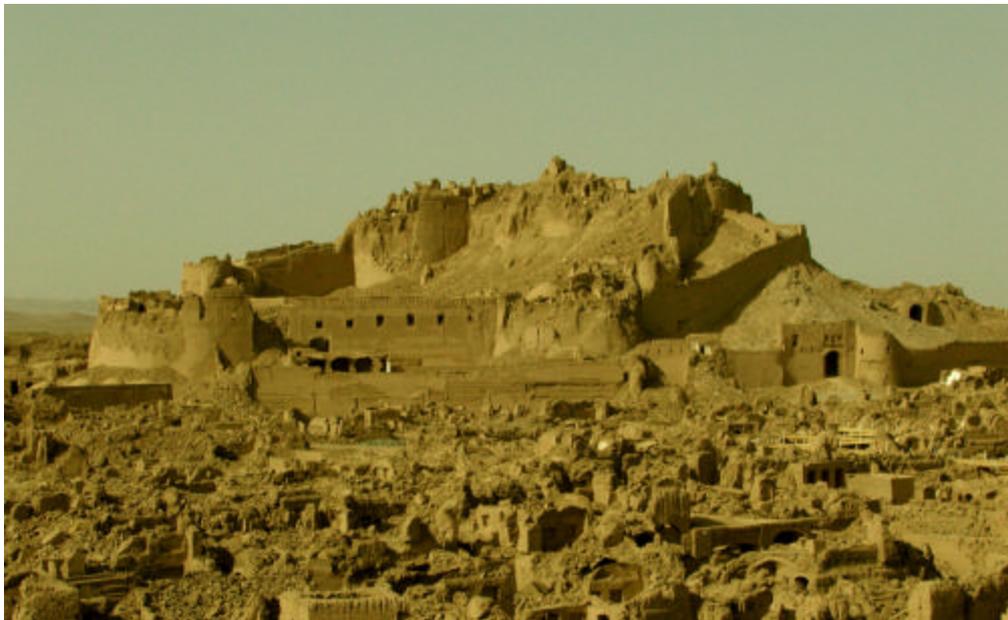
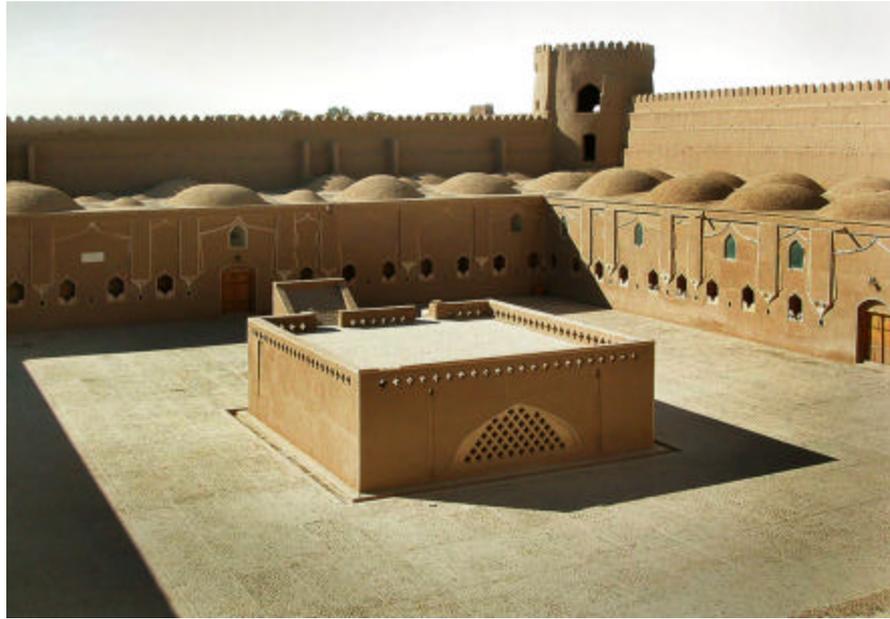
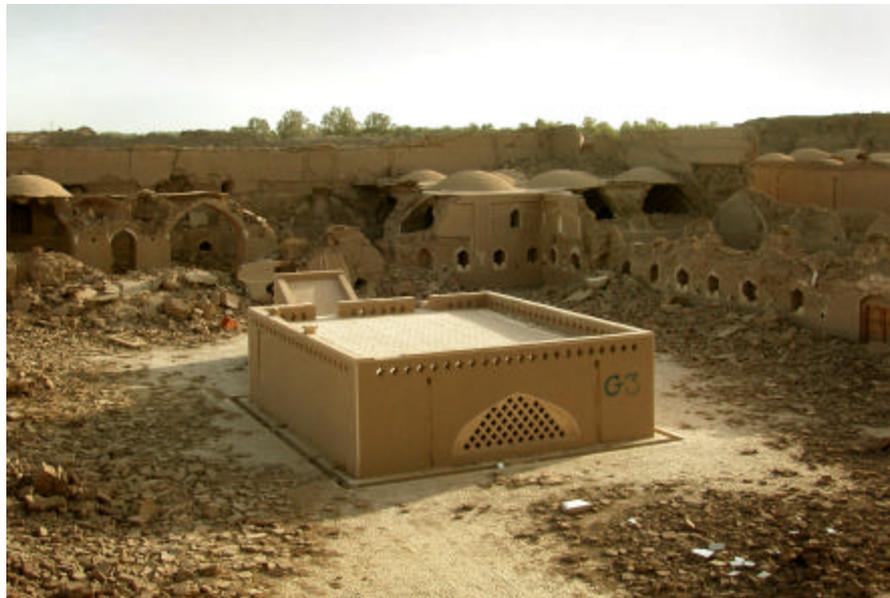
The first clue to an explanation of the dilemmas presented by the observations came from an unexpected discovery during my first day at the site of a cracked and spalled section on one of the more intact sections of rampart walls surrounding the inner citadel. Curiosity about this evidence of the onset of damage from the earthquake led to the discovery of bore holes and a large amount of frass – evidence of extensive insect infestation. I learned from the Iranian archeologists that the insect damage observed was from termites which are quite common in Iran. Termites live in the unfired earthen walls, consuming the organic material (kehqel) that was used as reinforcement.

While walking out of the complex, I randomly stopped to inspect the broken edges of the standing ruins. The results of this observation established that the initial discovery was not unique. The entire Arg had been infested with termites at various points in its recent history, raising the question: *Did the Arg collapse because the damage caused by termites?*

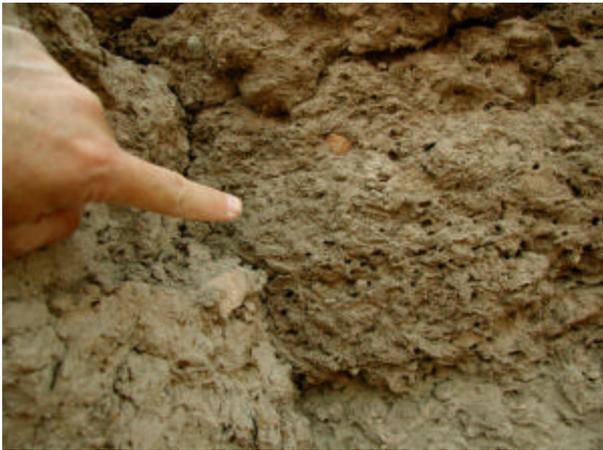
This question of the importance of the termites as a factor in the earthquake induced collapses was debated during the UNESCO, ICOMOS (International Council on Monuments and Sites), and ICHO (Iranian Cultural Heritage Organization, since changed to ICHTO: Iranian Cultural Heritage and Tourism Organization) meeting of the experts that took place that week, without arriving at a single consensus. My discovery of the termites, however, did serve to focus my own attention onto the nature of the earthen material itself in my further studies. It did not seem adequate to treat
