Performance of the Earthen Arg-e-Bam (Bam Citadel) during the 2003 Bam, Iran, Earthquake

Randolph Langenbach,^a MEERI

The Arg-e-Bam (Bam Citadel; in Farsi, *arg* means citadel) is a remarkable example of the earthen architecture and construction that was heavily damaged in the 2003 Bam, Iran, earthquake, which occurred on 26 December 2003. This paper presents the hypothesis that the collapse of the walls was caused largely by a combination of the effects of (1) the additive changes made to the walls, particularly in recent restorations, which resulted in variations in the density and response to vibrations of different layers of unfired earth construction in the walls, and (2) extensive damage from termites and loss of the cohesion of the clay from degradation and excessive drying out, all of which interacted with the earthquake vibrations of unusually high-frequency in such a way that many walls effectively burst from the loss of cohesion and subsidence of their clay internal cores. Concern is raised about the possibility of similar risks to other earthen monumental structures in future earthquakes. (DOI: 10.1193/1.2113167)

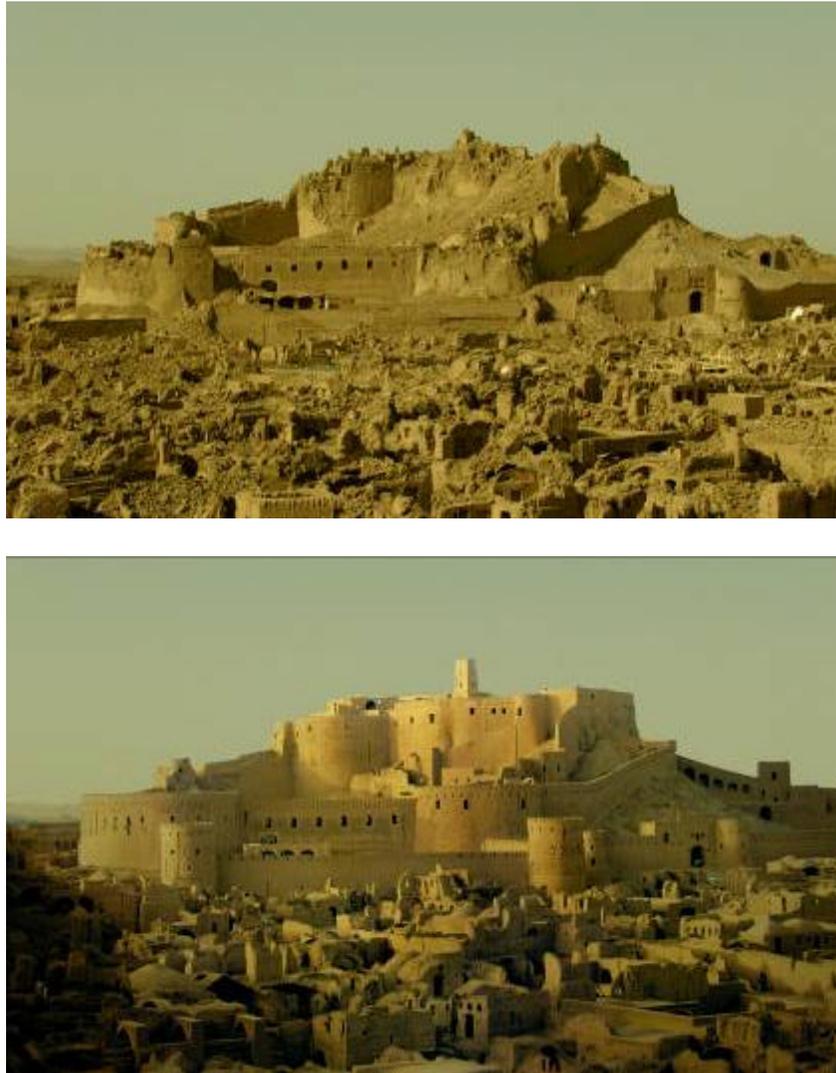
Figure 1. (a) The Arg -e-Bam before the earthquake (photo courtesy Iran Tourism Organization). (b) Exactly the same view after the earthquake. This and all other “after” photographs were taken by Randolph Langenbach in April 2004.

decade ended up with their steel frames wrapped into shapes like pretzels on top of heaps of crumpled infill masonry walls and floors. In the case of the ancient Arg, little remained that resembled complete buildings. A sea of formless rubble extended out as far as the eye could see (Figure 4). Even the Governor's House and Tower astride the hill that formed the central symbolic image for the site disappeared, leaving behind ruins that resembled a natural rock outcropping, untouched by human hands (Figures 1a and 1b).

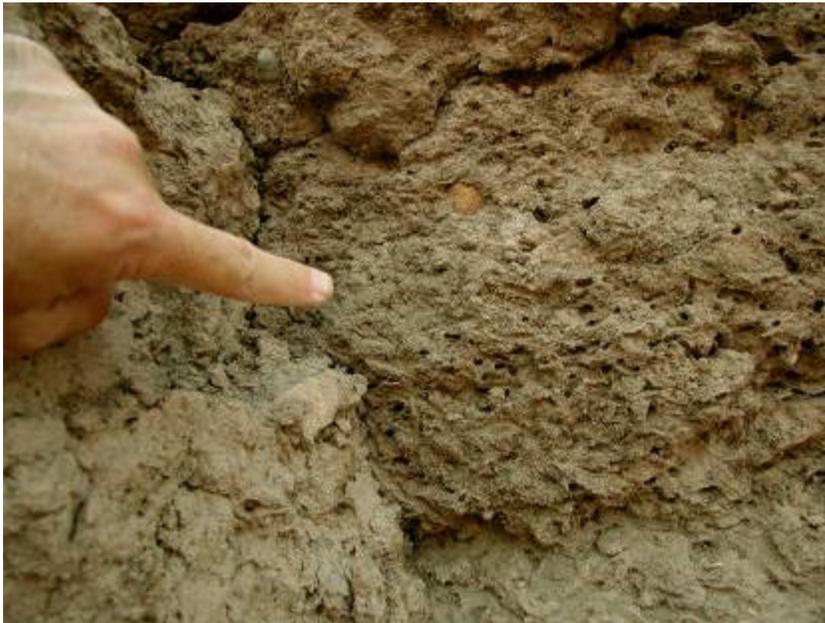
Figure 2. Evidence of termite damage in a wall of the Arg-e-Bam showing extensive deposits of frass with insect tunnels.

During the four months that followed the 26 December 2003 earthquake, which destroyed much of the Iranian desert city of Bam, much was said in the international press about the damage to the Arg-e-Bam, a majestic, historic, earthen-walled citadel in Iran (Figure 1). Nowhere in this coverage, however, were there any comments about termites. While on a visit to the Arg during the *International Workshop on Bam* sponsored by UNESCO, ICOMOS, and the Iranian Cultural Heritage Organization (ICHO)—now renamed the Iranian Cultural Heritage and Tourism Organization (ICHTO), this author observed evidence of an insect infestation in the broken remains of the city's walls. The Iranian archeologists working on the site identified the insects as termites, explaining that such termites are relatively common in Iran, but few other conservation architects or engineers with whom I spoke were aware of the termites in the Arg. While the termites did not cause the destruction of the historic Arg-e-Bam, the evidence of extensive infestation in the ancient earthen monument was unmistakable (Figure 2).

However, the succeeding phases of construction in the Arg over the centuries had produced walls of a very different composition than those of a newly constructed earthen building. These walls no longer consisted of horizontal layers of earth or sundried bricks. Through generations of erosion, repair, and remodeling, many of the walls had evolved into a series of vertical layers of earth, standing together like books on a shelf without bookends. Each of the different layers was of a different density and cohesion, resulting from the different ages, construction characteristics, and degradation. For example, modern *khesht* (adobe masonry) frequently encased older *chineh* (cob) construction (Figure 19), and the organic material used for reinforcement had rotted or been consumed by insects, leaving cavities and friable earth (Figure 2).

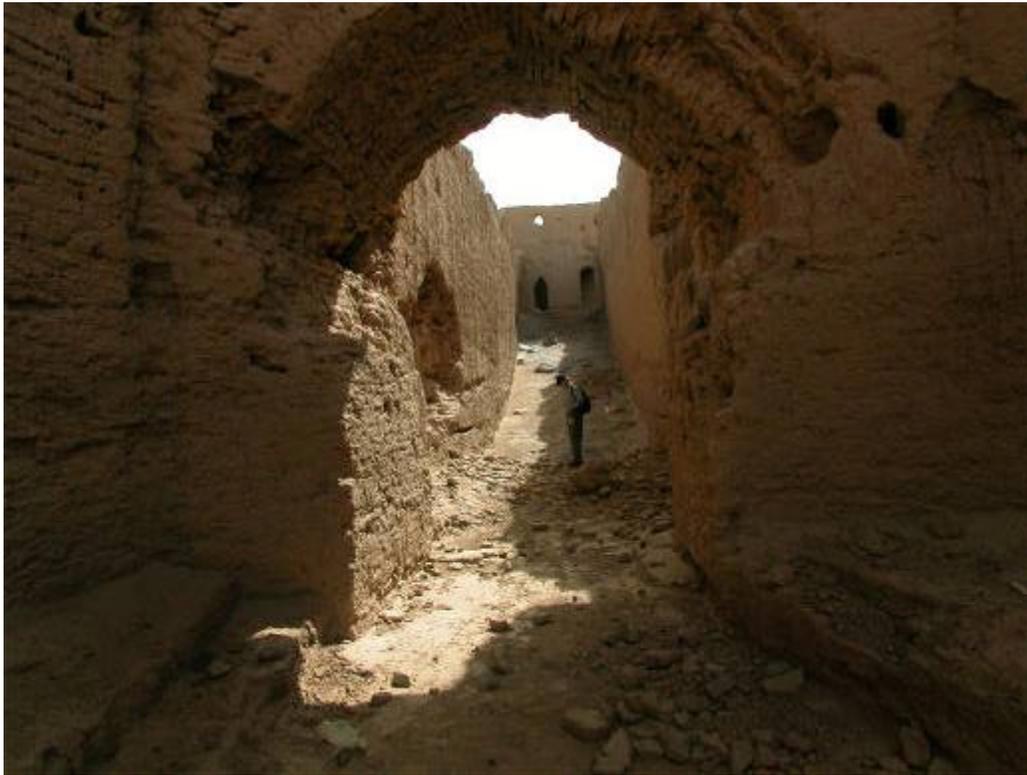
Figure 3. Shahrbast Wall, an unrestored, ancient earthen structure after the earthquake. The earthquake damage to these high unbuttressed walls was limited to the small amount of debris fall seen on the ground in the photograph.

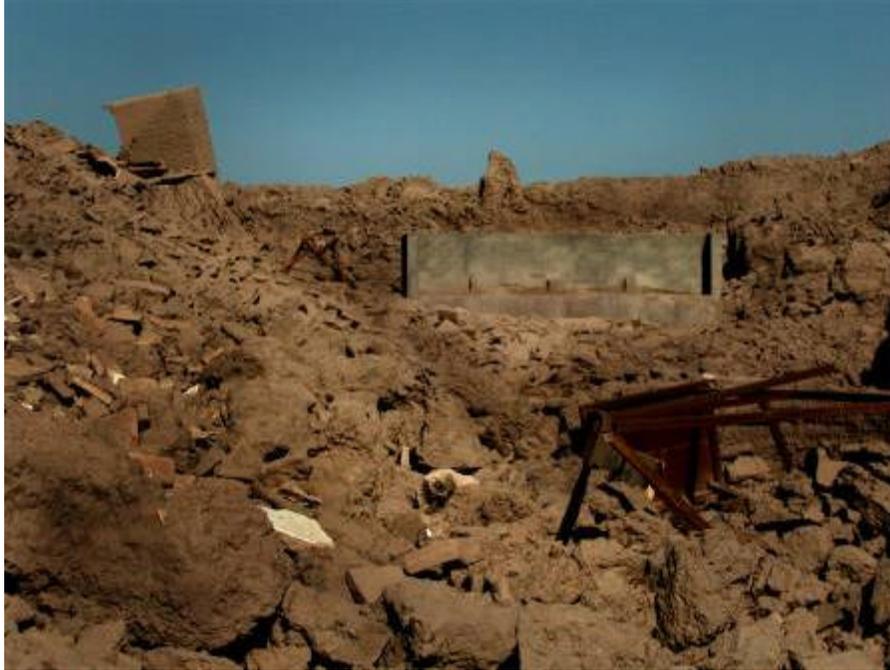
Figure 4. View of the ruins of the Main Mosque within the Arg. The only recognizable structure in this view across what had been the main courtyard is the concrete ceremonial washing basin.

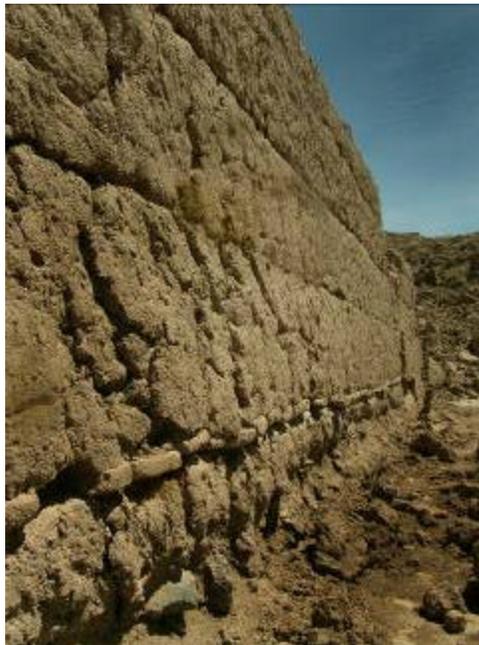
Figure 5. *Chineh* wall inside the Arg -e-Bam that was only slightly damaged in the earthquake.

the city. The chineh garden walls are generally about 2–2.5 meters high and 50–100 cm thick at the base, with a batter reducing them to only a few cm thick at the top. Most of the date palm groves in Bam and in Baravat are surrounded by walls of this type. The Iranian chineh construction found in Bam is characterized by a series of bands of clay that are about 50 cm high that represent each “lift” in the construction process. These lifts were constructed along the wall from one end to the other and then made smooth and level on the top before proceeding with the next lift (Figures 5, 13, 25, and 26).

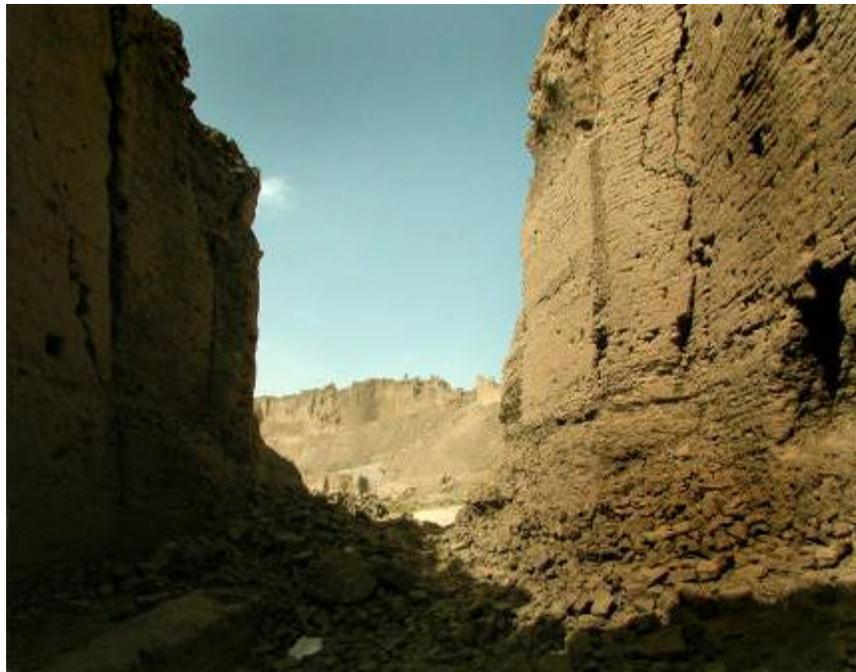
Figure 7. View from the Shahrbast Wall looking towards the ruins of the inner citadel of the Arg e-Bam. These towering walls, gnarled by time, were largely unaffected by the earthquake.

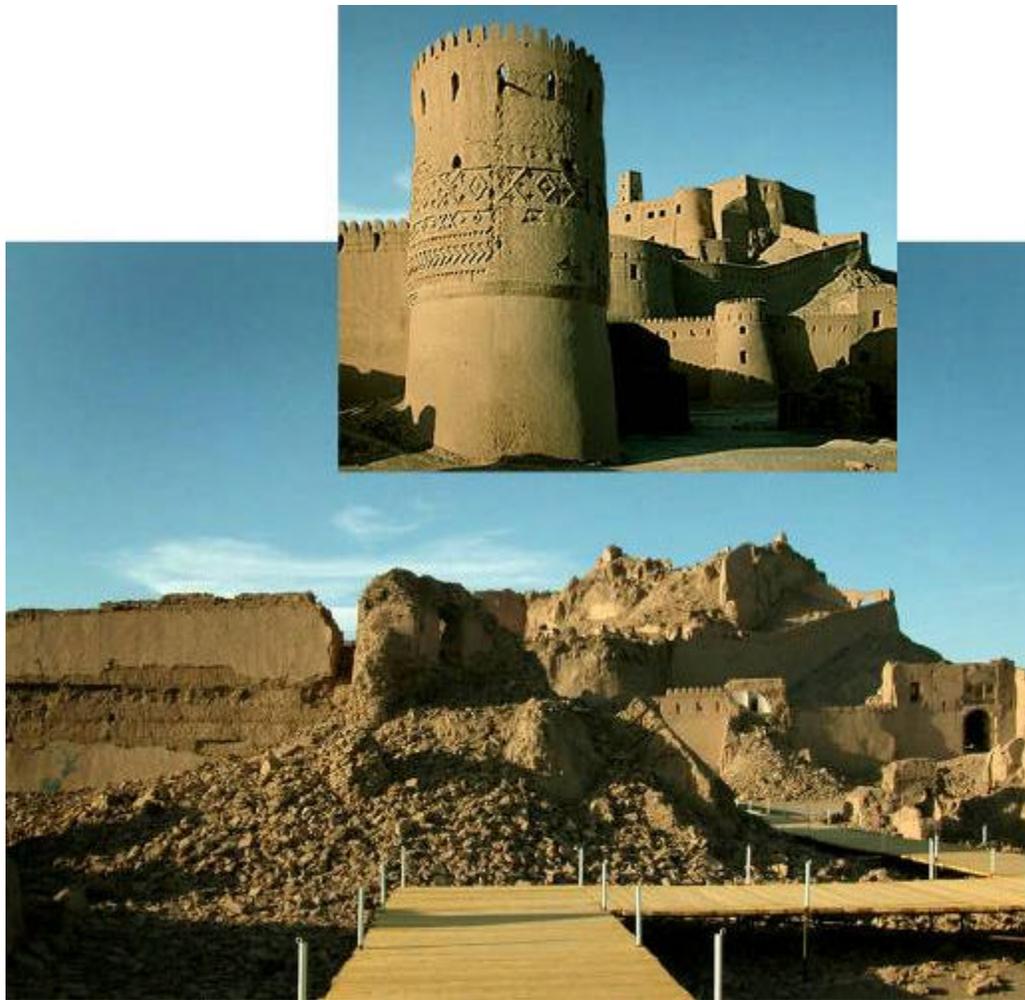
Figure 8. “Before” and “after” views of the tower and enclosure around the Stables Court with the inner citadel in the distance. The pre-earthquake image was taken only a month before the earthquake (“before” image by Mary Hardy, Getty Conservation Institute, 2003).

- The circular structures, such as the turrets on the ramparts, fared worse than the long straight walls and rectangular structures (Figures 1, 8, 16, and 23).
- The Governor's House and other structures that were part of the hilltop of the inner citadel were more completely destroyed than were the structures lower down the hill (Figure 1).
- Almost every structure in the Arg that remained standing showed evidence of the onset of damage through the spreading to their walls from the inside out, as evidenced by the preponderance of vertical cracks (Figures 11, 18, and 19).
- Most of the earthen masonry domes and vaults in the complex, many of which had been rebuilt in the late twentieth century, collapsed. The largest dome in the complex was on the icehouse, a structure outside of the walled town and which had been converted into an auditorium. This dome collapsed as if punched in.

buildings were constructed on the lower hillside. One section of the terrace that supported a building above the Stables Courtyard collapsed altogether, carrying away the front half of the rooms constructed on it (Figure 16). The round turrets appeared to have failed at the bottom, instead of splitting apart at the top as one might have expected. Their seemingly strong walls were simply pushed out at the base, while sections of the upper walls slid down the rubble. The upper ornamentations were the only recognizable pieces left (Figures 8 and 17, tower on left).

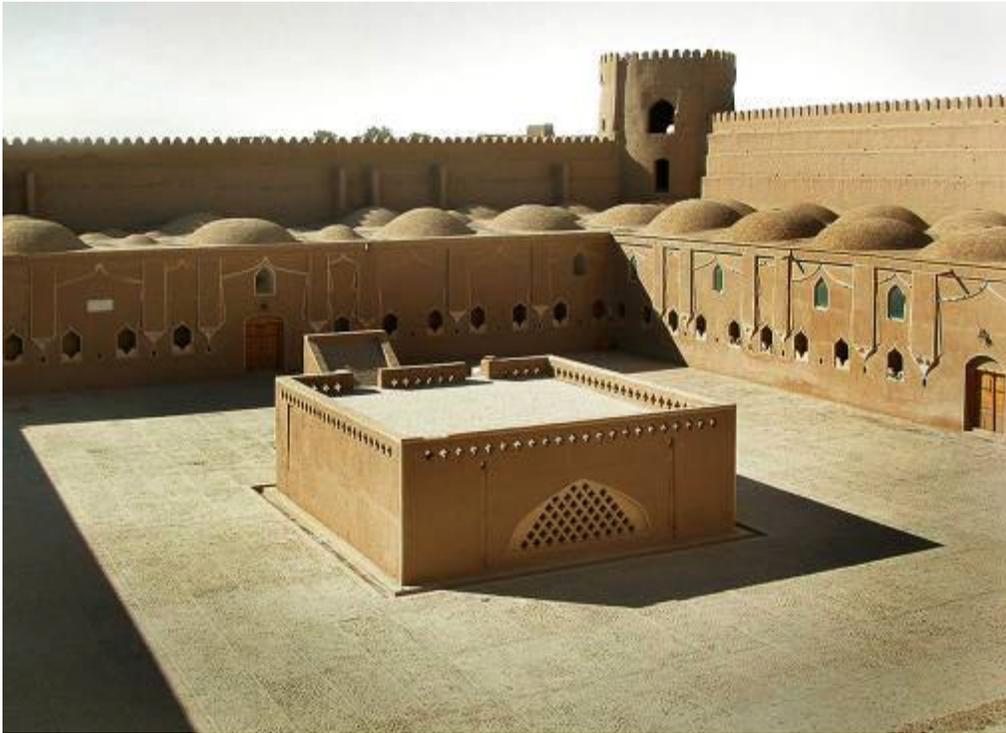
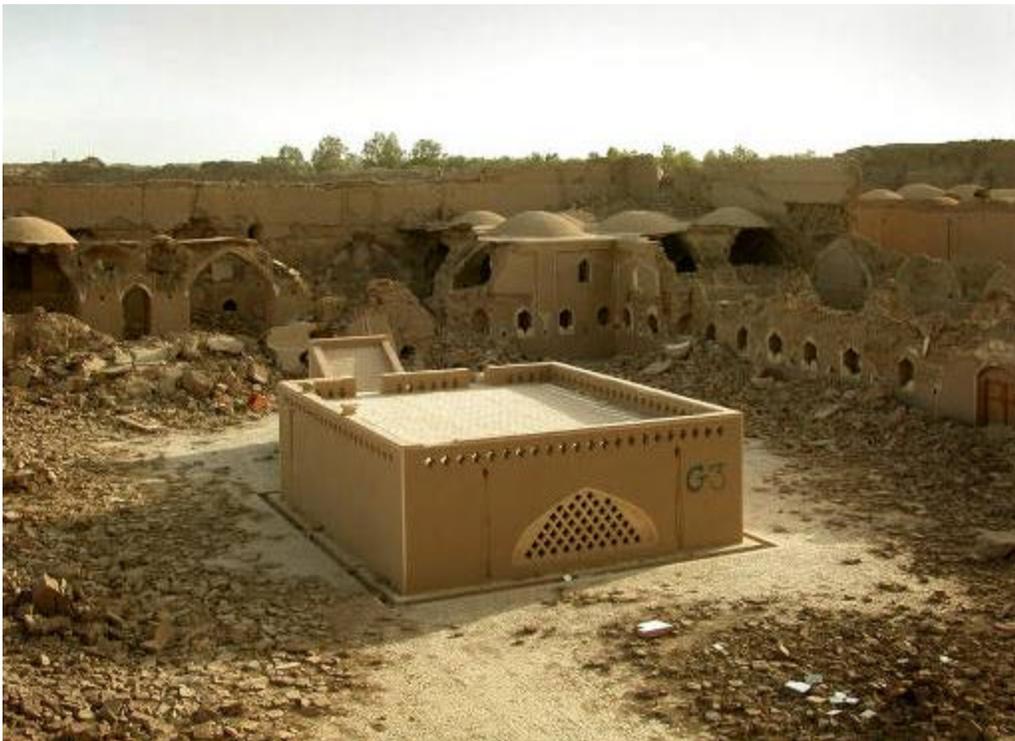
Figure 9. (a) “Before” view (November 2003) of the Stables Courtyard showing the superstructure over the cistern that had been recently reconstructed in fired bricks (photo by James Conlon, Columbia, University). (b) Same view after the earthquake.

- A brick reconstruction of a structure with internal vaults over an ancient water cistern in the center of the stables courtyard (Figures 9a and 9b) survived with no evidence of even so much as a crack from the earthquake. In aerial photographs taken in 1974, the cistern was uncovered, and the current structure is a recent reconstruction in modern fired brick masonry (Blair 1974).

In contrast to the bursting walls, the masonry structure over the cistern in the center of the Stables Courtyard performed much better, despite being of unreinforced masonry.

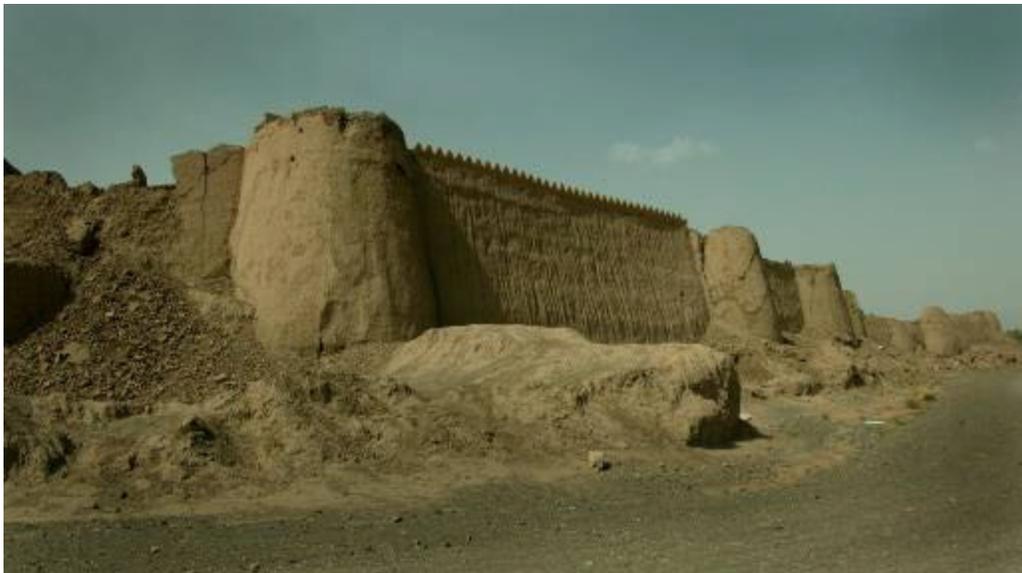
Figure 10. North-facing ramparts were significantly less damaged in the earthquake than the other outer rampart walls surrounding the Arg. Notice that the crenellations are still intact on this one section, the only section where this was observed to be the case.

- The outer ramparts on the south, east, and west sides of the walled city suffered a great deal of damage, with the loss of their projecting turrets and complete destruction of the top crenellations and walkway; yet the north-facing ramparts survived in better condition (Figure 10).

As for the better behavior of the north-facing ramparts compared to the other city walls, the subsurface soil conditions along the riverbank where the wall is located may account for some of this difference. The alluvial soils may have served to damp out some of the vibrations rather than causing the increased intensity that is familiar at sites farther from the epicenter. Further research is needed to determine whether this explanation is plausible. Also, like the walls of the nearby Konari neighborhood, these walls had not been altered and restored along their tops as much as the other walls around the Arg. It was the newer, restored, upper-level battlements, walkways, and crenellations that consistently suffered the most damage, possibly because of differences in soil densities and the vibration response of

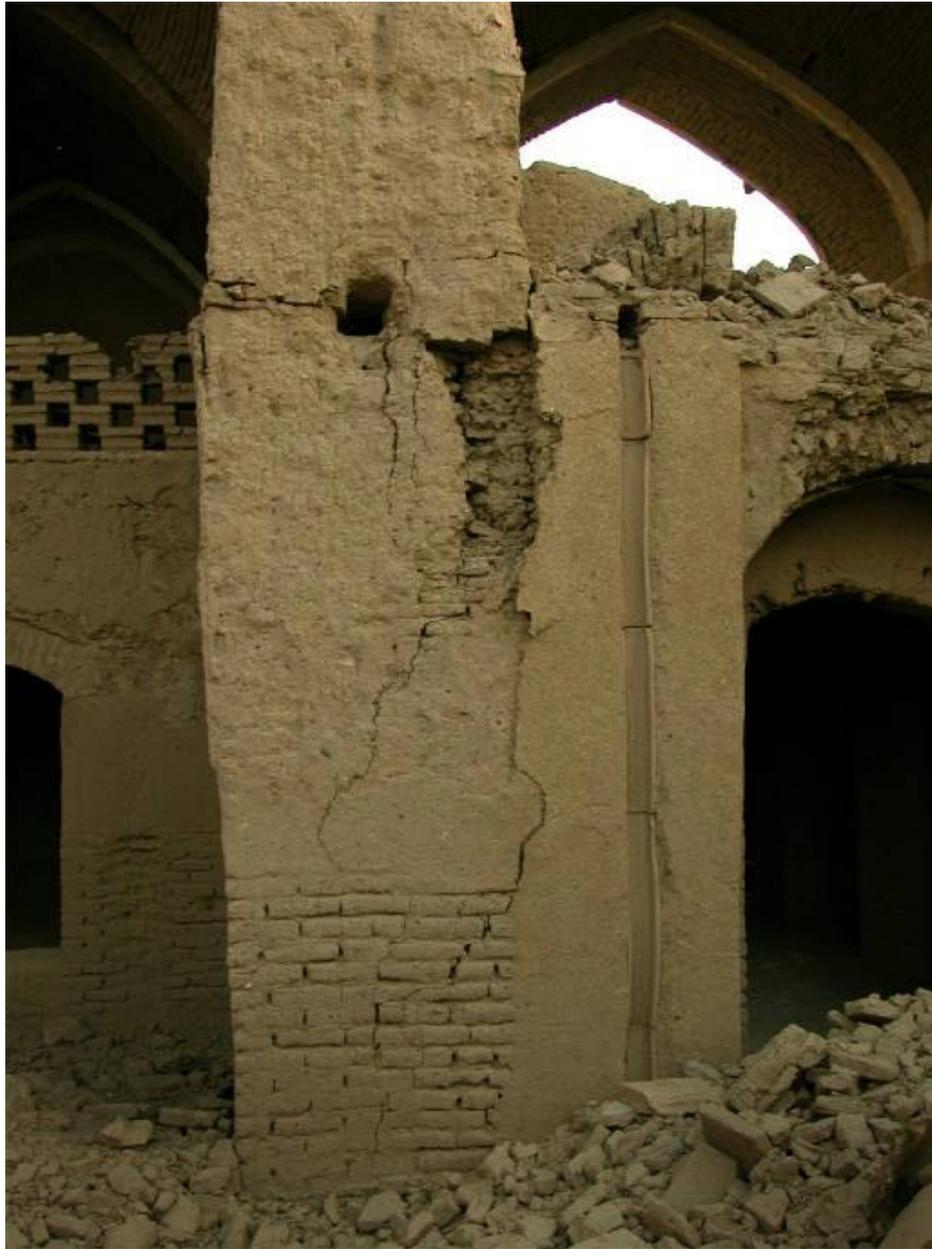
Figure 11. Pier in a partially collapsed section of the Caravansary showing the bursting of the outer layers from internal expansion from the earthquake vibrations.

The collapse of the structures at the top of the hill (Figure 1) seems to have been caused in part by the failure of the retaining walls and fill that had been constructed up from the lower hillside to widen the platform at the top of what had originally been a narrow rock outcropping. The failure of the walls of many buildings and ramparts was also consistent with the lateral spreading of the material in the cores of their walls. The exterior layer of adobe bricks was forced out from internal pressure (Figures 11, 18, and 19).

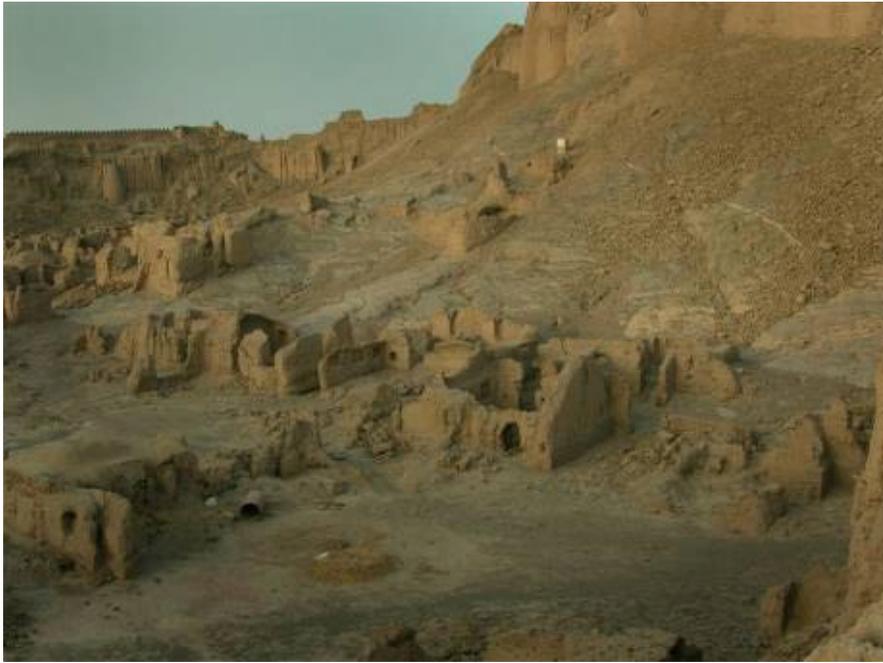
Figure 12. The unrestored ruins in the Konari neighborhood of the Arg-e-Bam after the earthquake. Although abandoned and untouched for more than 150 years, these structures survived the earthquake with comparatively little damage.

The unmodified and restored structures included most of those in the northwest section of the walled town known as the *Konari* neighborhood (Figure 12), and also those structures just outside of the Arg to the northeast, including the tall *Shahrbast Wall* (Figures 3, 7, and 13), located near the icehouse, and the *Khale Dokhtar*, located on the opposite riverbank to the north. Some of these surviving unrestored structures are of considerable size and height and were undoubtedly subjected to shaking of close to the same characteristics as the rest of the Arg, but they remained standing, except for some smaller parts that broke off (Figure 13). Even in a few of these damaged sections, termites were in evidence.

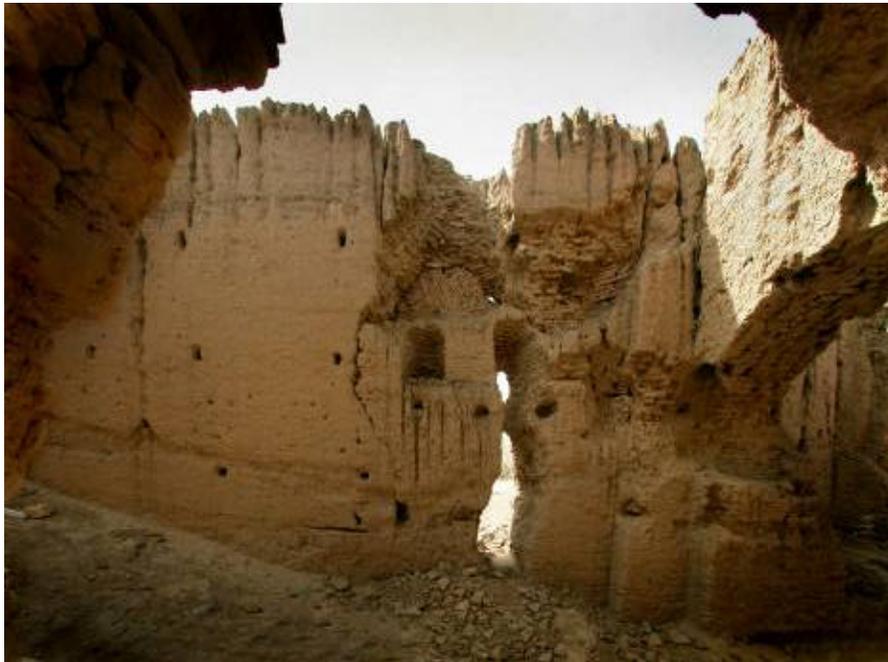
Figure 13. The interior of the Shahr-bast Wall showing the onset of damage at the interface of earthen constructions of differing types and periods.

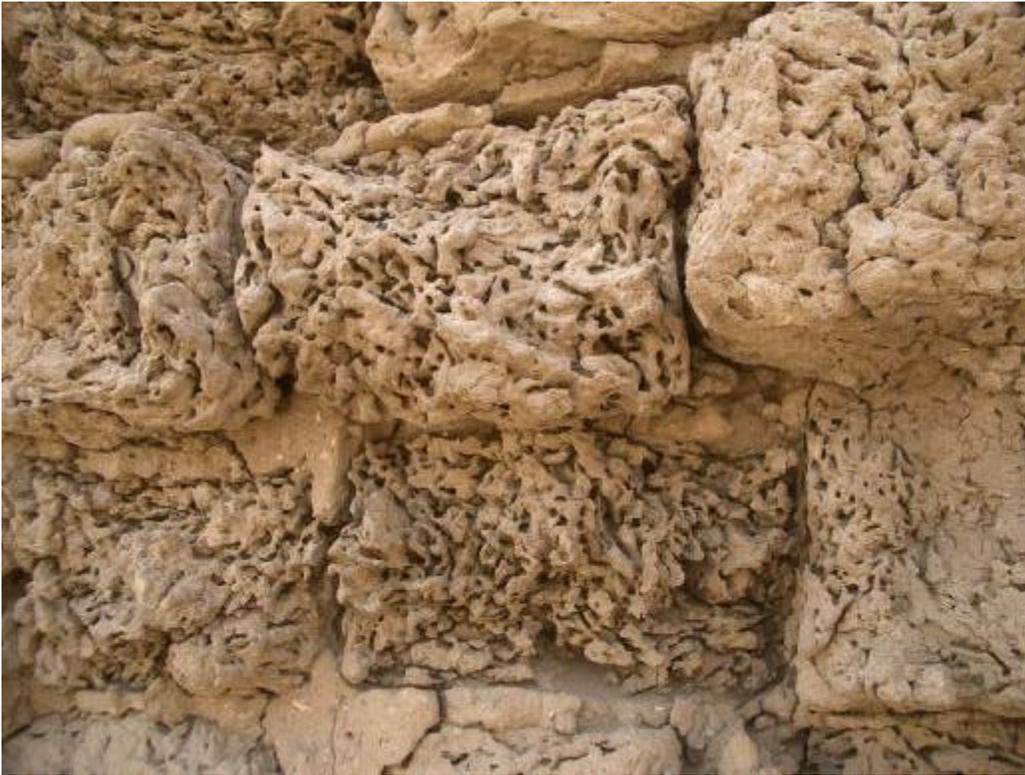
Figure 14. Termite damage found in mud bricks dating from 2700 BCE at the Shunet el Zabib at the archeological site of Abydos in Egypt (photo by Anthony Crosby).

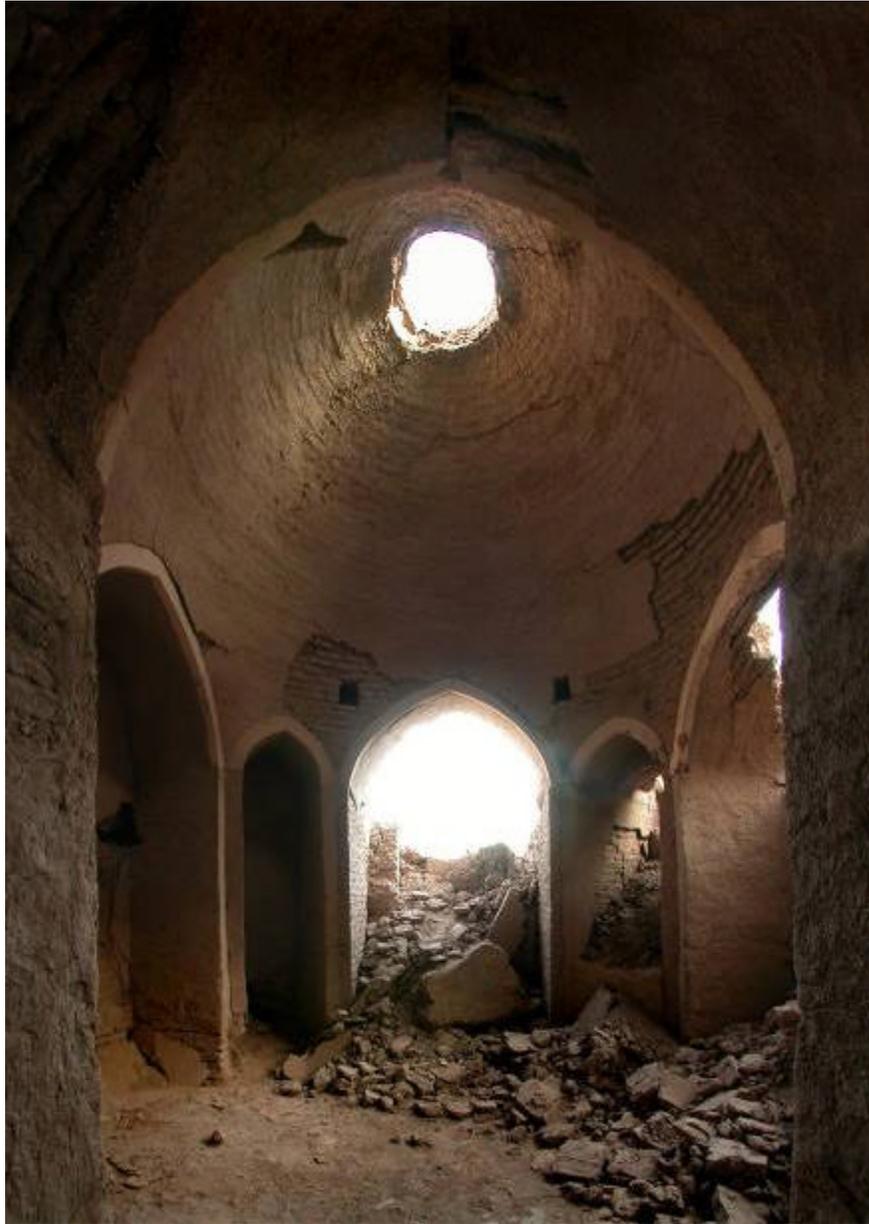
Figure 15. This surviving domed room at the base of the inner citadel gives an idea of the simple, but impressive, spaces that had been in the Arg. It is now completely surrounded by rubble from the structures that had surrounded it.

However, in the Arg, even the usually common diagonal tension, or “X” cracks, were relatively rare. It appeared as if the structures had exploded from the inside and crumbled straight to the ground in a scatter of small pieces. Rubble was everywhere. It formed a mat of broken material that in some places was almost as high as the still-standing remains of the walls. The previously completely restored Grand Mosque, for example, was unrecognizable after the earthquake. In the rubble pile, there was barely enough left intact to discern the outline of what had been its large courtyard (Figure 4). The few ancient vaulted and domed rooms that did survive were often ones that had once been deep within the intertwined fabric of the complex, but now, with everything having fallen away from around them, they stand alone to give an impression of what had once existed (Figure 15).

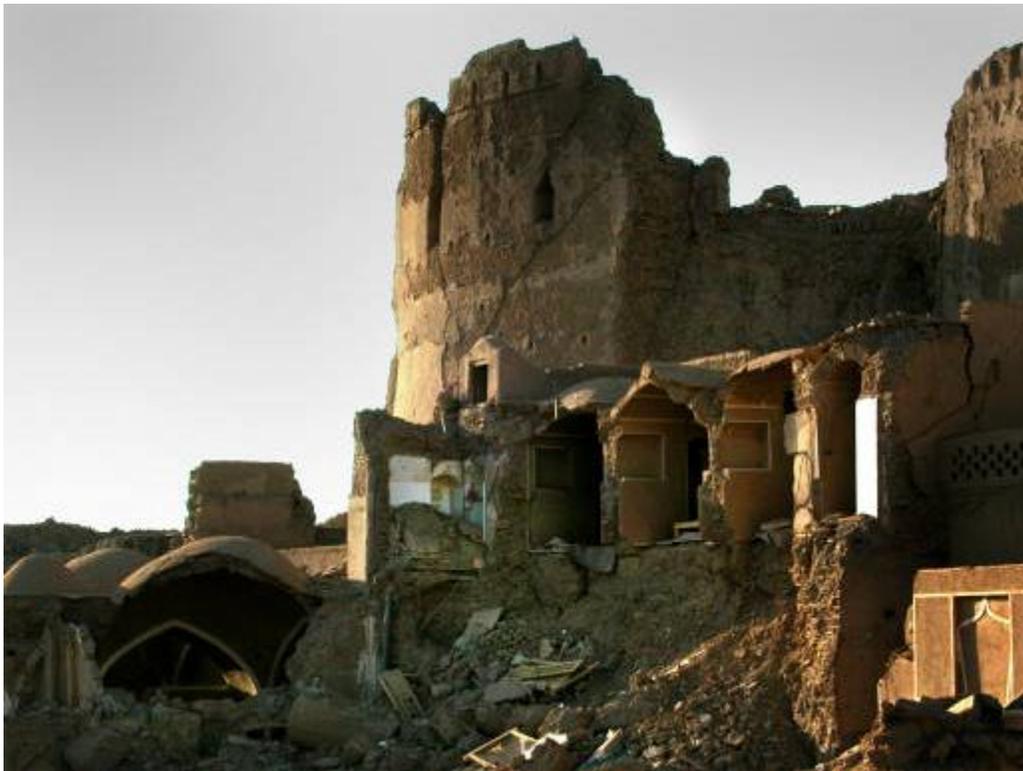
Figure 16. Buildings above the Stables Courtyard that collapsed from the lateral spreading failure of the retaining wall and fill beneath.

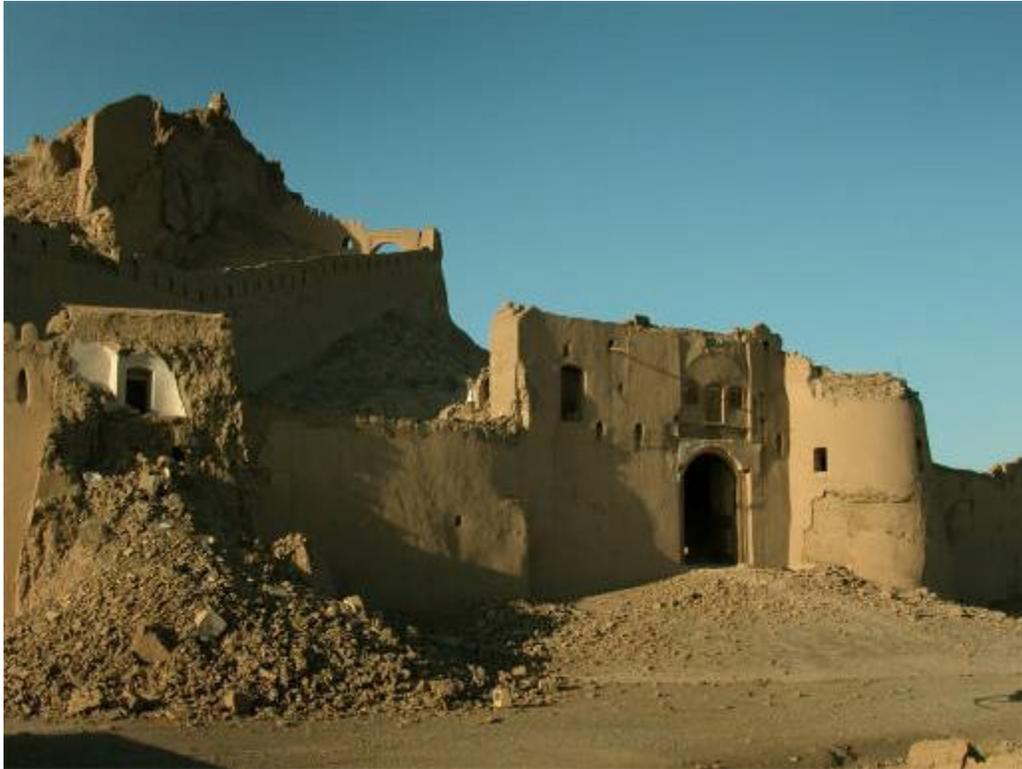
Figure 17. The turret on the right is one of the few turrets to have survived the earthquake. It is interesting to note that this turret was unique among all of the turrets in that it had a room in its base rather than being solid earth. Although it is counterintuitive to find greater earthquake resistance for a thin-walled structure with a room in it when compared to a solid base, the fact that it did not have the large mass of loosely consolidated fill that collapsed in the others may explain its resilience, in addition to the existence of the timber diaphragm of the second floor that serves to hold it together.

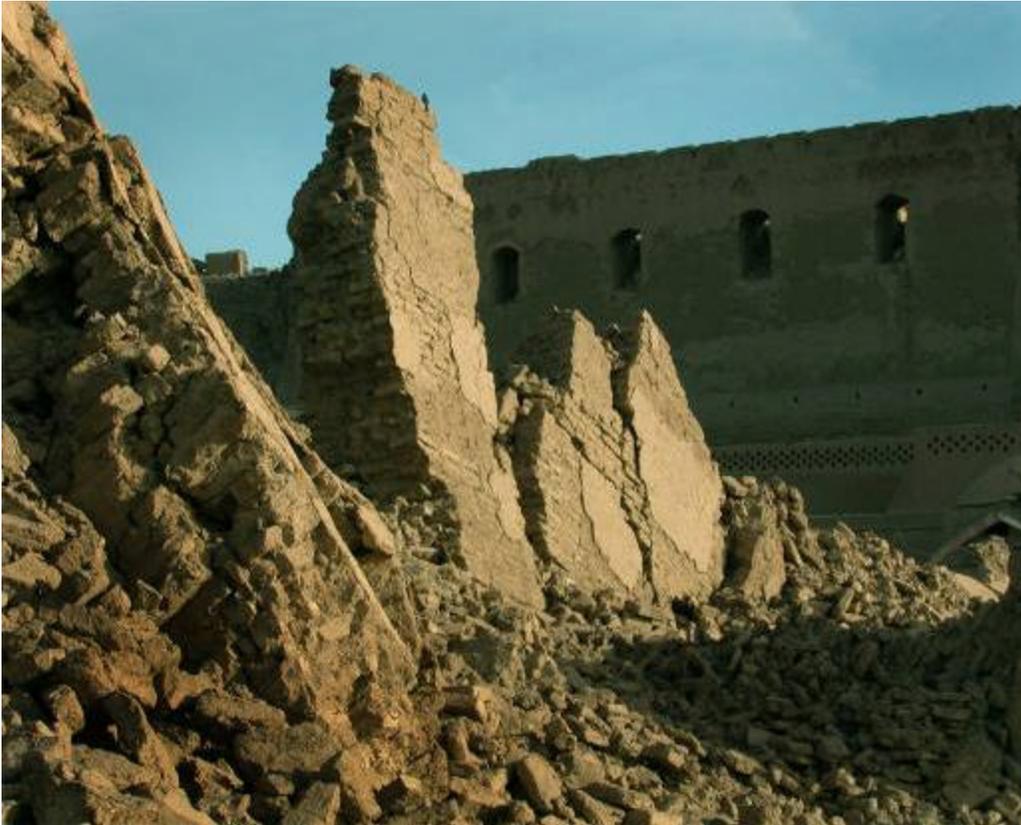
Figure 18. View of a portion of the wall around the Stables Courtyard showing the vertical fracturing of the wall into segments as it had collapsed from failures at its base.

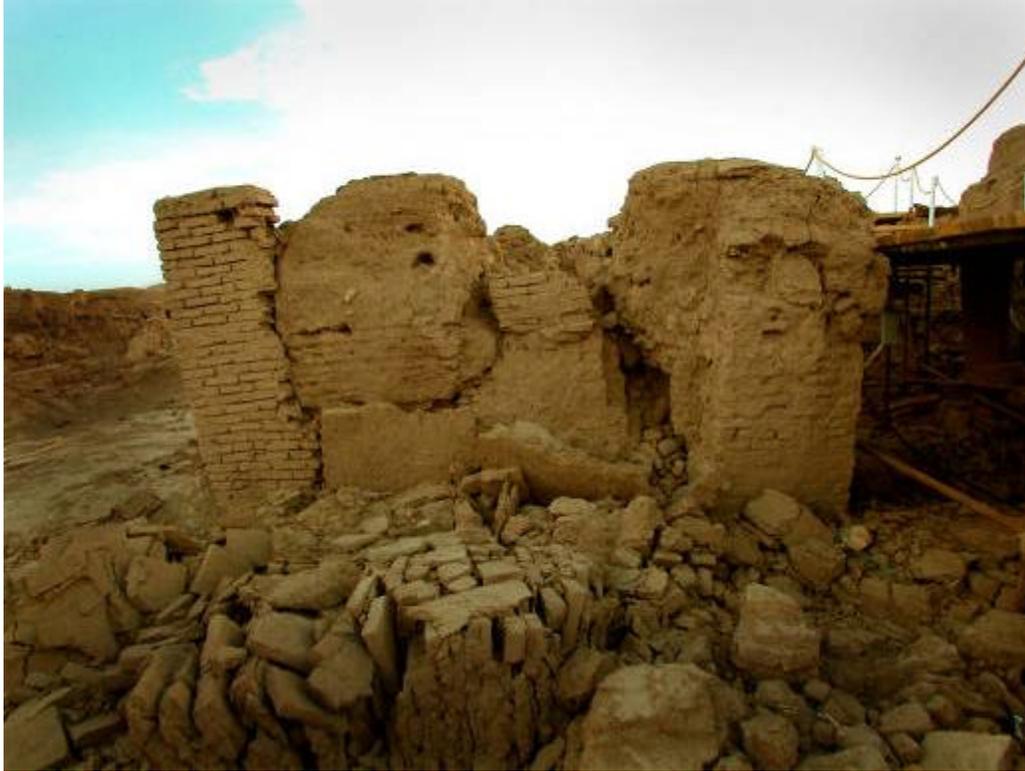
Figure 19. A massive pier composed of different periods and types of *khesht* and *chineh* construction that have separated from each other during the earthquake.

Many chineh walls, both ancient and modern, did prove to be remarkably durable in the 2003 earthquake. As one passes through areas of gradually increasing damage in the city of Bam, these walls are seen to have remained standing even when nearby houses and multi-story steel frame buildings collapsed. Near the Arg, which is located close to the epicenter, the damage to the garden walls is clearly greater, but large sections have nonetheless remained standing that in both the parallel and perpendicular directions to the earthquake waves. Also, in the Arg, many walls of the unmaintained and unrestored structures mentioned above that survived the earthquake largely intact were of chineh construction (Figures 3 and 13). There are examples where both chineh walls and separate pre-twentieth-century walls of khesht construction survived intact, whereas, in other locations where chineh was later reinforced with khesht, the damage was observed to be the most extensive (Figure 19).

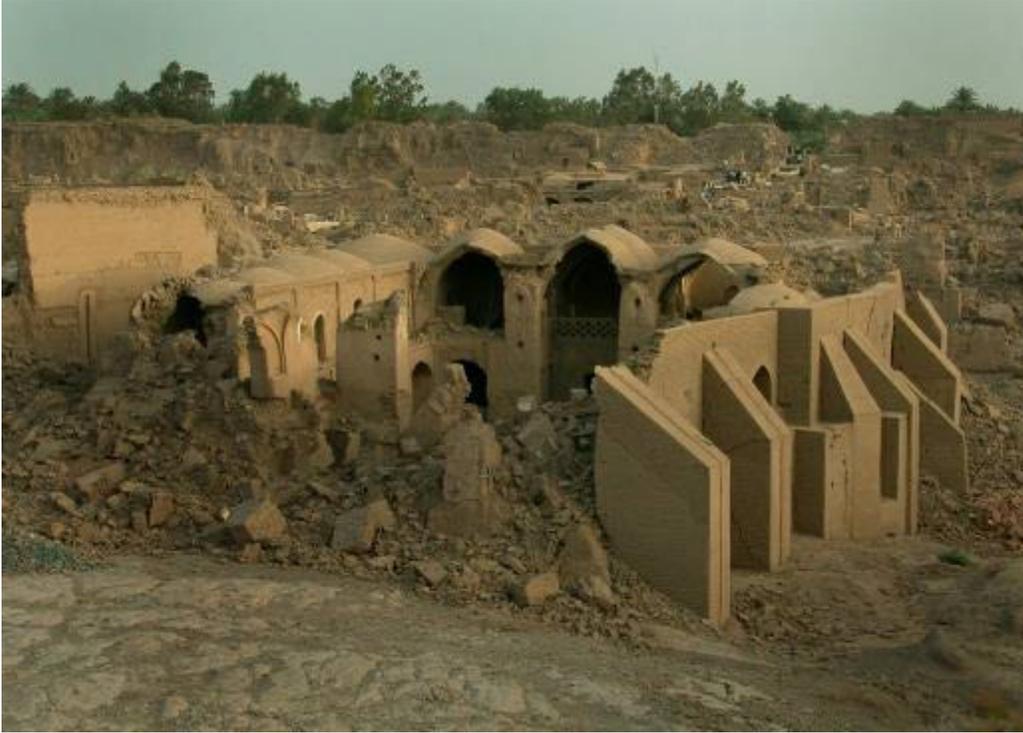
Figure 20. The ruins of the Caravansary show that the domed rooms on the second level behind the buttresses have collapsed, while the ones opposite still remain. There are no buttresses behind the external wall of the opposite side. The fifth buttress has begun to collapse at its base.

Also of interest is the Caravansary (Figures 20 and 21), where rooms on the second level of the buttressed west side of the complex collapsed, leaving the east side, which lacked buttresses, largely intact. The buttresses themselves were also damaged, with one collapsing from the crushing of its base.

The story of this complex became even more interesting when I learned from the historic photos that the side that collapsed had been largely reconstructed only a few years earlier, whereas the side that remained standing had mostly survived from antiquity. In aerial photographs of the Caravansary taken in 1974, the domes on the east side were almost completely intact, whereas on the west side they had collapsed. At that time, the buttresses on the west side only extended up to the level of the first floor. As late as 1996, the condition of both sides was similar to how they were in 1974, except that the small holes in the east side domes had been fully repaired (ICHO 2004a).

At the time of the earthquake, photographs show that the restoration of the west side of the Caravansary had been completed (ICHO 2004b). The domes had been reconstructed and the west wall and buttresses had been extended up to the roof level. Ironically, in the earthquake, it was this newly constructed and fully buttressed side that fell. This was simply one more example of the finding that the areas with the greatest amount of strengthening, reconstruction, or even of continued maintenance were the most heavily damaged.

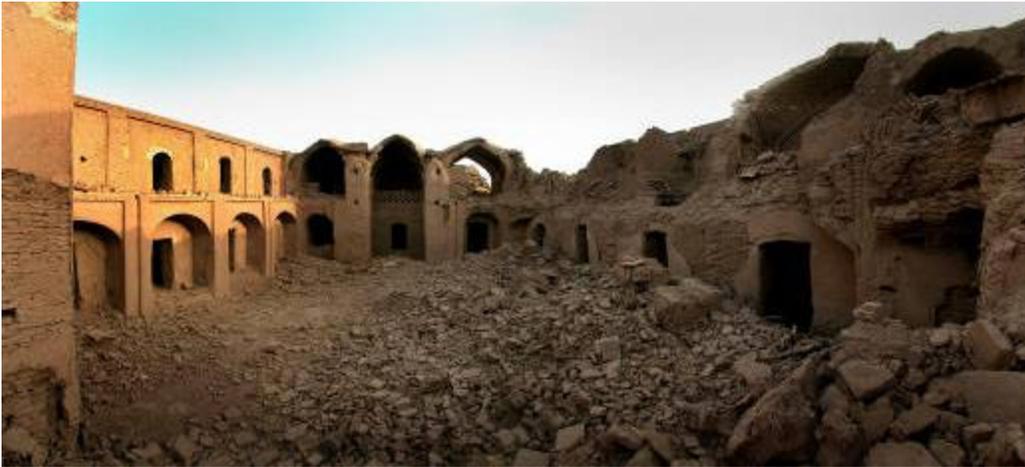
Figure 21. The interior courtyard of the Caravansary. The buttressed side is behind the collapsed rooms to the right.

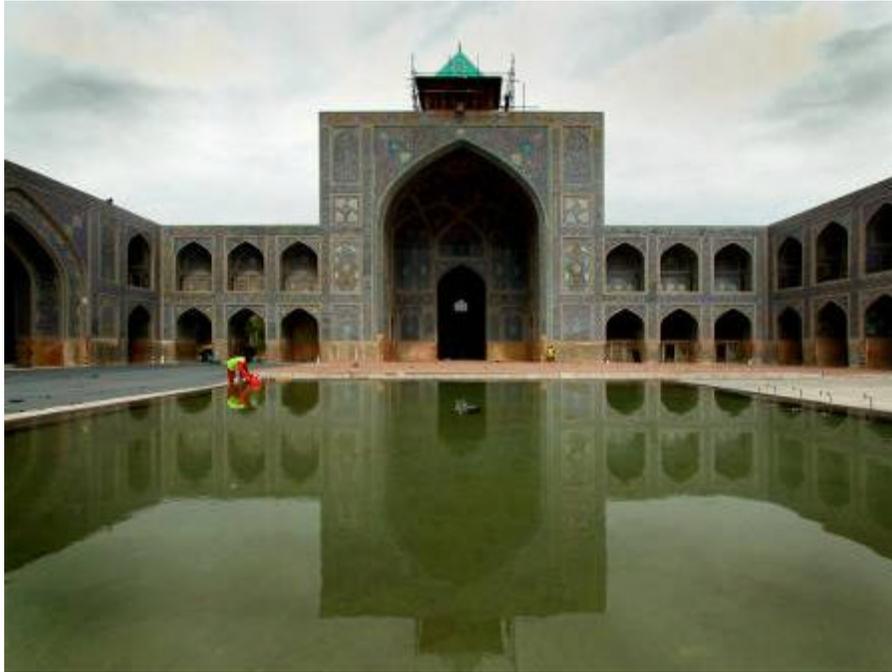
Figure 22. The Imam Mosque in Isfahan, April 2004. The inner cores of many of these walls and the walls of other great monuments in Isfahan are constructed of unfired clay.

splendid city (Figure 22) have confirmed that termites have been found in the walls of several earthen monuments during recent restoration work. These conservators explained that the damage caused by the termites had to be addressed in the restorations by consolidating the earthen cores of some of the walls.

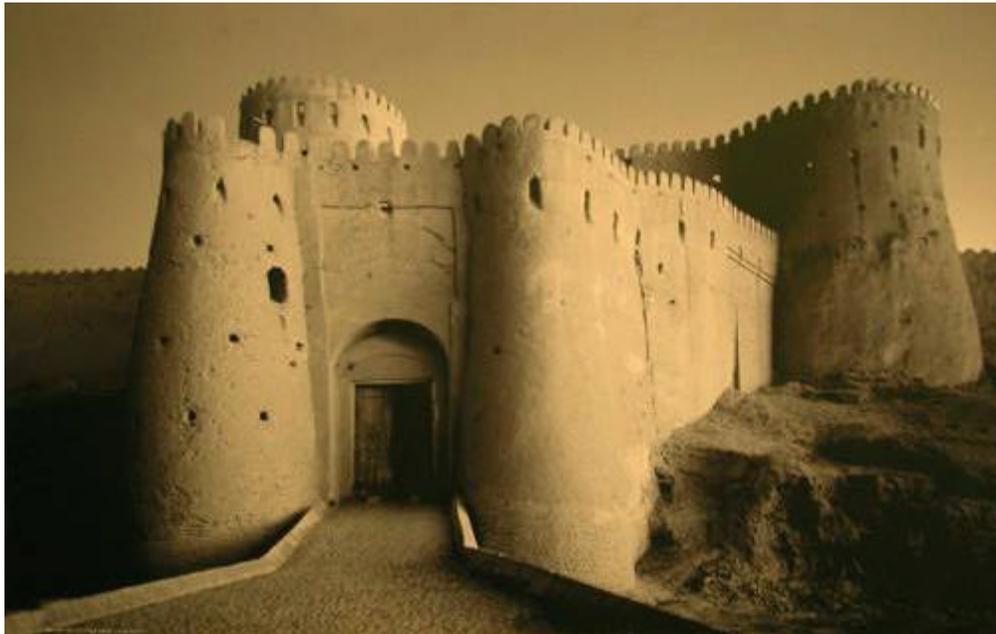
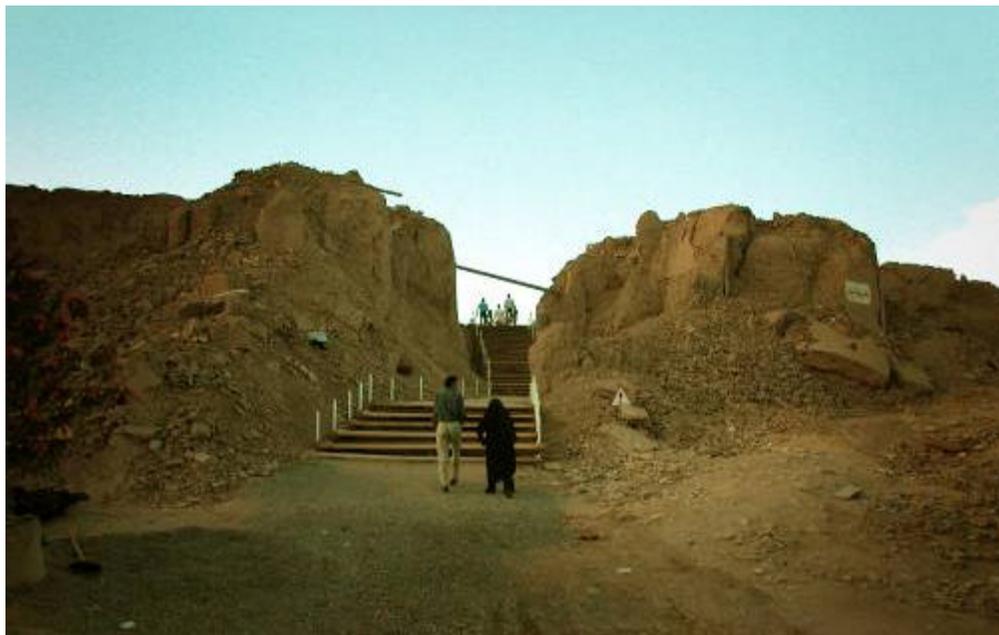
Figure 23. (a) Main Gatehouse to the Arg in 1988 (photo by M.R. Javadi, Iran). (b) Same view after the earthquake.

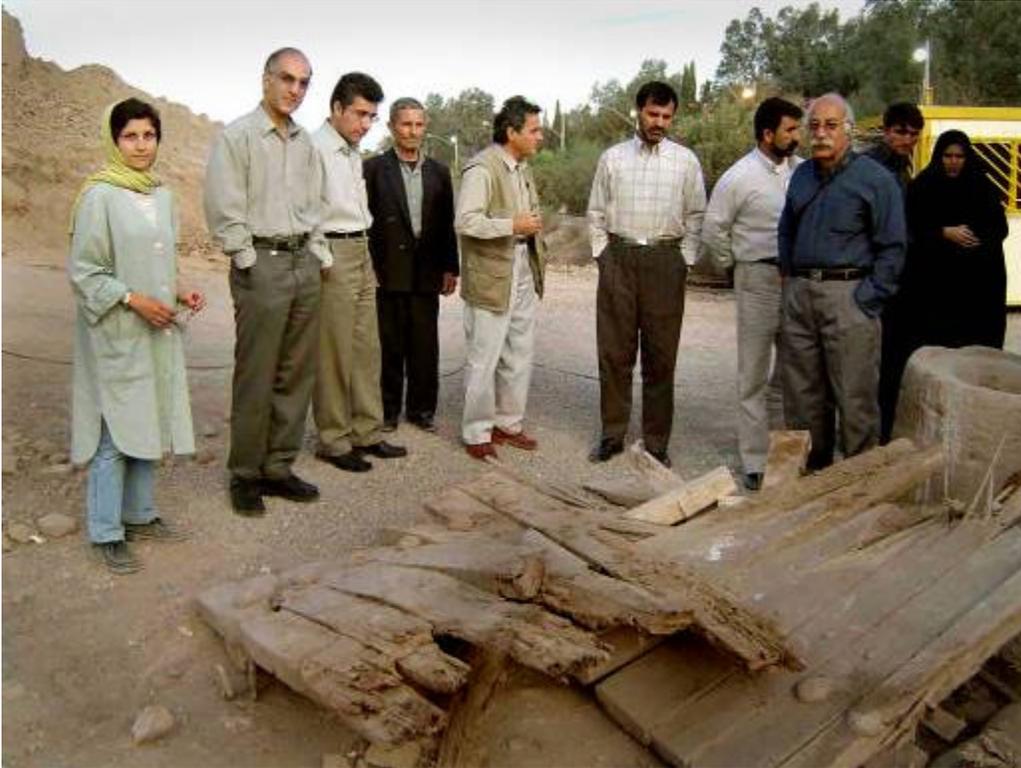
Figure 24. Iranian professional team of conservators inspecting the doors to the Main Gatehouse of the Arg after they were excavated and found to have been partly consumed by termites after 11 months under the collapsed earth of the gatehouse (photo courtesy of Professor Mehrdad Hejazi).
