Performance of the Earthen Arg-e-Bam (Bam Citadel) during the 2003 Bam, Iran, Earthquake

Randolph Langenbach,^a MEERI

The Arg-e-Bam (Bam Citadel; in Farsi, *arg* means citadel) is a remarkable example of the earthen architecture and construction that was heavily damaged in the 2003 Bam, Iran, earthquake, which occurred on 26 December 2003. This paper presents the hypothesis that the collapse of the walls was caused largely by a combination of the effects of (1) the additive changes made to the walls, particularly in recent restorations, which resulted in variations in the density and response to vibrations of different layers of unfired earth construction in the walls, and (2) extensive damage from termites and loss of the cohesion of the clay from degradation and excessive drying out, all of which interacted with the earthquake vibrations of unusually high-frequency in such a way that many walls effectively burst from the loss of cohesion and subsidence of their clay internal cores. Concern is raised about the possibility of similar risks to other earthen monumental structures in future earthquakes. (DOI: 10.1193/1.2113167)

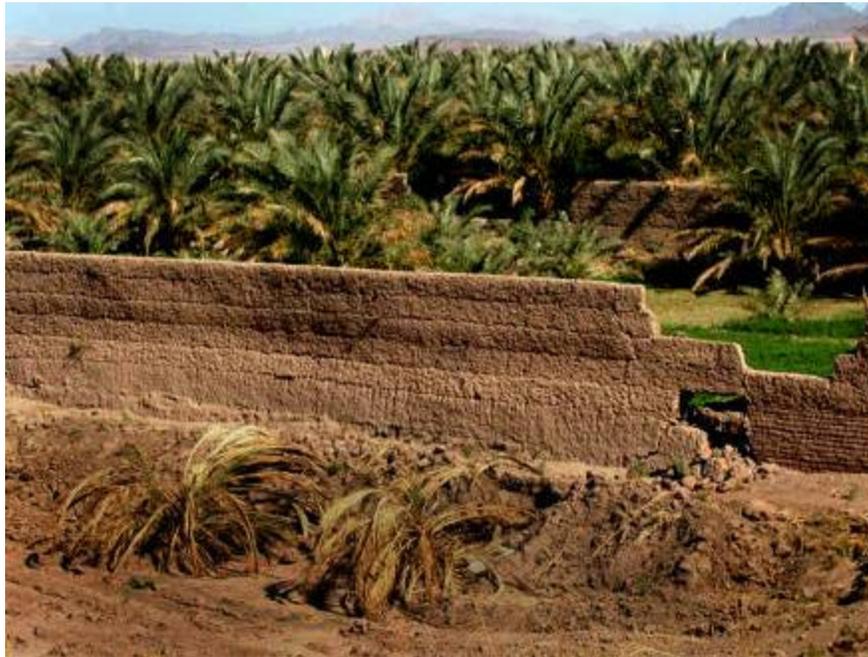
Figure 25. *Chineh* garden wall, probably of recent origin, on the opposite side of the river from the Arg. This wall shows the cracks that commonly exist in *chineh* walls, and also how this ordinary earthen garden wall survived the earthquake almost completely intact.

the city. The chineh garden walls are generally about 2–2.5 meters high and 50–100 cm thick at the base, with a batter reducing them to only a few cm thick at the top. Most of the date palm groves in Bam and in Baravat are surrounded by walls of this type. The Iranian chineh construction found in Bam is characterized by a series of bands of clay that are about 50 cm high that represent each “lift” in the construction process. These lifts were constructed along the wall from one end to the other and then made smooth and level on the top before proceeding with the next lift (Figures 5, 13, 25, and 26).

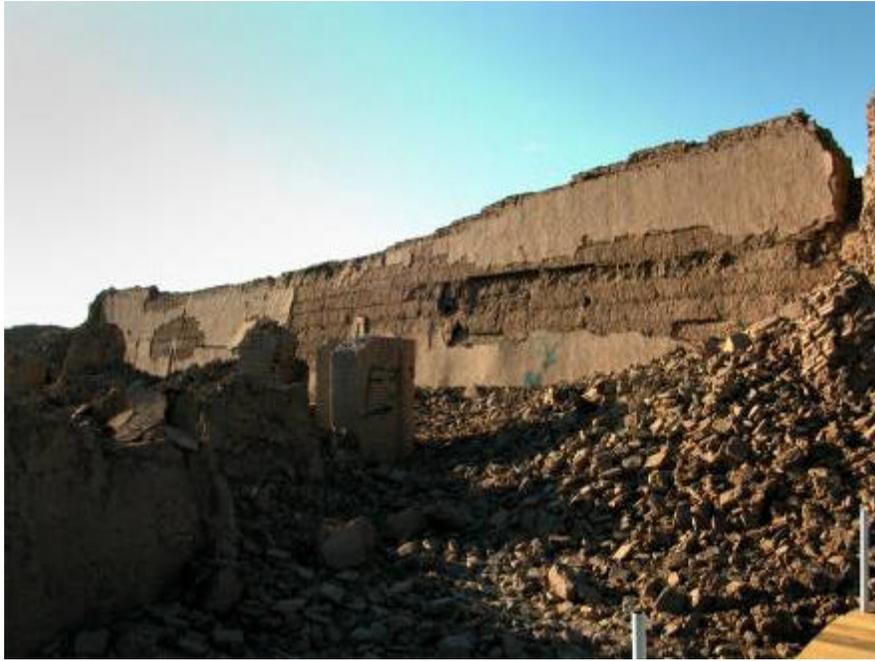
Figure 26. The south-facing outside wall of the Stables Courtyard showing how the layering of the *chineh* walls has interrupted the cracking and collapse of sections of the wall, thus helping to maintain the stability of the partly undermined upper part of the wall. This is next to, and at right angles to, the *khesht* wall that is collapsed seen in Figure 18.

This differs from northern European cob construction, which lacks such clearly defined horizontal interfaces between the lifts. There may have been a number of reasons for this construction detail in chineh, such as protection against rising damp and the shedding of water, but one structural reason may have been to avoid vertical cracks through the wall, a problem that is all the more acute in a dry climate. Because these walls are constructed only of uncompressed dried mud, they began their life with many vertical cracks and checks from the initial drying out process. In fact, the Getty Seismic Adobe Project report states: “Substantial cracks nearly always exist in historic adobe buildings as a result of past earthquake activity, wall slumping, or foundation settlement. Cracked walls are a typical feature of these buildings.” Throughout history, Iranian builders would have striven to avoid the negative structural effects of this inevitable cracking as much as possible. This would have been done for stability in general, not just because of earthquake risk, but the earthquake risk may have contributed to the evolution of the system that was used, while the local limitation on resources would have limited the builders to the use of unfired earth. Consequently, the horizontal control joints in the chineh walls may be a result of this effort to control the effects of crack propagation by interrupting the progression of cracks through what would otherwise have been a uniform material.

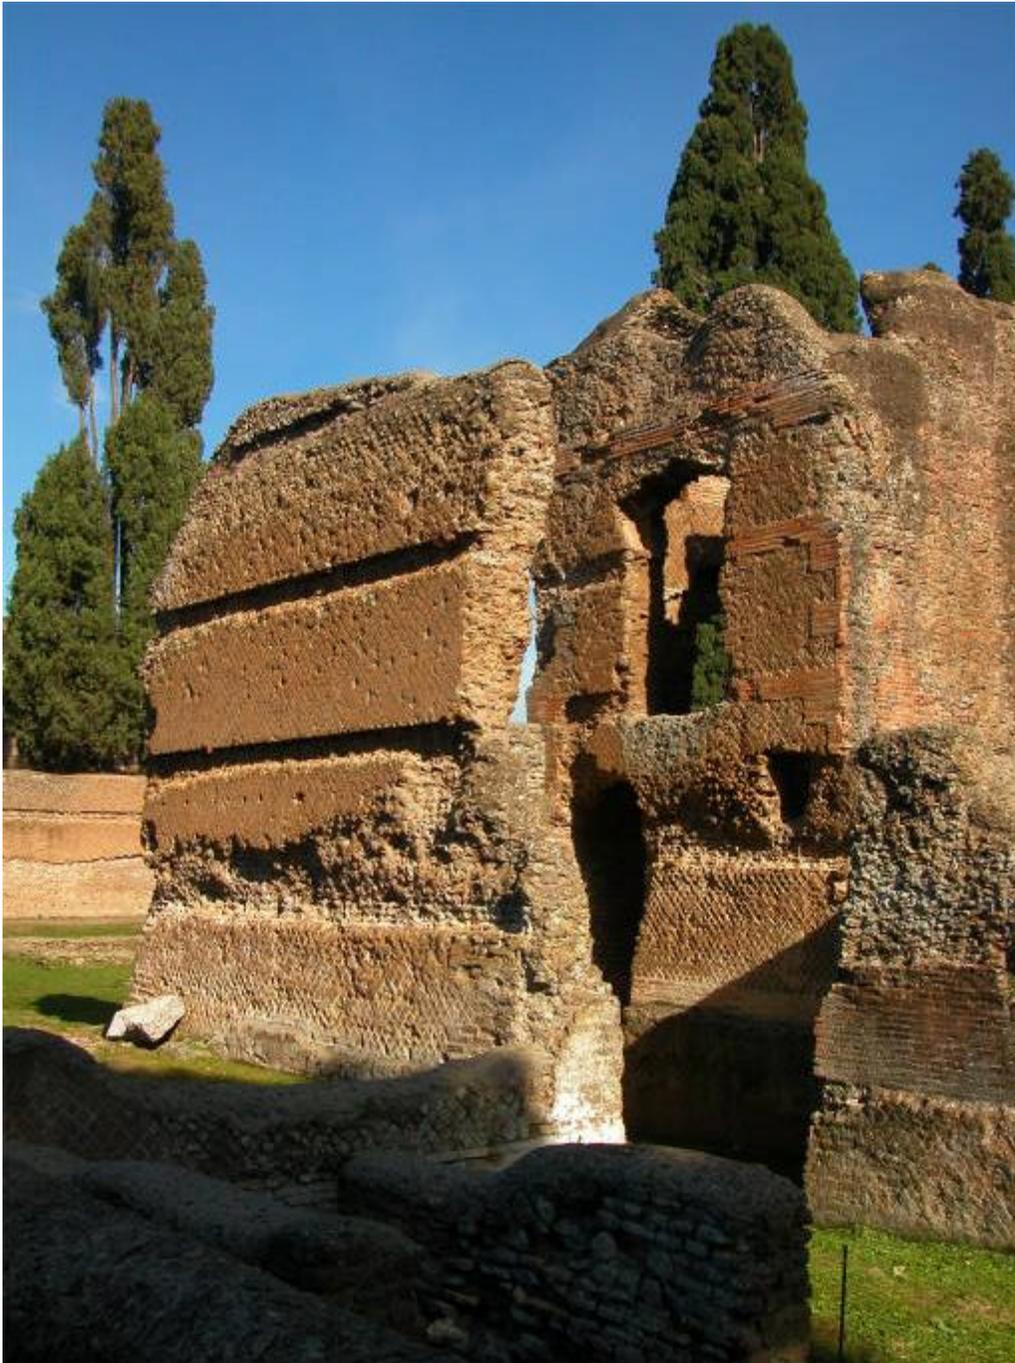
Figure 27. A wall at Hadrian's Villa near Rome showing the bands of brick that were laid into a wall constructed with natural cement with a tile facing. The crevices are the result of the later chipping out of the bricks for re-use.

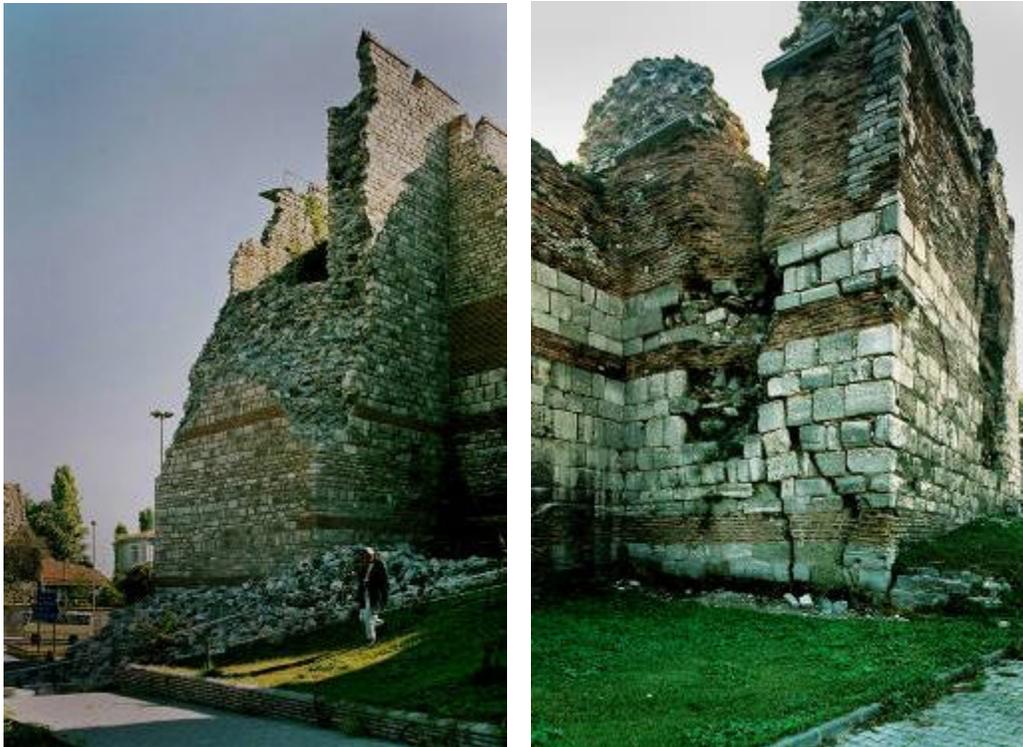
Figure 28. (a) A modern reconstruction of a tower as part of the ancient Theodosian City Walls in Istanbul, Turkey. This reconstructed tower collapsed during the 1999 earthquake. The bands of red brick on the wall were fake veneers rather than full through-wall layers of brick. (b) A surviving portion of the original Theodosian city walls in Istanbul, which are next to the tower seen in 28a. The large cracks and damage pre-dated the 1999 earthquake, which caused no further damage to this unrestored ancient wall. The bands of brick extend through the rubble core.

These and other Iranian examples are worth exploring for further information on the effectiveness of such horizontal bands of masonry laid into earthen walls, but the lesson to be learned is that what we sometimes only think of as architectural details originally may have been developed to serve more practical structural needs. This point is reinforced by the following example in Istanbul: during the 1999 Koçaeli earthquake, the only part of the ancient city walls to collapse was a tower that had been completely reconstructed in new masonry only a few years before (Figure 28a).

The next tower (Figure 28b)—despite its heavily decayed and cracked condition—remained standing. The surviving ancient tower had horizontal brick bands that extended through the rubble stone core of the wall. The restorers of the new tower only placed the brick bands on the surface of the wall as a veneer, constructing the tower with thick walls of rubble set in mortar with a thin cut stone veneer. The lesson that can be learned from this event is that architecture, structural design, and construction practices for ancient buildings are part of an integrated system, not separate or unrelated features. The hidden parts of the ancient walls are every bit as important as what can be seen on the surface. Illustrative of this fact, the pre-modern builders most likely understood the importance of the simple concept of crack-stopping, since it was one of the few measures that they had at their disposal to improve the stability of unfired earthen construction in desert environments.
