HERITAGE AT RISK *Special Edition*

Cultural Heritage and Natural Disasters
Risk Preparedness and the Limits of Prevention

Understanding What Works: Learning from Earthquake Resistant Traditional Construction

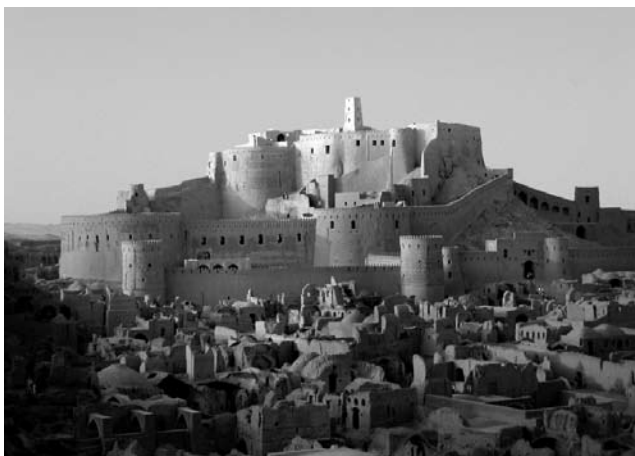
Fig. 1. The Arg-e Bam before the earthquake (photo courtesy Iran Tourism Organization)

In the morning of 26 December 2003 the world woke up to news of an earthquake in Iran, in which an entire city was reported to have been destroyed and tens of thousands of people killed—illustrated with a pair of pictures of the ancient Bam Citadel, known as the »Arg-e Bam,« a site that was claimed to be the largest earthen structure in the world. The »after« picture (fig. 2) showed a sea of rubble where layer upon layer of undulating earthen walls had once been—like a child’s sand castle on the beach after it had been kicked down by rude kids. Soon this pair of pictures became the unwitting symbol for the sudden annihilation of approximately 30,000 people estimated to have died in the earthquake. *Unfired earthen construction—how can it possibly be safe? Isn’t it time that it should be banned outright?*

However, the images of the destruction of this historic earthen structure hid the real truth of this earthquake—namely that almost all of the over 30,000 people who died in the earthquake, died in collapsed *modern* buildings! Even within the Arg itself, those parts that had remained abandoned and unrestored for as long as 150 years suffered very little damage. The worst damage was concentrated in those parts that had been restored and reconstructed over the previous half-century.

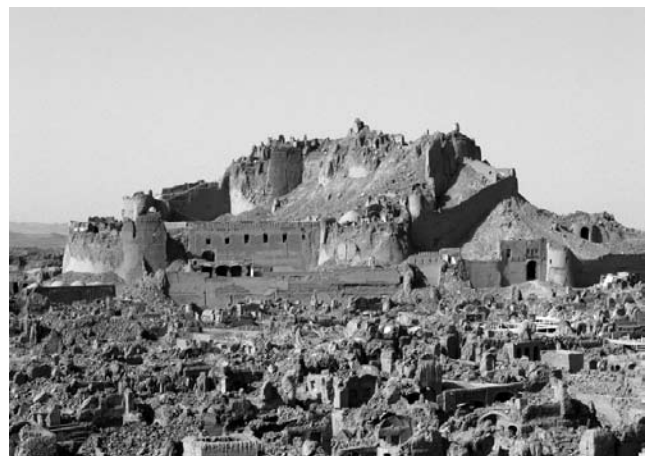
Fig. 2. The Arg-e-Bam, exactly the same view after the earthquake (photograph © Randolph Langenbach)

Returning to the collapse of the Arg-e Bam, finding one and two-story high earthen remains of buildings that have been roofless and abandoned for over 150 years still standing atop the epicenter of an earthquake that turned nearby modern steel buildings into twisted pretzels and destroyed concrete buildings even farther from the epicenter has to make one reexamine some of our present-day preconceptions. As has been attributed to Mark Twain: »For every problem there is always a solution that is simple, obvious, and wrong.« There has to be a reason why the earthquake did not collapse these walls when it pulverized walls that had been repaired and rebuilt back into complete buildings, but teasing the message to be learned out of the ruins of what had been such a grand monument requires more than training in a discipline. It also requires a certain amount of humility and willingness to learn to »listen« with our eyes to the message our ancestors are telling us through the cultural artifacts they have left behind.

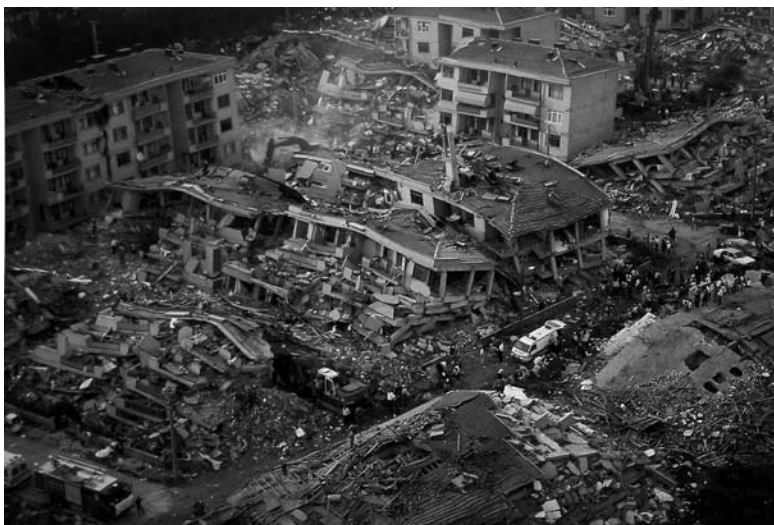
Fig. 3 Aerial view of collapsed apartment blocks, Gölçük (photo courtesy UN-ISDR)

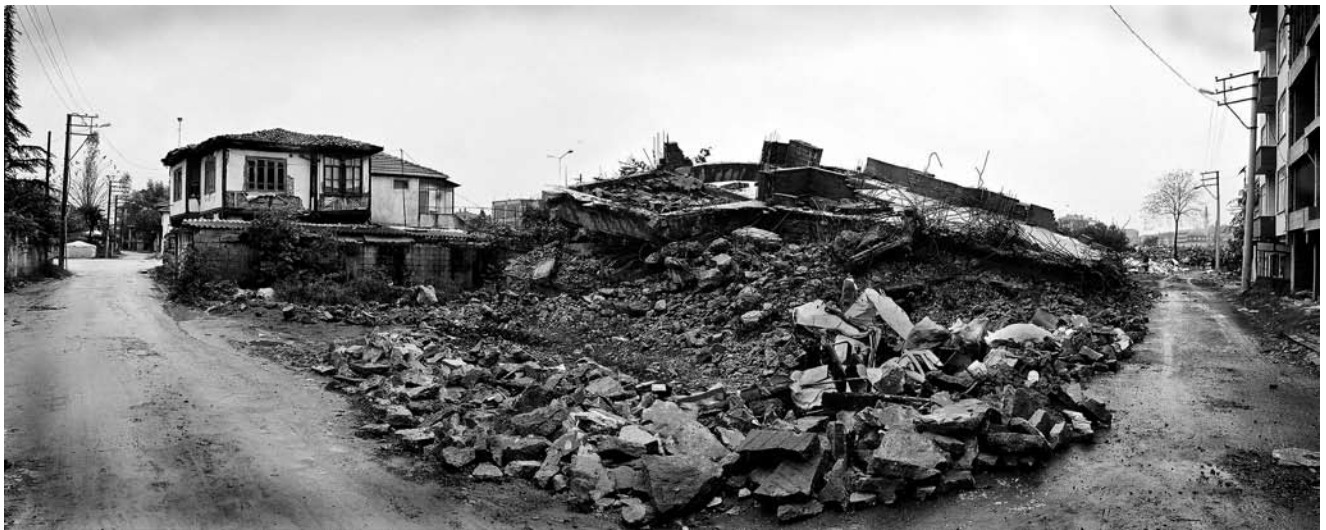
Fig. 4 Surviving *humiş* house next to a row of collapsed reinforced concrete buildings, Adapazari, Turkey, 1999 (photograph © Randolph Langenbach)

Wattle and daub was also common in Britain, where earthquakes are rare, and in earthquake-prone Turkey, where it is called *Bağdadi*. Turkey is also important for *humuş*, mentioned above, the masonry infill-frame construction which performed well in comparison to the reinforced concrete buildings in the 1999 earthquakes. It may have been the spreading influence of the Ottoman Empire into Moghul India that carried some of these construction types east into Kashmir and also into Ahmedabad, where similar timber-laced vernacular buildings survived the 2001 Gujarat earthquake when scores of reinforced concrete buildings collapsed.

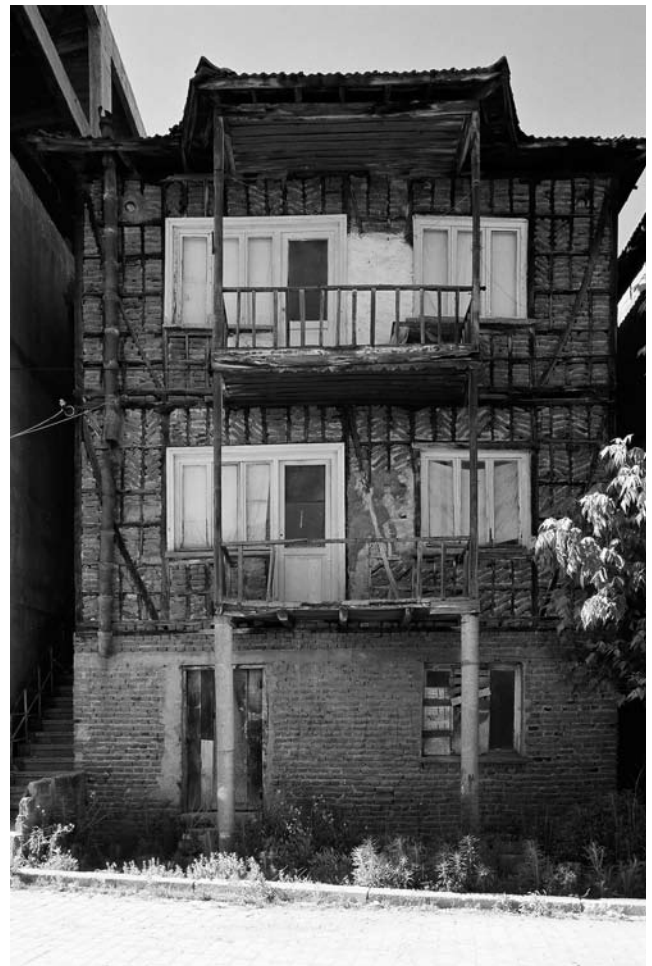
Fig. 5 This three story house in Gölcük located less than one km from the fault was undamaged by the 1999 earthquake, while a number of reinforced concrete buildings on the adjacent blocks collapsed (photograph © Randolph Langenbach)

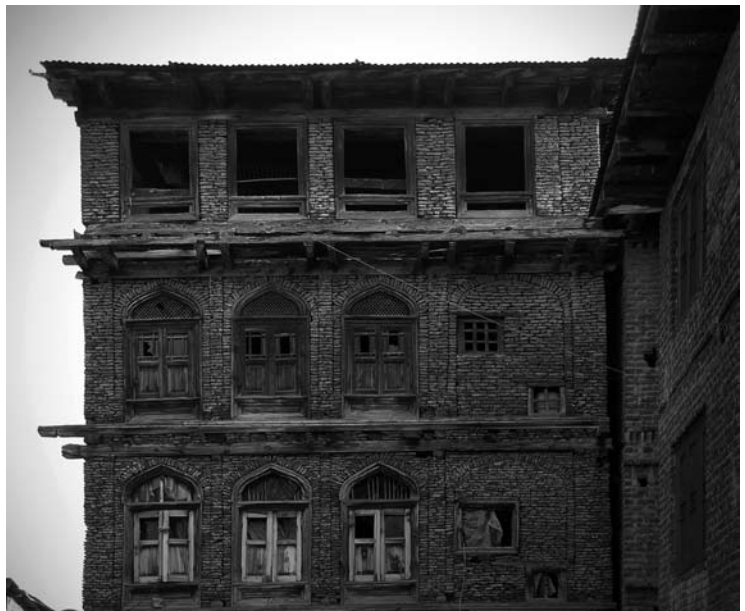
Fig. 6 Example of *taq* construction in Srinagar, Kashmir, 2005. The timbers in the masonry walls only run horizontally parallel to the wall and through the wall (photograph © Randolph Langenbach)

There are two basic types of traditional construction with earthquake resistance capabilities found in Kashmir. One, of solid bearing-wall masonry with timber lacing, is known as *taq* and the other, a brick-nogged timber frame construction, is known as *dhajji-dewari*. Both use timber within the plane of the masonry wall to serve to hold the buildings together. *Dhajji-Dewari* is characterized

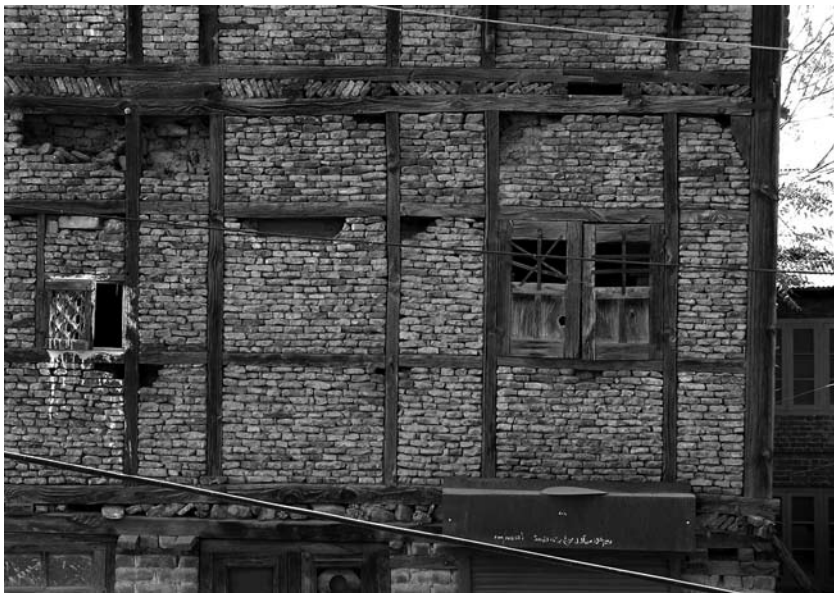
Fig. 7 Example of *dhajji dewari* construction in Srinagar, 2005. The timbers form a complete frame, and the masonry is inset into the frame (photograph © Randolph Langenbach)

by having a complete timber frame, with one wythe of masonry forming panels within the frame.⁵

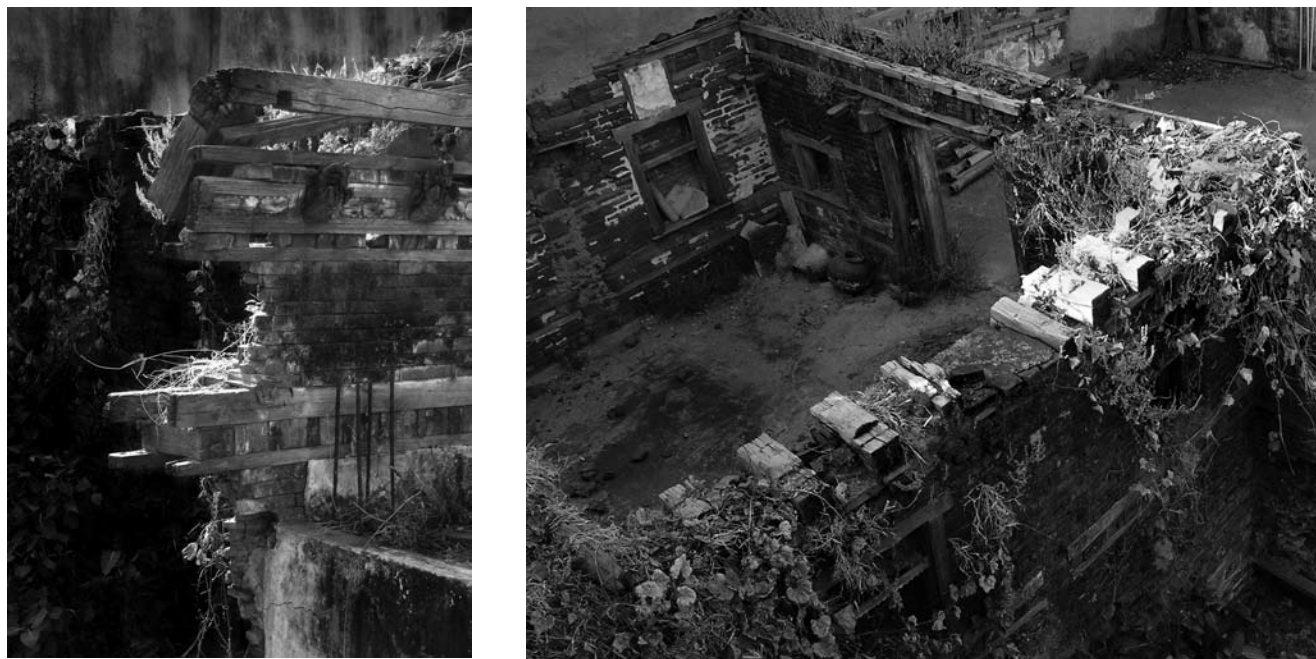
Fig. 9 and 10 Views of ruins of a house in the walled city of Ahmedabad, showing a form of timber lacing similar to that found in *taq* construction in Kashmir. In the partially dismantled building, the construction with runner beams tied together with cross-timbers pegged to the beams is visible (photographs © Randolph Langenbach)

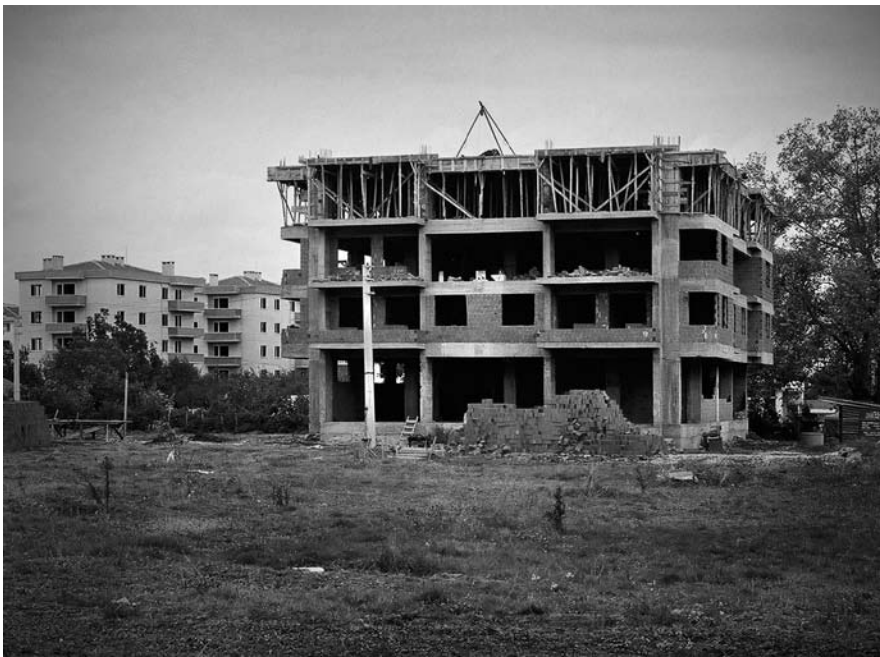
Fig. 11 Typical Turkish reinforced concrete building under construction showing installation of the hollow block infill (photograph © Randolph Langenbach)

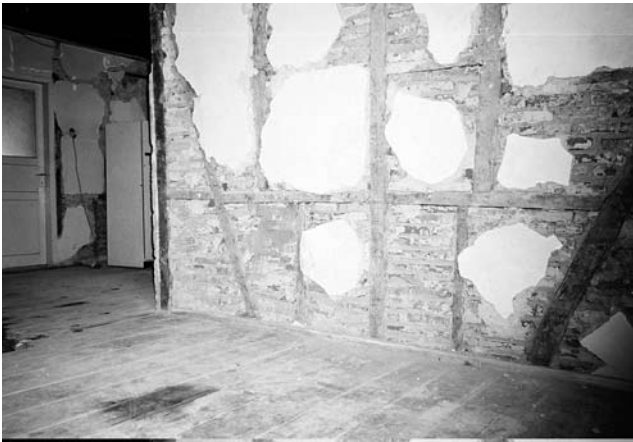
Fig. 12 *Hımış* interior wall in a house in the Düzce earthquake damage district showing »working« of wall that caused loss of plaster (photograph © Randolph Langenbach)

subdivision of the walls into many smaller panels with studs and horizontal members and the use of low-strength mortar combine to prevent the formation of large cracks that can lead to the collapse of an entire infill wall. As stresses on the individual masonry panels increase, shifting and cracking first begins along the interface between the panels and the sub-frame members before degradation of the masonry panels themselves. When the mortar is weaker than the masonry units, cracking occurs in the mortar joints, allowing the masonry units, held in place by the studs and cross-pieces, to remain intact and stable. The resulting mesh of hairline cracking produces many working interfaces, all of which allow the building to dissipate energy without experiencing a sudden drop-off in lateral resistance. By comparison, standard brittle masonry infill walls without an »armature« lose their strength leading to their collapse soon after the initial development of the diagonal tension »X« cracks.

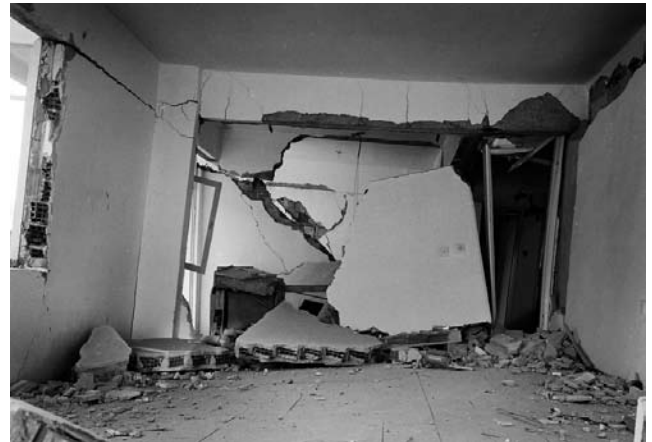
Fig. 13 Collapse of a brittle interior hollow clay block wall illustrating typical failure pattern for such walls lacking subdivision of the masonry (photograph © Randolph Langenbach)

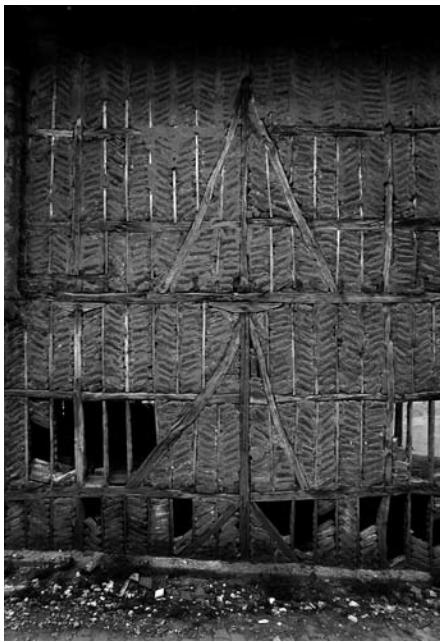
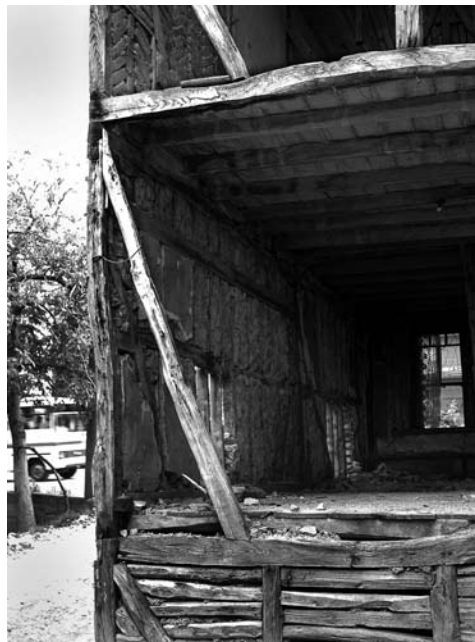
Figs. 14 and 15 Partially demolished house in Gölcük at the time of the earthquake showing the single brick wythe thickness of typical *humuş* wall. Fig. 14 shows the exterior and fig. 15 the interior face of the same wall. Despite its condition, the earthquake had little affect on it. 2003 (photographs © Randolph Langenbach)

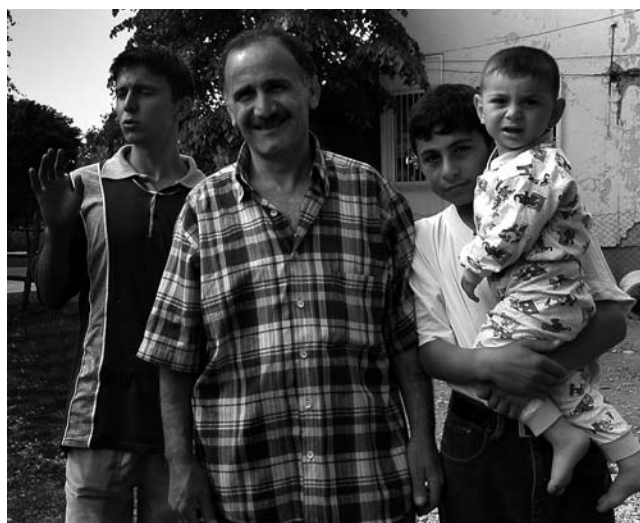
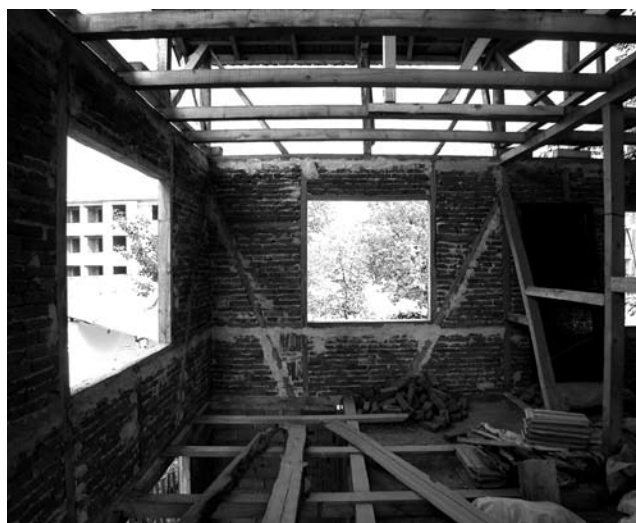
Figs. 16 and 17 After witnessing the destruction of reinforced concrete buildings in Düzce while his father's *hımış* house survived undamaged, this resident of Düzce (left) decided to stop construction of a new reinforced house and change it to *hımış* construction (right) (photographs © Randolph Langenbach)
