**INDIA CHAPTER OF THE AMERICAN CONCRETE INSTITUTE**

**International Conference On Forensic Engineering  
Failure Diagnosis And Problem Solving**

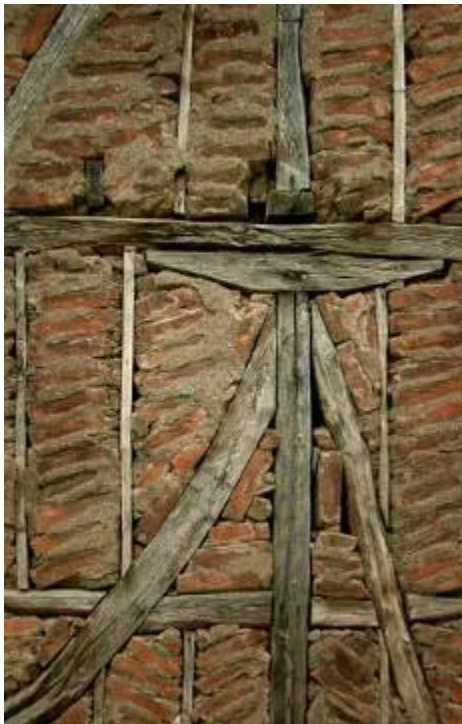
**Figure 1:** Detail of traditional *hımiş* construction in Turkey in mid-20<sup>th</sup> century house in Gölcük.

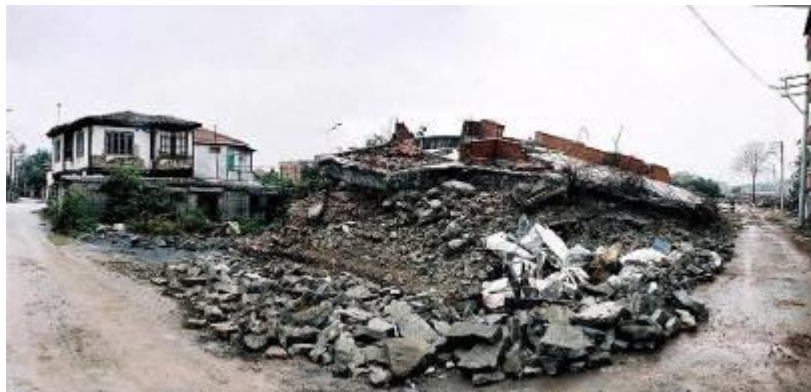
**Figure 4:** Surviving *hımiş* house next to a row of collapsed reinforced concrete buildings, Adapazari, Turkey, 1999.

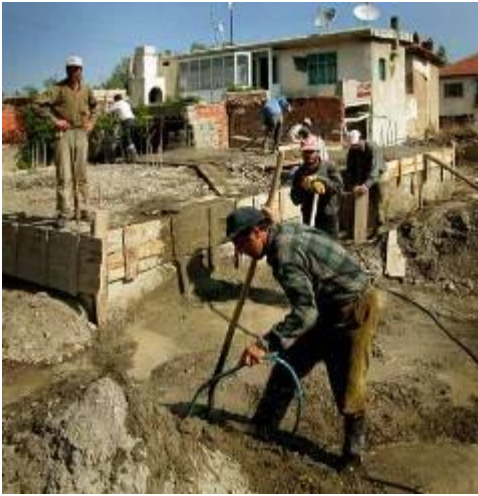
**Figure 8: LEFT:** House being reconstructed to replace one destroyed in Afyon earthquake. Concrete is being mixed on ground with garden hose and without slump test or measurements.

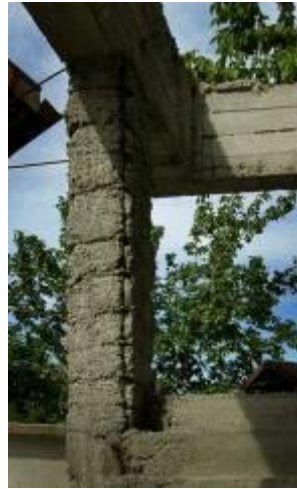
**Figure 9: RIGHT:** Concrete column in new mosque being constructed on site of building destroyed in Afyon Earthquake showing rock pockets leaving re-bar exposed. Vibrators are not used in most Turkish construction.

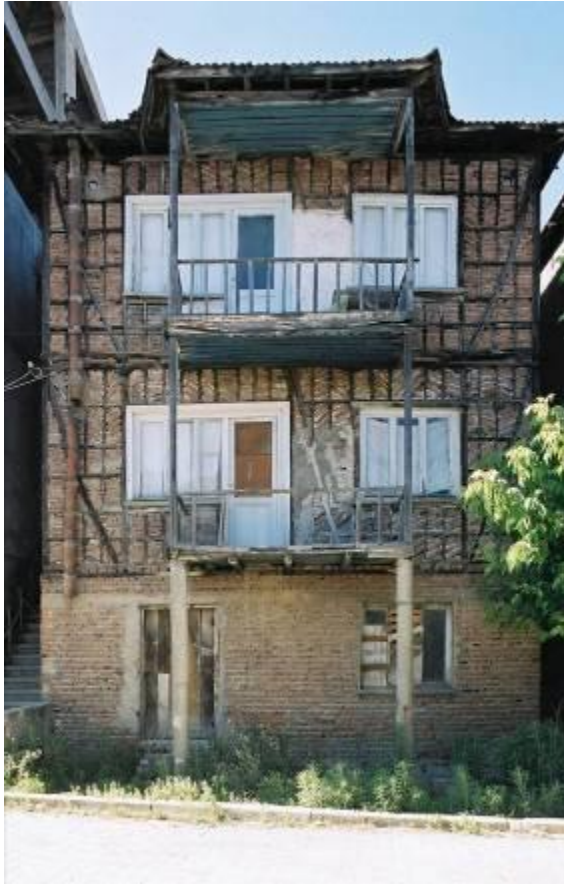
**Figure 10:** This three story house in Gölcük located less than one km from the fault was undamaged by the 1999 earthquake, while a number of reinforced concrete buildings on the adjacent blocks collapsed.<sup>1</sup>

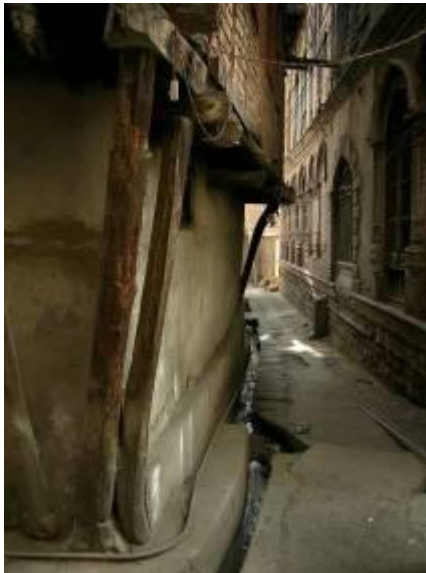
**Figure 11:** Traditional timber and masonry buildings in Srinagar, Kashmir, 2005.

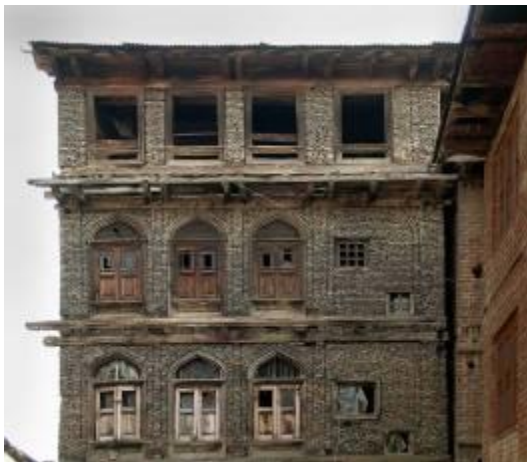
**Figure 13:** Example of *Taq* construction in Srinagar, Kashmir, 2005. The timbers in the masonry walls only run horizontally parallel to the wall and through the wall.

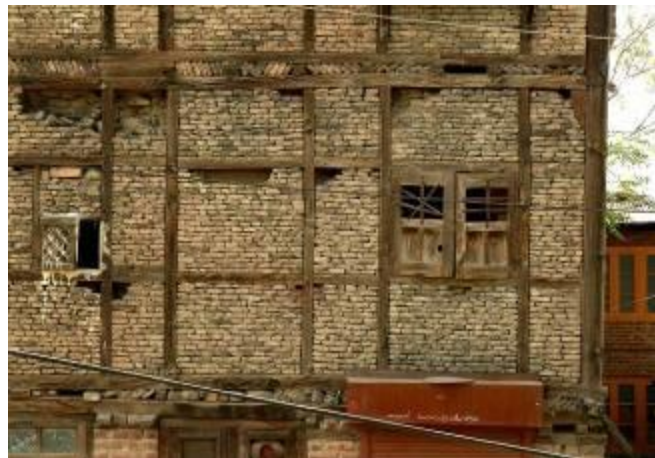
**Figure 14:** Example of *Dhajji Dewari* construction in Srinagar, 2005. The timbers form a complete frame, and the masonry is inset into the frame.

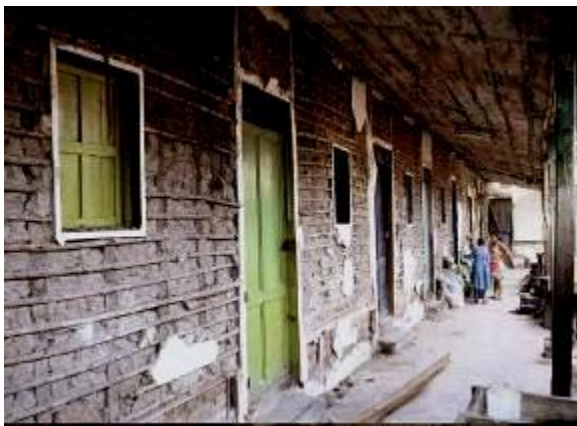
**Figure 15:** *Bahareque* construction in San Salvador showing effects of 1986 earthquake. The loss of the stucco shows that the wall underwent deformations without loss of its underlying structural integrity.

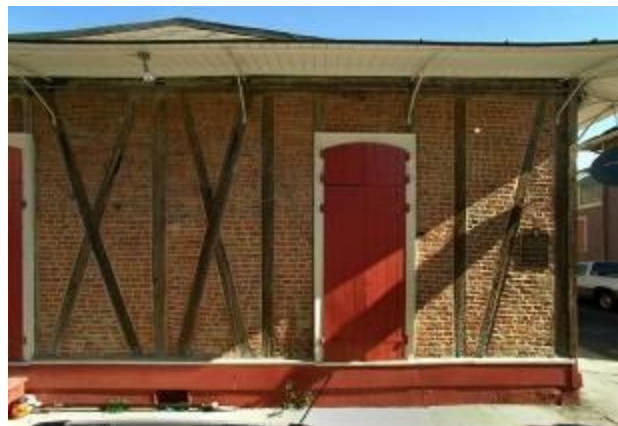
**Figure 16:** *Colombage* construction in the French Quarter of New Orleans, 2006.

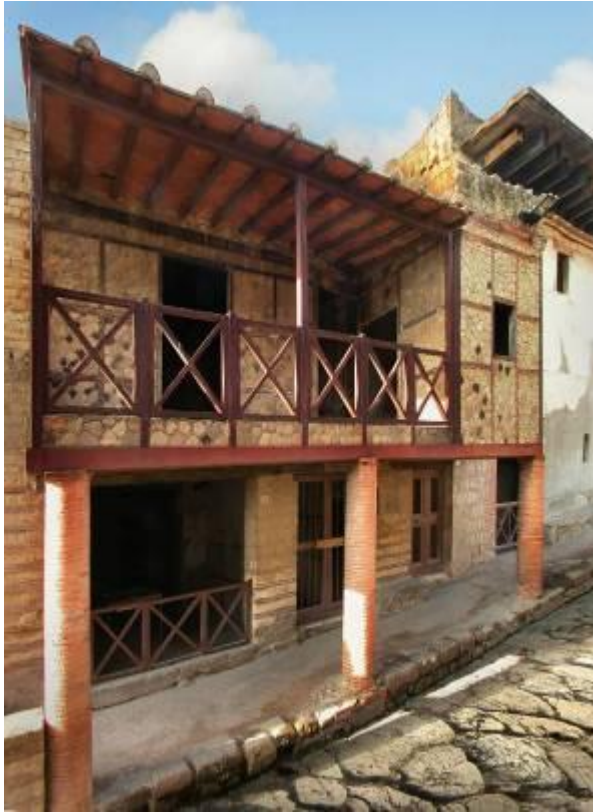
**Figure 17:** The *Craticii* House at Herculaneum, 2003.

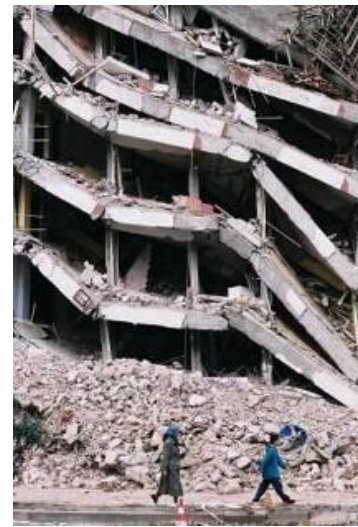
**Figure 19:** Partial collapse of RC Building, Gölcük , Turkey, 1999.

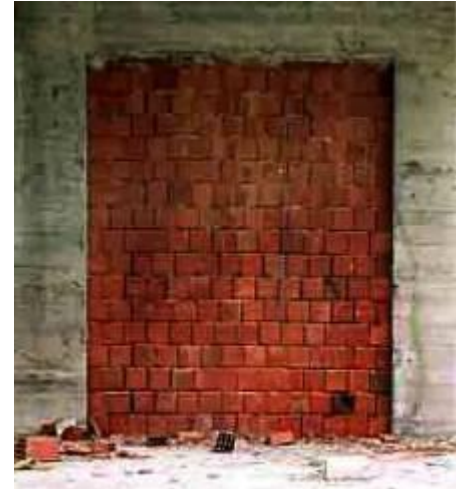
**Figure 21:** Typical hollow clay block infill as used in reinforced concrete residential construction in Turkey.

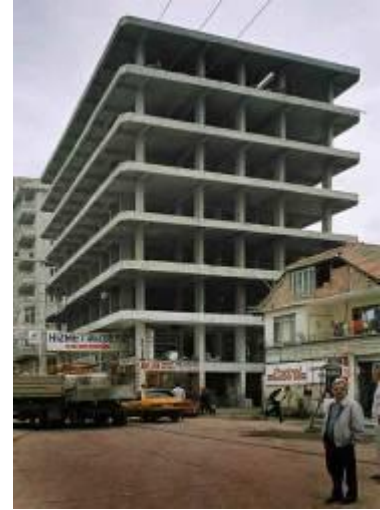
The seemingly reasonable for including only the weight, but not the resistance of the infill is perhaps that it was thought that the design would be more conservative than if the infill walls were taken into account as an active part of the lateral resisting system. By not including them, and thus not depending on them for part of the lateral capacity calculations, the walls then could be moved at will, and the frame (in theory) would be strong enough to carry all of the structural loads as was proposed by Le Corbusier with his publication of his famous “Domino House” in 1915 (Figure 24) which helped to promote the use of this system around the globe.

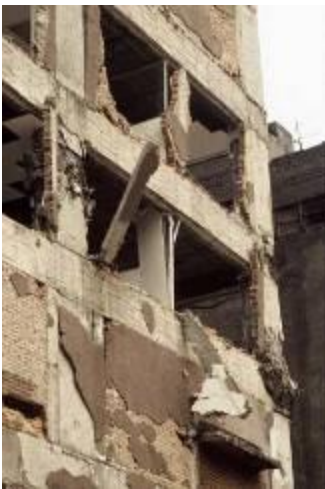
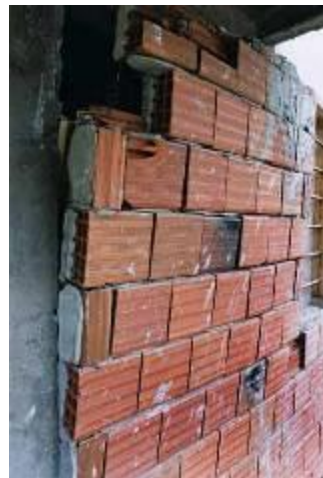
**Figure 24:** Infill wall RC building in Mexico City damaged in 1985 earthquake. The infill masonry in this structure almost caused the collapse of the building. The damage to the corner column that left the building teetering on the edge of collapse can be seen on the right.

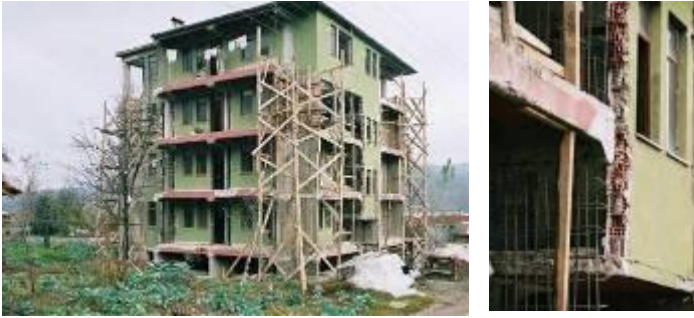
**Figure 27 & 28:** Five story building damaged in the 1999 Düzce earthquake in Turkey, being retrofitted with reinforced concrete shearwalls. No.30 shows the existing hollow clay block walls removed and steel being inserted for the construction of a reinforced concrete shearwall. These images illustrate the extent of the work, and disruption needed for earthquake strengthening using shearwalls. The occupants had to move out for the duration of this work as many existing walls were removed.

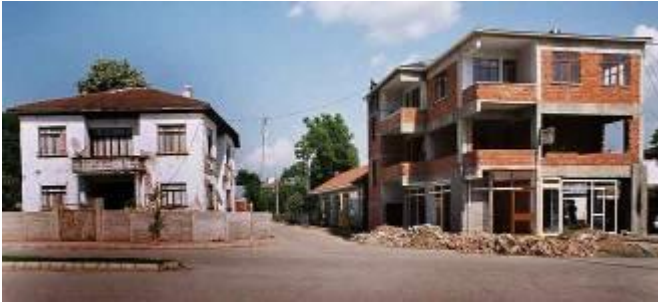
**Figure 29:** Three story RC building next to a 2½ story *hımış* house near Düzce after the 1999 Düzce earthquake showing the repair of severe damage to the RC building (notice the size of the ground floor columns). The *hımış* structure has lost only stucco on the side. Almost all of the hollow clay block on the RC building has been reconstructed after the earthquake. This shows that even low rise RC buildings sometimes suffered more damage than nearby traditional buildings.

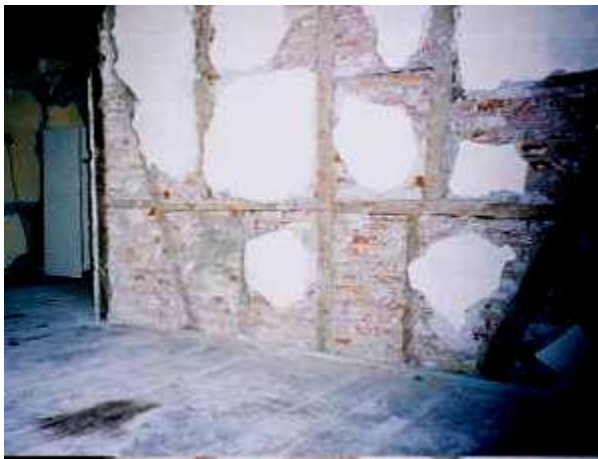
**Figure 30:** *Hımış* interior wall in house in Düzce earthquake damage district showing “working” of wall that caused loss of plaster.

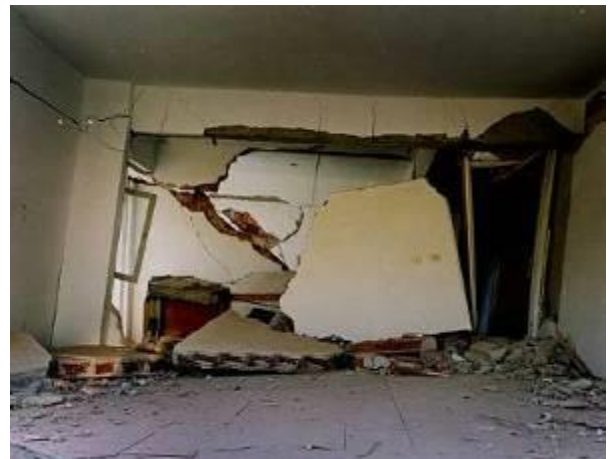
**Figure 31:** Collapse of a brittle interior hollow clay block wall illustrating typical failure pattern for such walls lacking subdivisions.

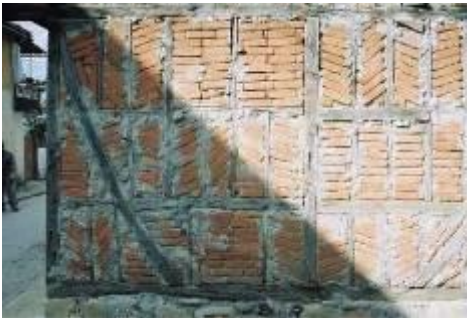
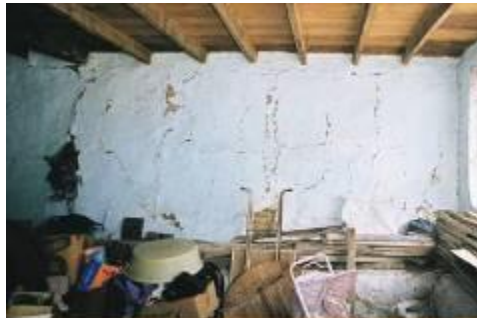
**Figure 33:** Exterior of 1955 *hımış* house in Gocuk damage district one month after 1999 earthquake. Do damage is visible.

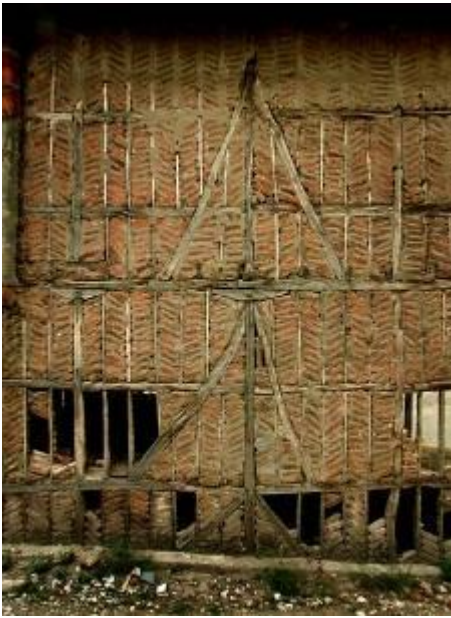
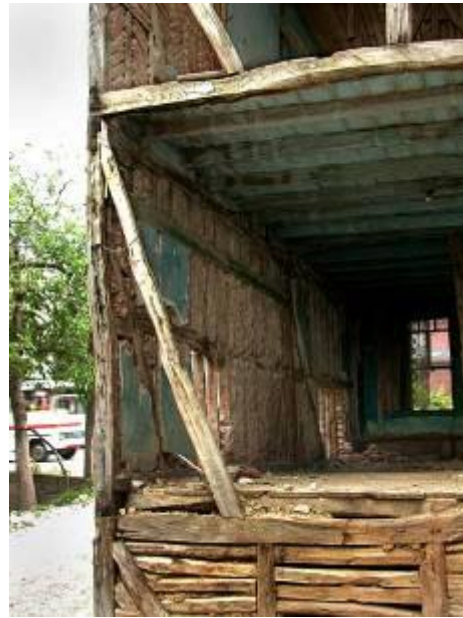
**Figure 35:** Partially demolished house in Golcuk showing the single brick wythe thickness of typical *himiş* wall. On the LEFT is the exterior and on the RIGHT is the interior face of the same wall.

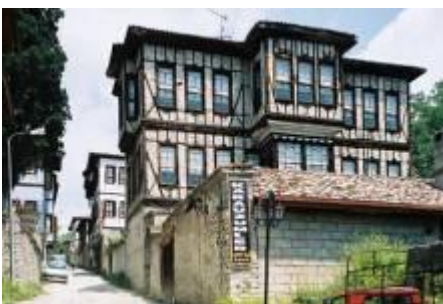
**Figure 37:** Large 3 story house in *himiş* construction, Safranbolu, Turkey, 2000. Safranbolu is now on the World Heritage List because of its unique collection of intact Turkish vernacular houses.
