ICOMOS Symposium: Tangible Risks, Intangible Opportunities: Long-Term Risk Preparedness and Responses for Threats to Cultural Heritage

Was Haiti in 2010 the next Tangshan in 1976:
Heritage Structures Reveal the Hidden Truth about Risk and Resilience during the Haiti Earthquake

Randolph Langenbach

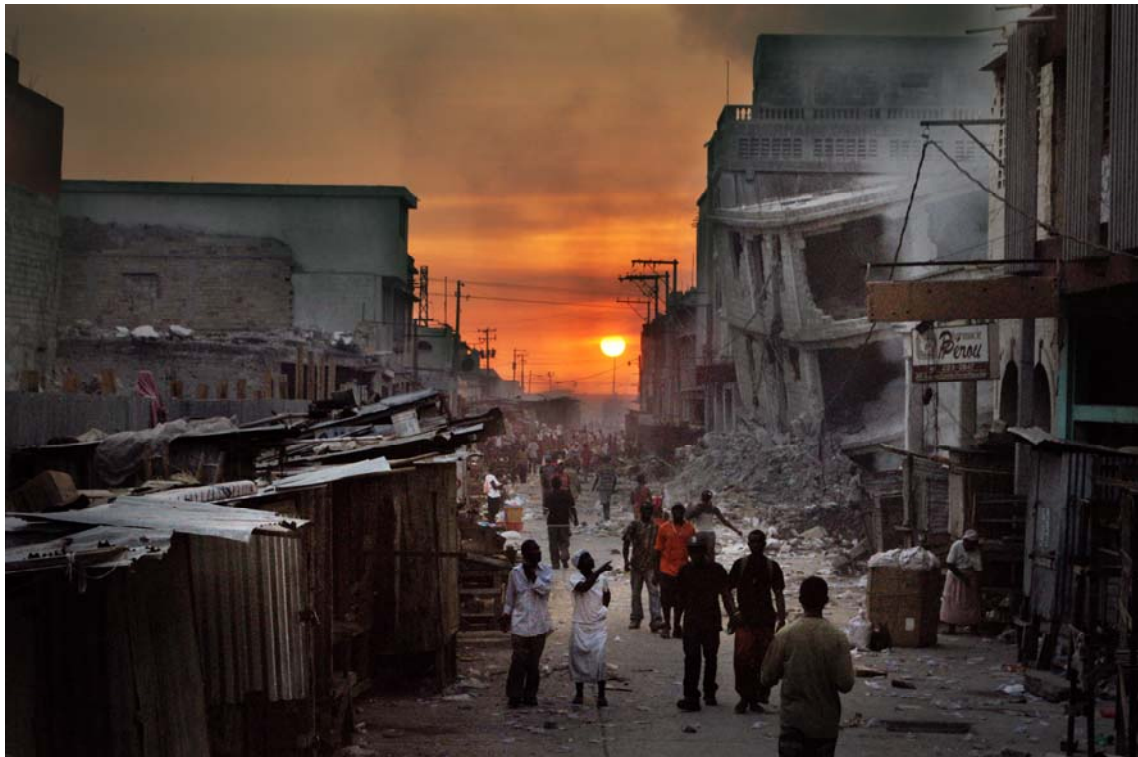
1. Like a scene from Dante's *Inferno*, central Port-au-Prince, 4 months after the earthquake. *Photo © Randolph Langenbach*

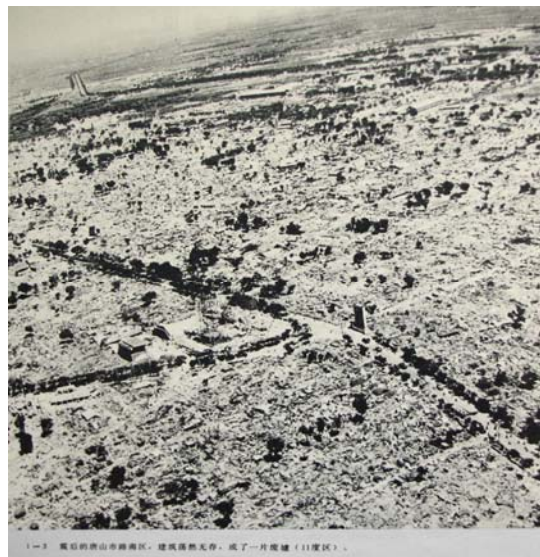
2. Tangshan before and after 1976 earthquake. Source: The Mammoth Tangshan Earthquake of 1976 Building Damage Photo Album "China Academy Of Building Research"

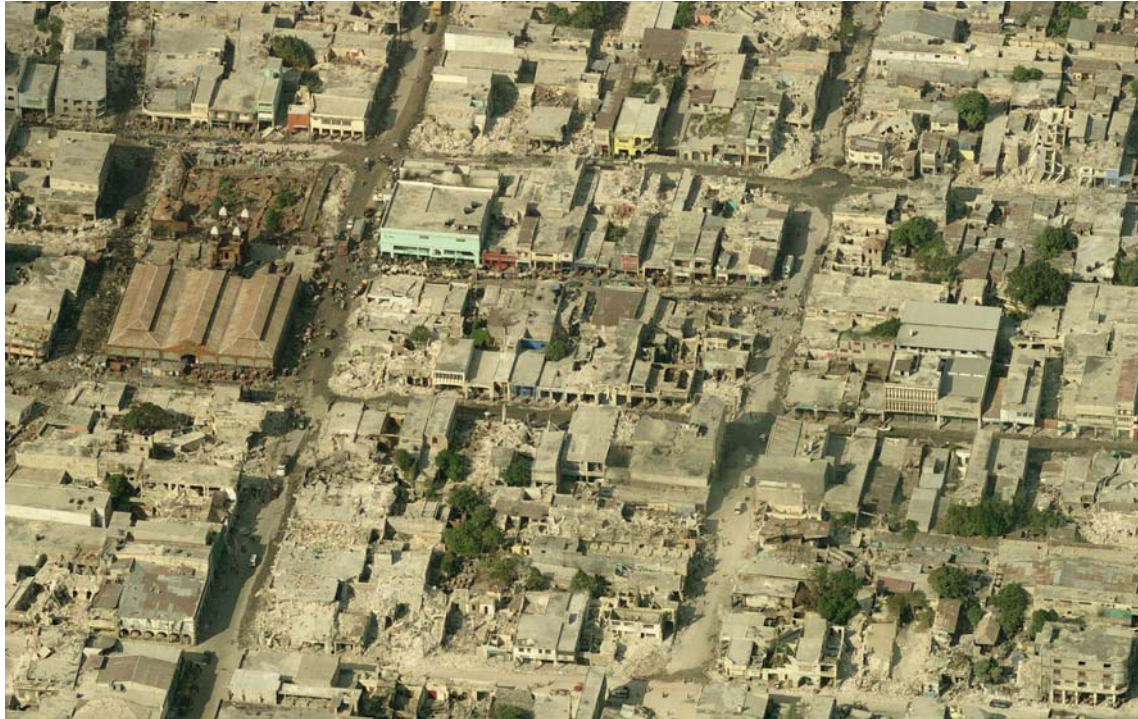
3. A detail from a Pictometry oblique aerial view of central Port-au-Prince one week after the earthquake. The collapsed unfinished building in Figure 1 is visible in the upper left. Photo © Pictometry International Corp.

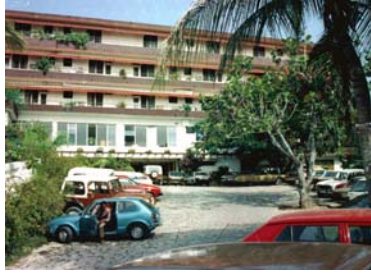
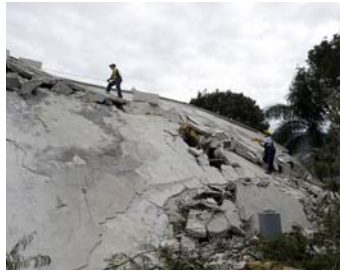
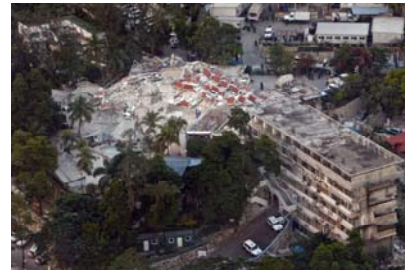
7. Five star collapses in Petionville: *left*: Hotel Montana before, and *center* after the earthquake 8. UN Headquarters after the earthquake. *Google images.*

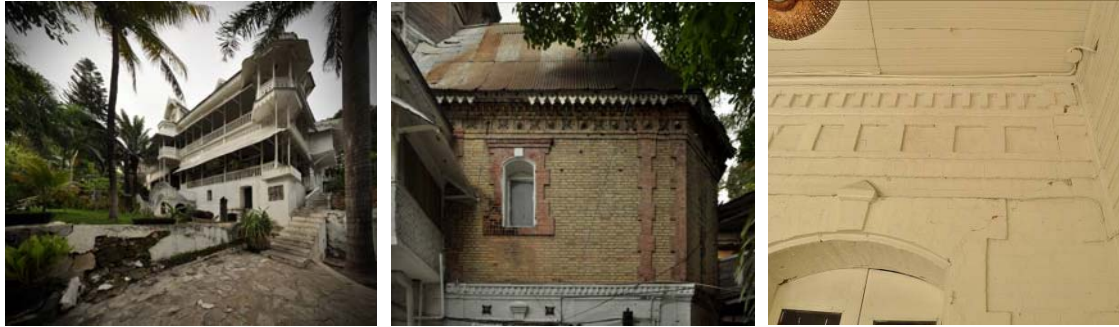
9. The unreinforced brick masonry Hotel Oloffson, Port-au-Prince after the earthquake. © Randolph Langenbach

In addition to the later USGS shakemap, there are other indicators on the ground that MMI-VII may actually be the more correct estimate. The Oloffson Hotel, a building which is contemporaneous with Mercalli's publication of the scale and is of URM construction with good quality brickwork (which in the MMI scale would be termed "*better built*") came through with only minor cracks, as specified for a VII (Figure 9). Other historic masonry buildings from the same period with poorly maintained rubble stone making up parts of the walls suffered damage from medium to heavy, but with very few collapses (Figure 10). This is also consistent with the MMI-VII classification. As evidence that the Oloffson was not on a site subjected to less shaking, a nine story RC hotel structure immediately behind the Oloffson pancake collapsed. All the affected buildings were within the central Port-au-Prince damage district, making it difficult to explain these phenomena as only a consequence of extreme differences in local site effects.⁶

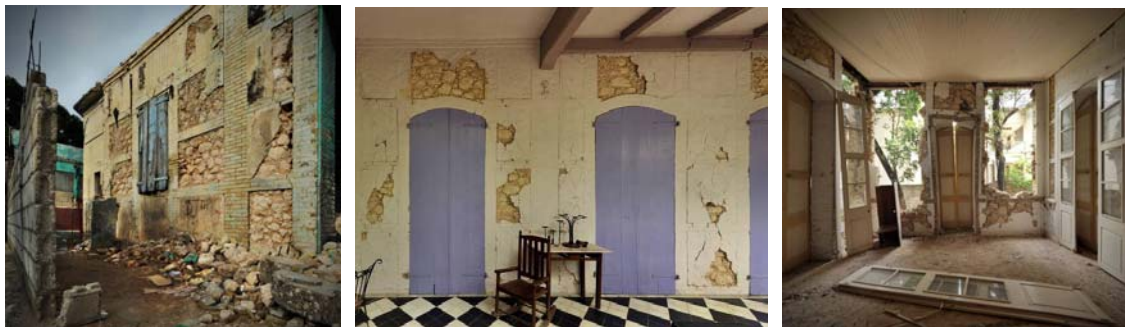
10. Brick and empanelled rubble stone construction, as is typically found in many of the Port-au-Prince "Gingerbread" Houses from the late 19th century, showing different levels of damage from onset, to collapse of the rubble panels. Surprisingly few houses with this construction collapsed overall, despite the weakness and vulnerability to earthquake shaking of this construction – a further verification that the intensity did not exceed MMI-VII at these Port-au-Prince sites. © Randolph Langenbach

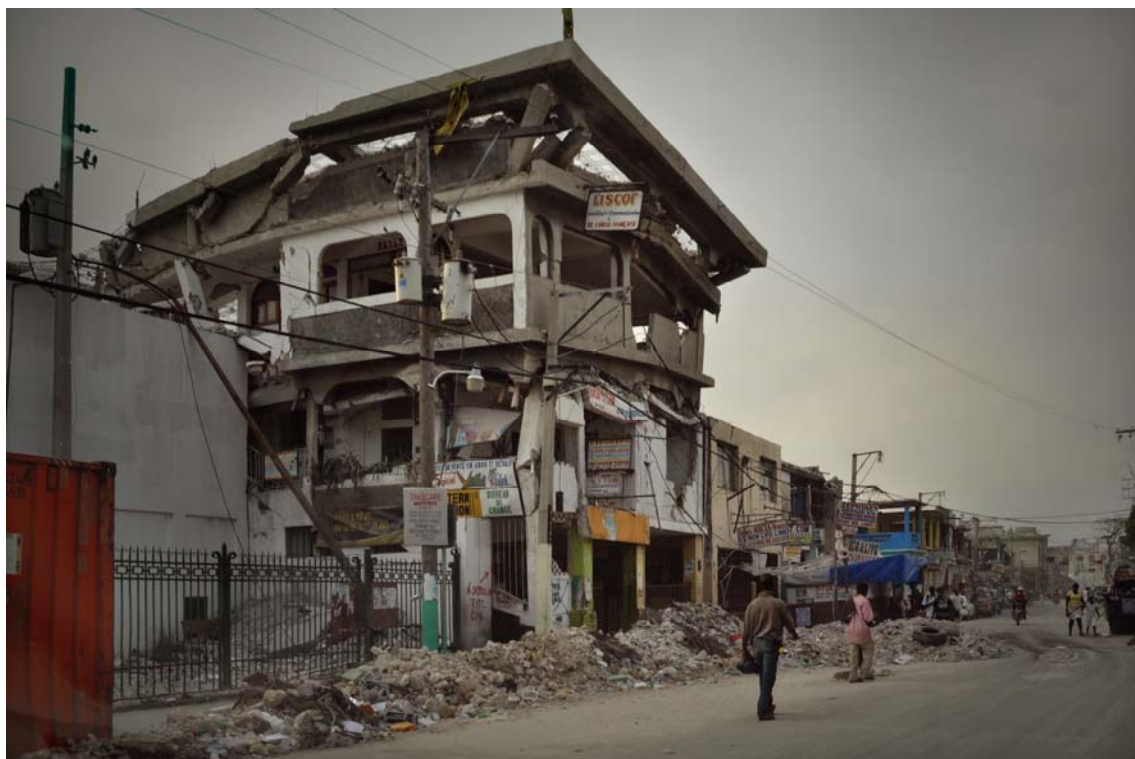
11. A downtown commercial building in a near state of collapse – illustrating the brittle vulnerable nature of many of the formal, contractor-built reinforced concrete buildings in Port-au-Prince. Many buildings of this type did pancake collapse, but, as demonstrated by the buildings on either side that are still intact, everything did not fall down. Approximately 40% of the buildings in the central city were partially or totally collapsed, but of the remaining 60%, many suffered little damage.
©Randolph Langenbach

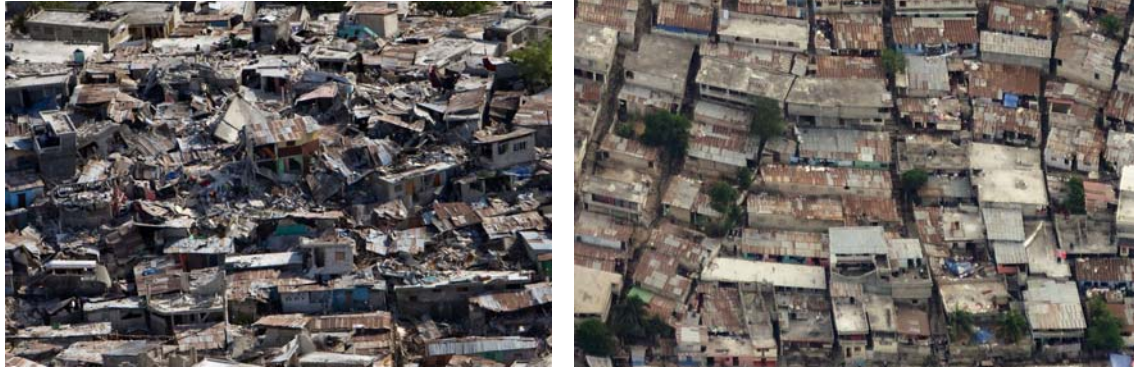
12. Views of *bidonville* near central Port-au-Prince showing (*left*) view of area with extensive collapses, and (*right*) area with very few collapses. A careful review of the Pictometry of the Port-au-Prince damage district as a whole has shown that views with minimal evidence of collapses was significantly more prevalent than those with heavy collapses. *left* –UNDP Global (from RMS Report), *right* © Pictometry

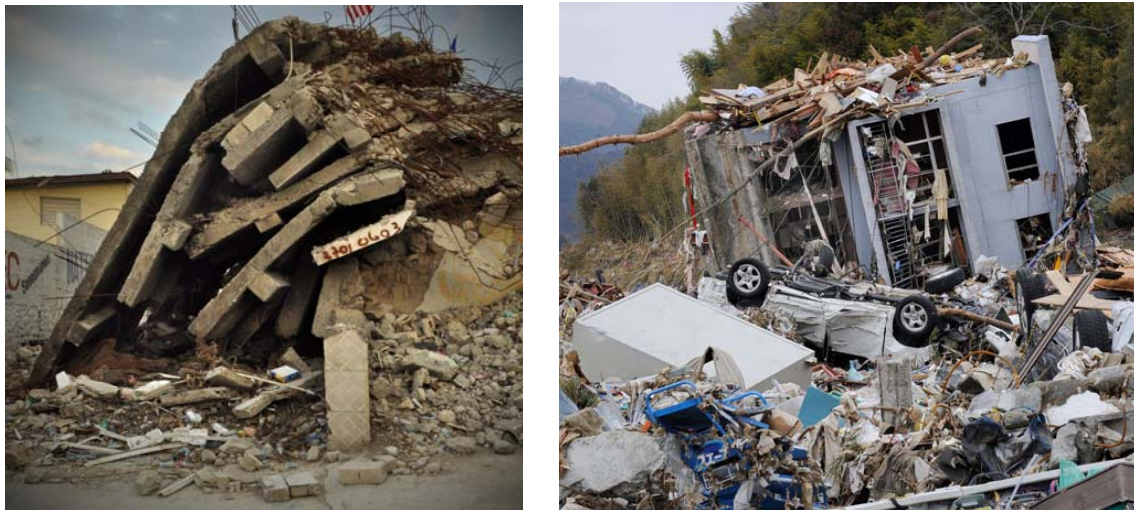
13. *left*: Pancake collapse of a reinforced concrete building on east (away from epicenter) side of Port-au-Prince. Pancake collapses of the heavy floors of multi-story RC buildings are particularly lethal and make it hard to extract the survivors. © *Randolph Langenbach*. *Right*: Reinforce concrete building in Rikuzentakata, Japan swept onto its side and carried upstream by the March 10, 2011 earthquake and tsunami. *AFP/Getty*

buildings were even found to have been turned on their side by the tidal wave and perhaps even moved some distance, remaining after the sea retreated with their superstructures intact, as shown in figure 10 (right) of one in Rikuzen. In Haiti, which is quite frequently subject to hurricanes, the resistance from weight of even poorly constructed concrete buildings makes that system favored over wood and lighter materials – but as can be seen, an earthquake of only moderately large surface shaking has made the choice to use concrete and cement blocks for almost 100% of the new houses in recent years unfortunate.

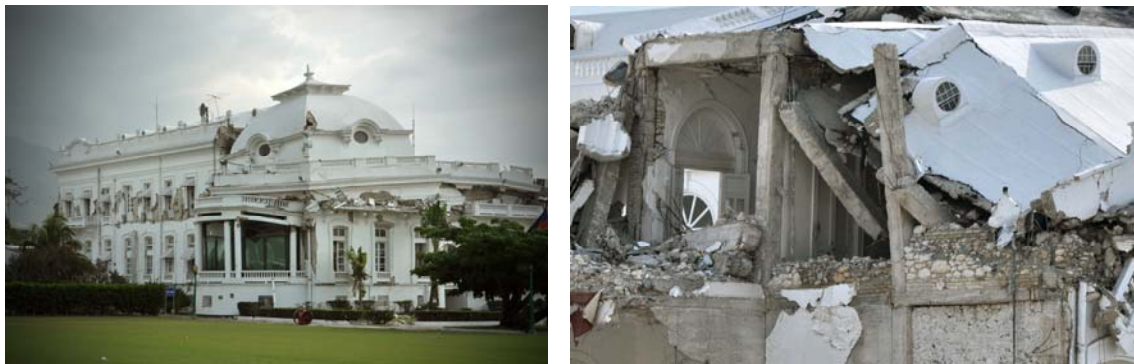
14. *left*: National Palace in Port-au-Prince after the earthquake and partial demolition, revealing the reinforced concrete frame infilled with rubble stone. The steel reinforcing bars in the exterior portions of the frame and poured concrete walls (visible on left side of left photo) were heavily corroded in this over 90 year old structure. *Left*: © Randolph Langenbach.

Concrete construction came to Haiti relatively early. The iconic view of this particular earthquake is the image of the collapsed National Palace, with its heavy white square domes scrunched down over the ruins of the building below. This building dates from 1916-18 and it is reported that it was finished by the U.S. Navy when the United States occupied Haiti.⁹ It has a reinforced concrete frame infilled with masonry – a masonry partially composed of rubble stone!

The Catholic Cathedral was also of reinforced concrete, with a steel truss roof. The upper level walls and towers collapsed, bringing down the roof. The steel reinforcing was minimal to begin with and the century of exposure to the tropical elements had caused corrosion in the reinforcing in many of the older concrete structures. The Cathedral collapsed very much as if it were a single wythe of unreinforced masonry as the rebars in it and the National Palace had in places almost disappeared from corrosion.

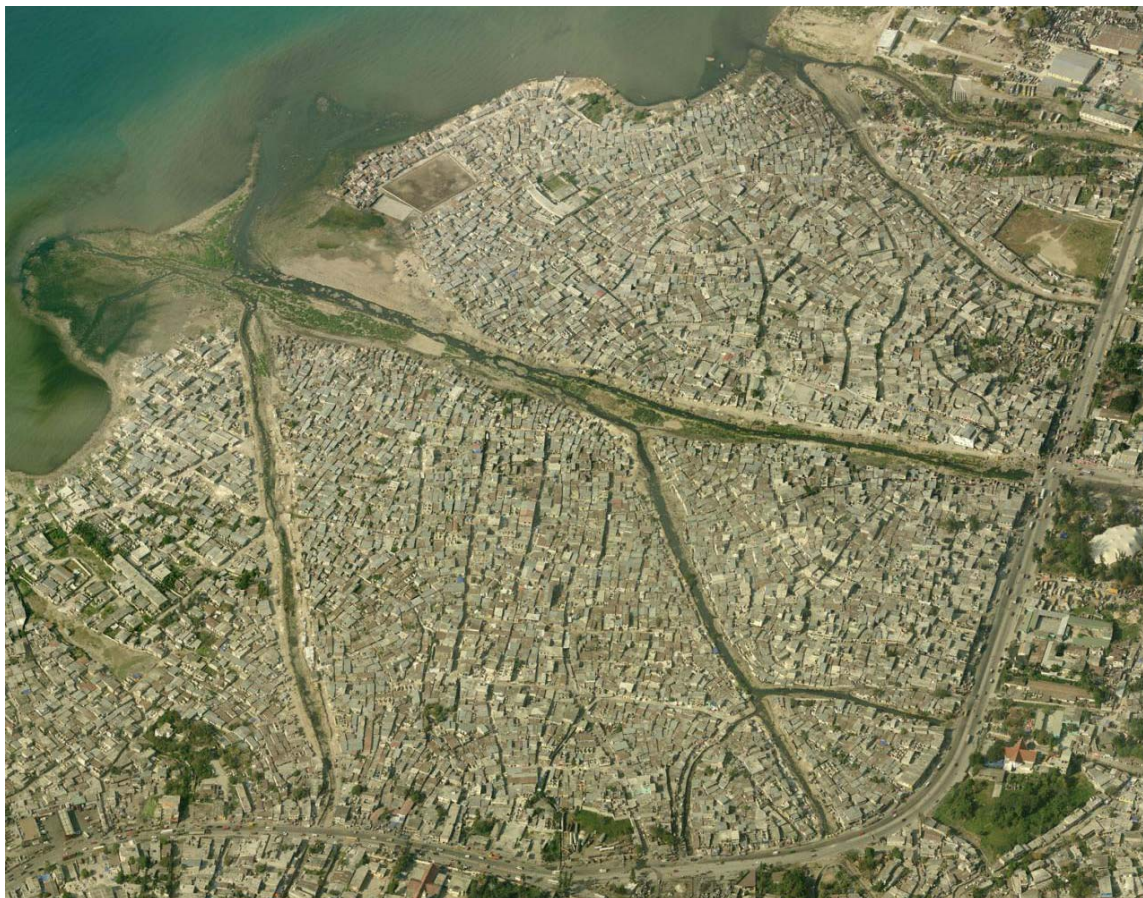
15a. Aerial view of Cité Éternelle, located on a combination of fill and an alluvial fan in central Port-au-Prince. *Images* © Pictometry. *Mosaic of images into a single view by Randolph Langenbach*

Then it may be worth looking at one area where steep hillsides are not a factor. One such area, presciently called “*Cité Eternal*,” is located immediately adjacent to the devastated city center (figure 15a&b). It is on land where one would expect to find the most damage – at the edge of the sea on fill and unconsolidated alluvium. The area consists mainly of one, two, and three story concrete block masonry buildings, with concrete slabs and roofs mixed into structures of lighter construction.

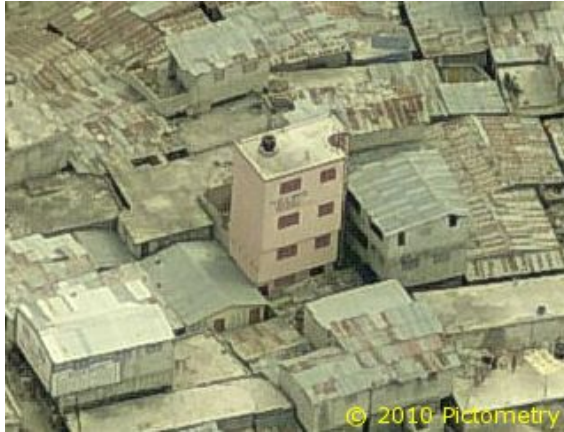
15b. Typical detail of Cité Eternal showing that two story buildings with one four story building – most of reinforced concrete. © Pictometry

While the largest number were one story buildings, there were many two story concrete masonry buildings – and not an insignificant number of three and four story buildings. Some buildings did collapse – but they were isolated examples – unlike the downtown where block after block was in ruins. Why?

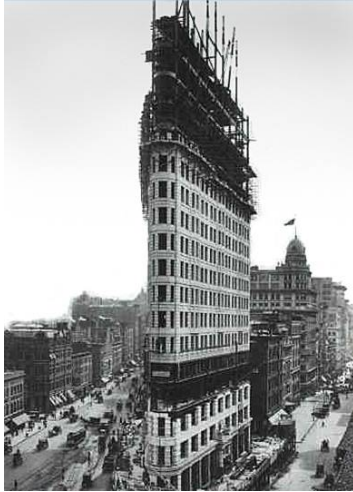
17. Flatiron Building in New York City under construction in 1902 showing the heavy stone masonry façade resting on the steel frame. The upper walls are constructed separately probably to ensure the weight is bearing on the frame rather than the lower masonry walls.

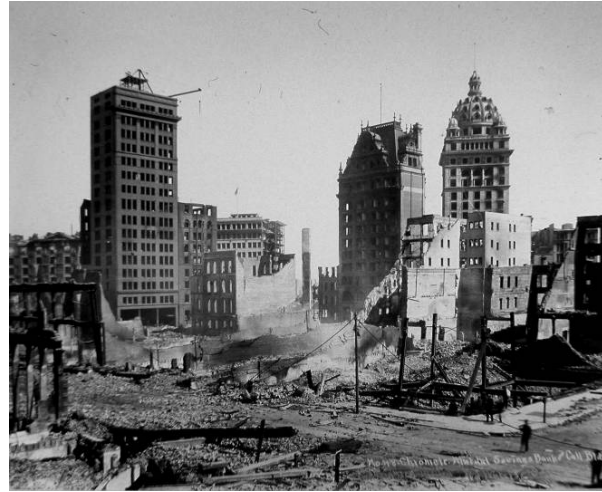
18. View of San Francisco after the 1906 earthquake and fire. The three tall buildings visible in this view were burned out by the fire that followed the earthquake, but all three were in good enough condition despite this to be repaired, and they are still extant today.

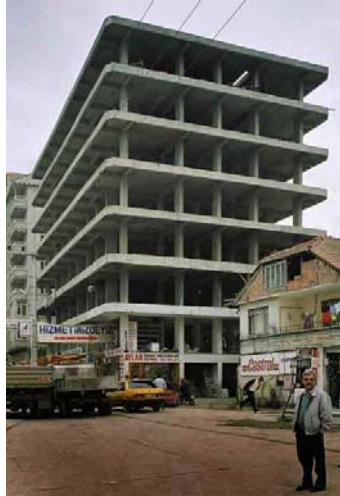
20. Building under construction in Gölcük, Turkey shown after the 1999 earthquake. Because the masonry infill walls had not yet been installed, frame action was able to occur, and thus the building was not collapsed by the earthquake.

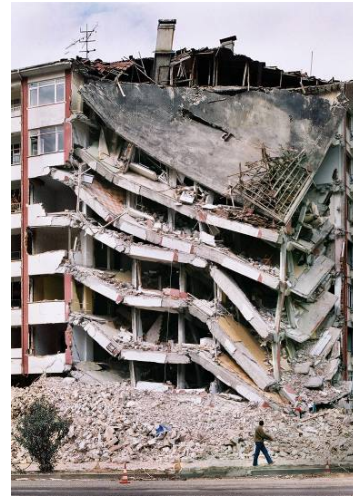
21. Building in Gölcük close to the one shown in Fig. 17 collapsed by 1999 earthquake. The heavy masonry infill walls together with open (soft) ground floors were often contributors to such collapses.

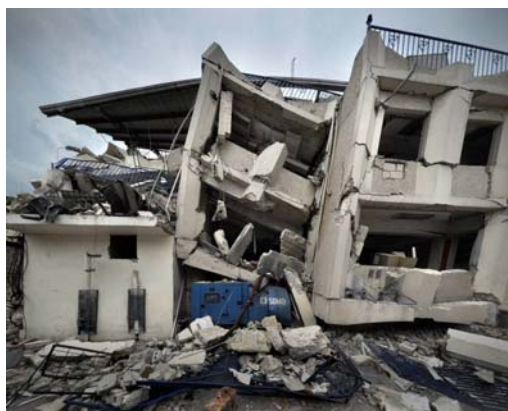
22. Reinforced concrete building in central Port-au-Prince nearly collapsed by the 2010 Haiti earthquake.

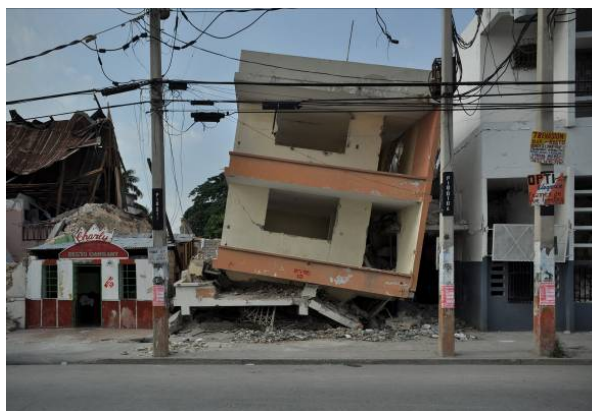
23. A formerly four story building in Port-au-Prince showing weak story collapse.

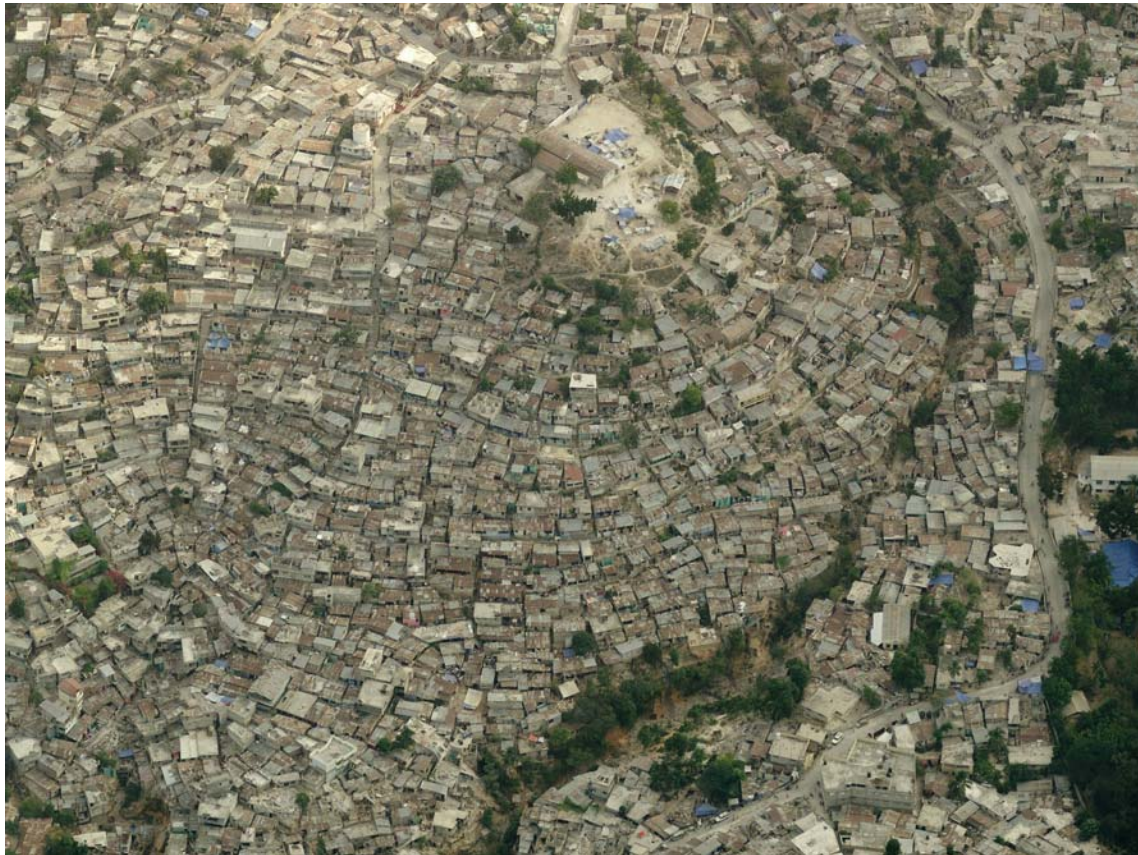
24. View of 4 Carrefour Feuilles area *bidonville*, close to the city center, Port-au-Prince. © Pictometry

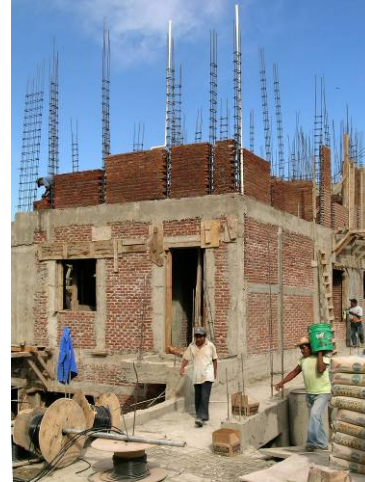
25. *left*, View of 4 Carrefour Feuilles area *bidonville*, close to the city center, Port-au-Prince. *Source: Carlos Barria-Reuters*
Right, Confined masonry construction photographed in Zihujatanejo, Mexico.

Thus these buildings are in fact more related in terms of structural typology to the pre-modern timber and masonry buildings that were of the vintage of those originally used to calibrate the Mercalli Scale. More importantly, their indigenous self-help based socio-economic context is also much closer to pre-modern rural culture than it is to the wealthier industrialized urban context where the moment frame with infill construction is more common.

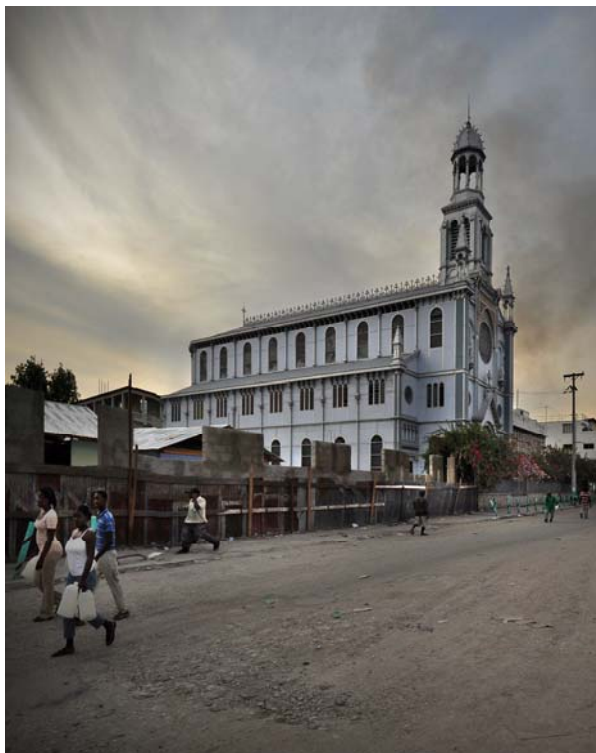
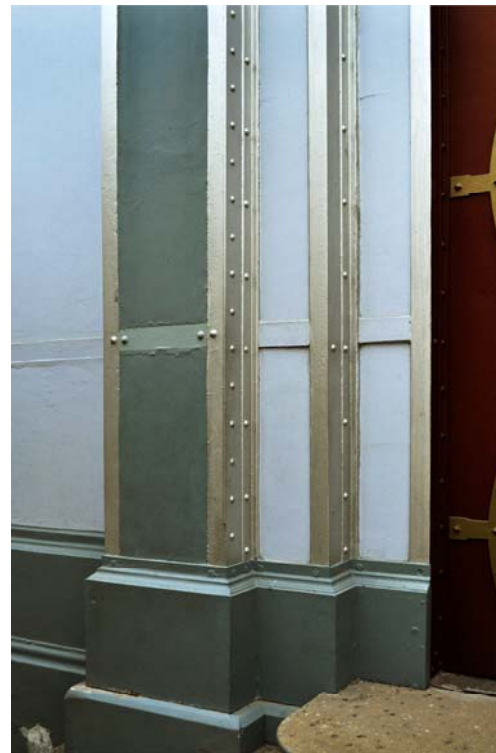
26. Saint Louis de Gonzague Chapel ca. 1890 in central Port-au-Prince.

In fact, there are three historical buildings in central Port-au-Prince that helps to reinforced this finding about the informal construction. Better than that, they stand as remarkable examples of a hitherto unexplored direction for future earthquake-resistant construction – even as a potential model perhaps of a better approach to reinforced concrete. The largest of these buildings is as high as the National Cathedral was before its collapse, and almost as large. It is older, now approximately a century in age, and yet it came through the earthquake with no visible exterior damage apart from broken glass in its large upper story windows. It is church called the Saint Louis de Gonzague Chapel (figure 26).

This good performance was confirmed not only with the Chapel, but also at a smaller chapel next to the collapsed National Cathedral which also came through almost unscathed, and a commercial building also near the National Palace which had thinner walls but survived with only a few missing panels.

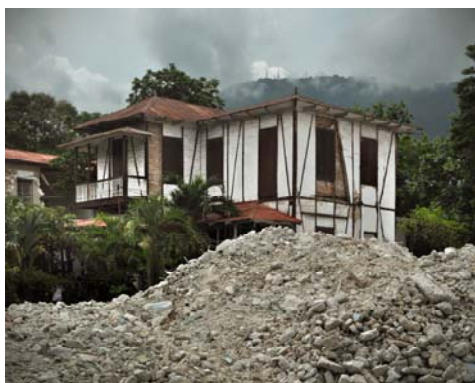
27. A Port-au-Prince house of colombage construction showing slight earthquake damage behind the rubble pile of a collapsed reinforced concrete building.
