# Historical Earthquake-Resistant Timber Frames in the Mediterranean Area

Chapter 3  
Timber Frames and Solid Walls:  
Earthquake Resilient Construction  
from Roman Times to the Origins  
of the Modern Skyscraper

## Timber Frames and Solid Walls: Earthquake Resilient Construction from Roman Times to the Origins of the Modern Skyscraper

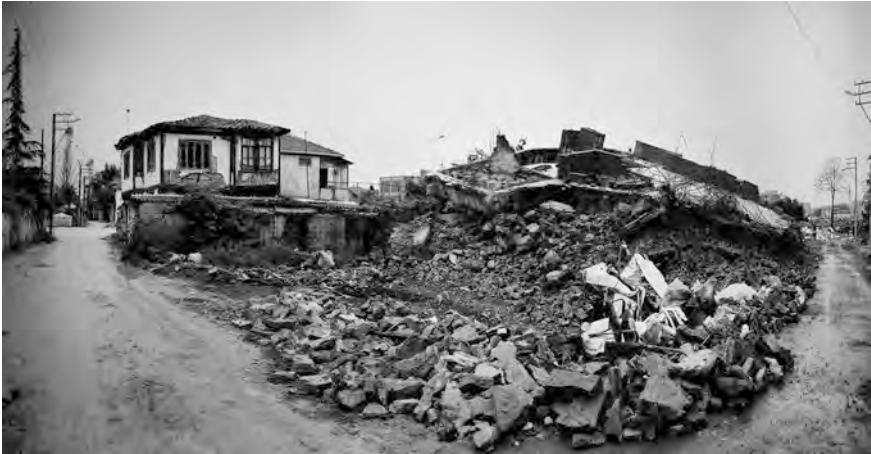
**Fig. 3.1** A traditional *humuş* construction house still standing next to a row as far as one can see of reinforced concrete apartment buildings in Adapazari, Turkey after the 1999 Kocaeli earthquake. Photograph by © Randolph Langenbach

In November 2000, 1 year after two devastating earthquakes struck near the Sea of Marmara in Turkey, a conference was convened by UNESCO, ICOMOS and the Turkish Government in Istanbul, called “Earthquake-Safe, Lessons to be Learned from Traditional Construction” [1]. The 1999 earthquakes in Turkey, as well as more recent earthquakes worldwide, have demonstrated that in spite of all of the knowledge of seismology and earthquake engineering gained over the last century in the science and practice, the death toll in such events has continued to rise. It has become apparent that steel and concrete, even when built according to modern codes, have not been able to guarantee seismic safety (Fig. 3.1).

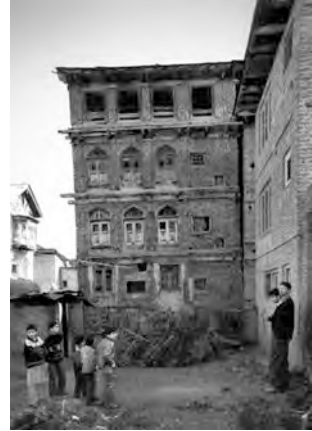
**Fig. 3.2** Four story building of *taq* construction in Srinagar, Kashmir, India. The timbers are on the inside and outside face of the wall. Photograph by © Randolph Langenbach

These buildings were observed almost a century earlier by Arthur Neve, a British visitor to Kashmir, when he witnessed the 1885 Kashmir earthquake: “*Part of the Palace and some other massive old buildings collapsed ... [but] it was remarkable how few houses fell .... The general construction in the city of Srinagar is suitable for an earthquake country; wood is freely used, and well jointed; clay is employed instead of mortar, and gives a somewhat elastic bonding to the bricks, which are often arranged in thick square pillars, with thinner filling in. If well built in this style the whole house, even if three or four stories high, sways together, whereas more heavy rigid buildings would split and fall*” [2] (Figs. 3.2, 3.3 and 3.4).

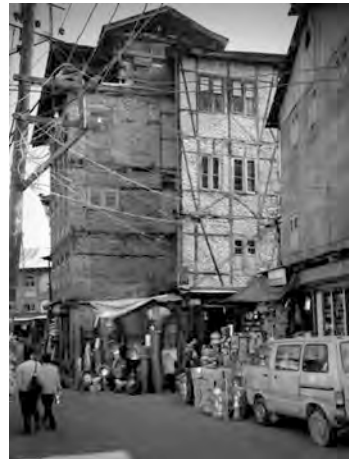
**Fig. 3.3** Buildings in Srinagar, Kashmir. The building on the left is of *taq* construction, and on the right is of *dhajji dewari* construction. Photograph by © Randolph Langenbach

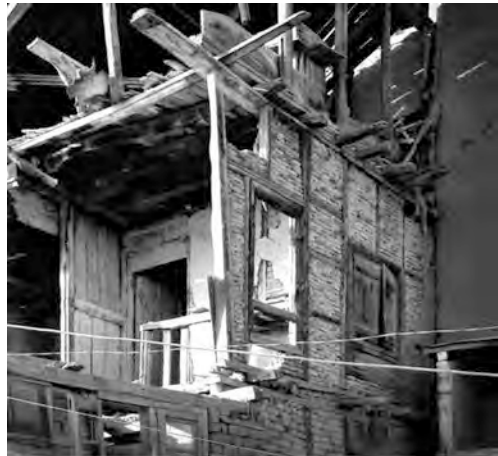
**Fig. 3.4** A partially demolished *dhajji dewari* building showing timber frame with typical single layer of infill masonry construction. Photograph by © Randolph Langenbach

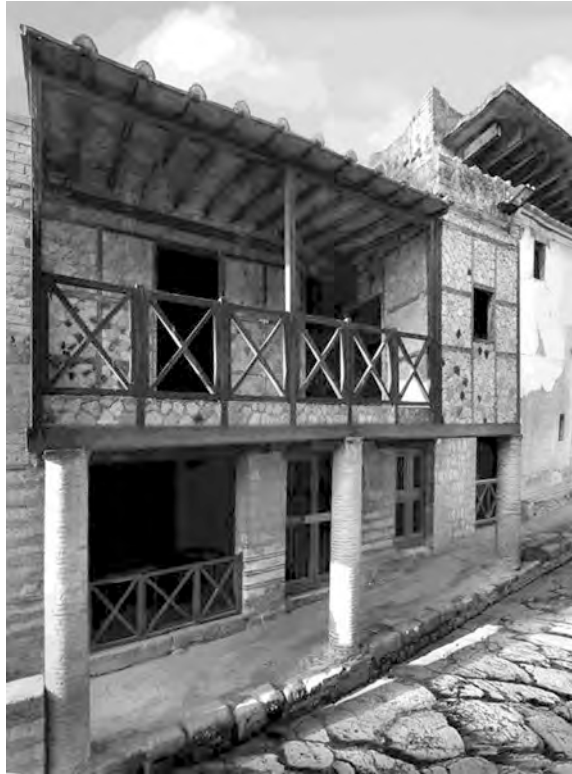
**Fig. 3.5** A building in the ancient Roman town of Herculaneum uncovered after having been buried in the eruption of Vesuvius showing an example of timber frame with masonry infill that is thought to have been called *Opus Craticium*. Photograph by © Randolph Langenbach

The origin of both types of timber-laced masonry systems dates as far back as the ancient world. The palaces at Knossos have been identified as having possessed timber lacing of both the horizontal and the infill frame variety [5]. This suggests that timber-laced masonry construction dates back to as early as 1500 to 2000 B.C. Evidence of infill-frame construction in ancient Rome emerged when archaeologists dug up the port town of Herculaneum that had been buried in a hot pyroclastic flow from Mount Vesuvius in 79 A.D. They found an entire two story half-timber house and interior walls in other houses believed by the archaeologists to be examples of what Vitruvius has called *Opus Craticium*. After the fall of Rome, infill-frame construction became widespread throughout Europe. Timber-with-brick-infill vernacular construction is documented to have first appeared in Turkey as early as the eighth century [6] (Figs. 3.5 and 3.6).

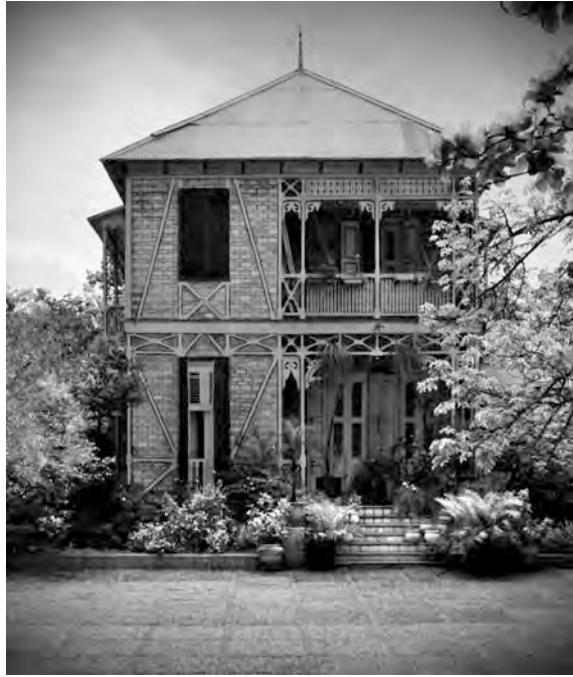
**Fig. 3.6** A single family middle class house of colombage timber frame with single layer infill masonry construction near downtown Port-au-Prince photographed after the 2010 earthquake. This house was in the heart of the damage district with collapsed reinforced concrete buildings nearby. Photograph by © Randolph Langenbach

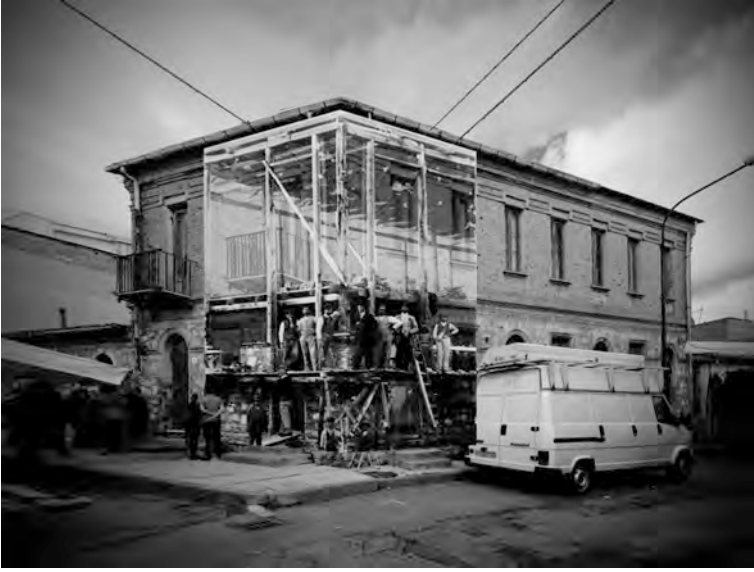
**Fig. 3.7** An early 20th century building in Mileto, Calabria, Italy constructed with a baraccata timber frame embedded on the inside face of the wall, with a photo of it taken during its construction. *Photo courtesy of the owner*

addition by my own former academic colleague, Stephen Tobriner [10]. Rather than commenting on or attempting to add to this considerable work, I wish here to focus on a particular document written more than 80 years ago in English by an American engineer, John Ripley Freeman, who undertook a remarkably comprehensive study of earthquake damage and earthquake resistant construction around the world [11]. His section on Italian earthquakes makes up 75 pages of his 900-page book, and early on in his treatise on Italy, he states “Italy, more than any other country, was the early home of scientific research of many kinds, and in its great engineering schools of today, offspring of its ancient universities, the sacred flame of learning still burns brightly” [11, p. 564] (Figs. 3.7 and 3.8).

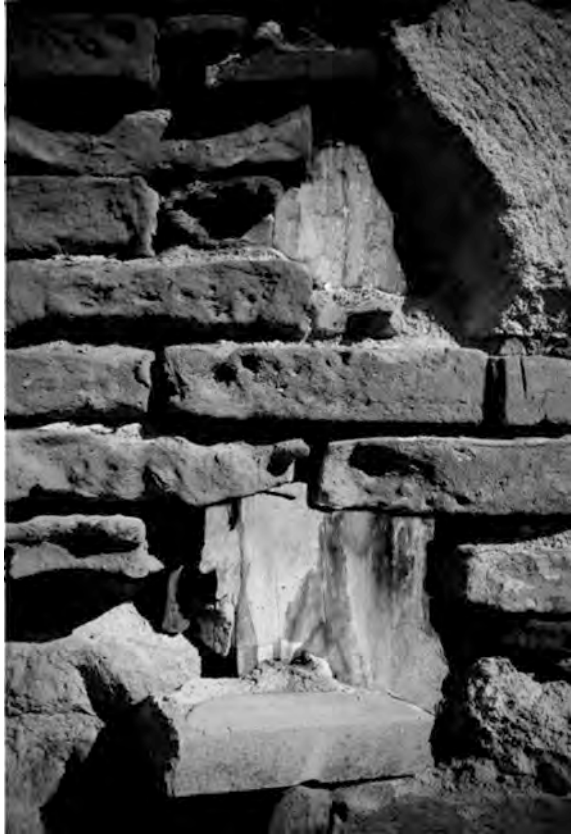
**Fig. 3.8** A vertical column of the timber frame in the building in Fig. 3.7 showing through holes in the brickwork. Photograph by © Randolph Langenbach

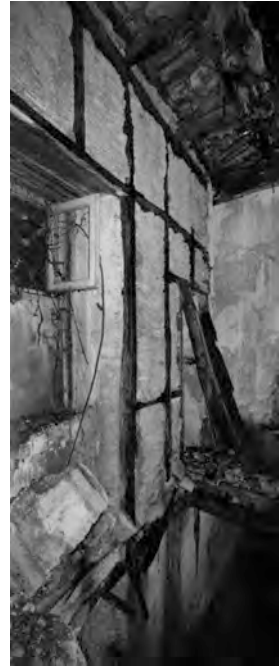
**Fig. 3.9** Side view of exterior wall showing the thickness of masonry in the Bishop's House in Mileto, Calabria, Italy constructed after the 1783 earthquake showing *casa baraccata* framework embedded in the inside face of the masonry wall. The house has been abandoned for many years. Photograph by © Randolph Langenbach

Noting the report’s reference to “*cases where materials were lacking for a more nearly perfect system of construction*”, it is interesting to speculate on what, in 1909, the committee members may have been referring to. The report on the 1908 earthquake stated that “*the greatest resistance was presented by houses of one or two stories in height, constructed of the best brick masonry and resting on rock or firm soil,*” but the sub-committee on the 1905 earthquake made an interesting observation about a new form of construction—reinforced concrete stating that “*... four structures of reinforced concrete in Messina, which remained wholly unharmed*” which “*the sub-committee cited as examples of the capabilities of this material when properly used*” [11, p. 568] (Figs. 3.9, 3.10 and 3.11).

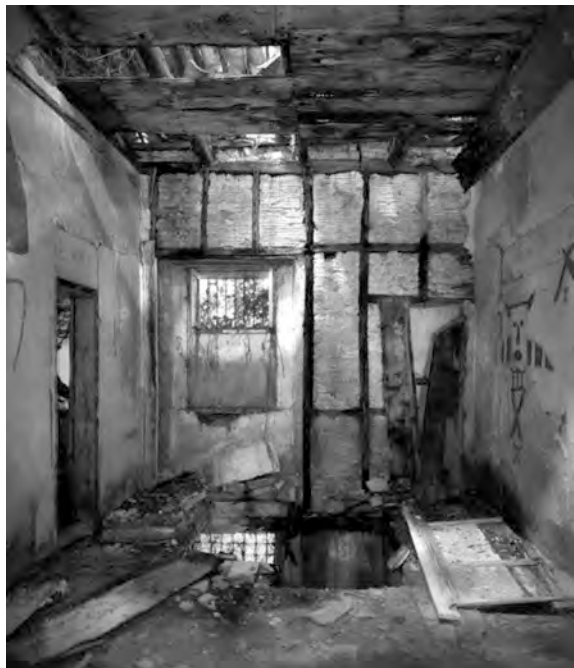
**Fig. 3.10** Interior elevation view of the same wall as shown in Fig. 3.9 of the embedded *casa baraccata* framework in the Bishop's House in Mileto, Calabria, Italy. Photograph by © Randolph Langenbach

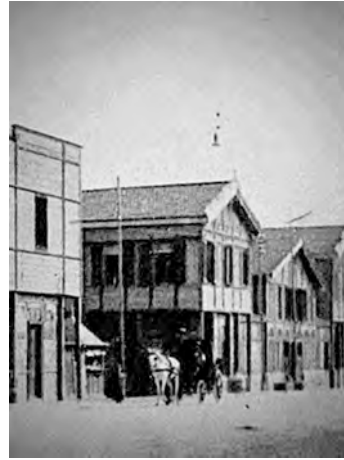
**Fig. 3.11** This view of Messina as rebuilt after 1908 was identified by Freeman as “built under the new building laws.” In the caption to the image, Freeman states “In some [buildings] the framework is concealed, and in others [such as these shown] it is revealed and made an architectural feature” [11, p. 562]  
 Photograph by © Randolph Langenbach

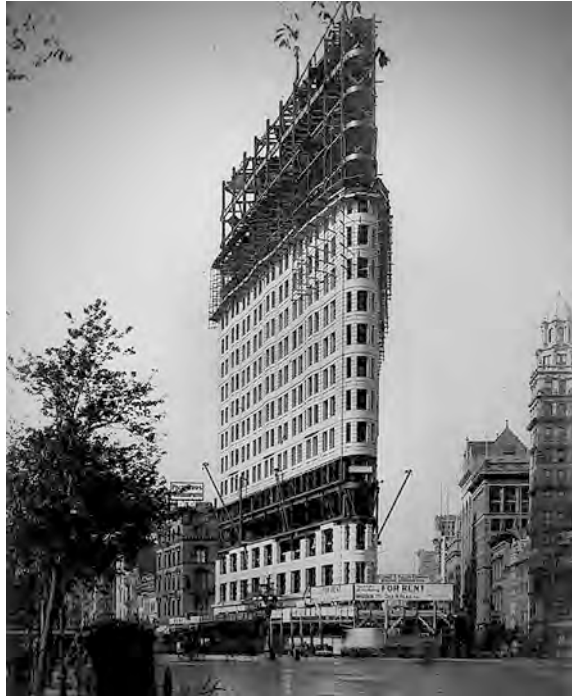
**Fig. 3.12** Flatiron Building in New York City under construction in 1902 showing the heavy stone masonry façade resting on the steel frame. The upper walls were constructed separately probably to ensure the weight is bearing on the frame rather than the lower masonry walls. U.S. Library of Congress Photograph

An interesting fact about the historical development of the modern skeleton frame construction and portal frame analysis at the late 19th and early 20th centuries is that thick masonry infill and cladding was very much an accepted part of early steel and RC building construction, even though it was then, as now, not considered in the engineering calculations for lateral resistance. This is made clear by the author of one of the first textbooks on the subject of skeleton frame construction, Joseph Freitag when in both the 1895 and 1901 editions, he writes that “*‘Skeleton Construction’ ... suggests a skeleton or simple framework of beams and columns, dependent largely for its efficiency upon the exterior and interior [masonry] walls and partitions which serve to brace the structure, and which render the skeleton efficient, much as the muscles and covering of the human skeleton ... make possible the effective service of the component bones .... While the steel frame is more or less reinforced by the weight and stiffening effects of the [masonry infill], still no definite or even approximate values can be given to such items, except their purely static resistance or weight*” [13] (Figs. 3.12 and 3.13).

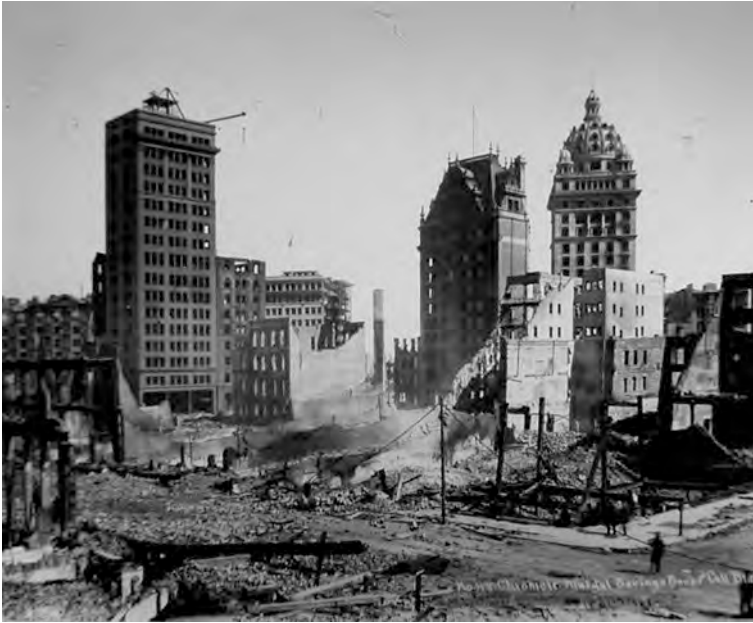
**Fig. 3.13** View of San Francisco after the 1906 earthquake and fire. The three tall buildings visible in this view were burned out by the fire that followed the earthquake, but all three were in good enough condition despite this to be repaired, and they are still extant today. Photograph courtesy Bancroft Library, U.C.Berkeley

It was only a little over two decades after the construction of the first skeleton frame “skyscraper” in Chicago, the 10 story Home Insurance Co. Building by William Le Baron Jenney, that the 1906 earthquake in San Francisco put skeleton frame buildings—even some done by the same architects as those in Chicago—to the test. As it turned out, they passed that test remarkably well. Indeed, one must ask why these first generation steel skeleton skyscrapers in San Francisco remained standing with undamaged frames and repairable damage to the masonry walls, when so many frames with infill masonry buildings have been collapsed by earthquakes a century later. As clearly stated by Freitag, it was not the frame alone, but the masonry in partnership with the frame that was responsible. Many of these buildings are now more than 100 years old, and despite having been burnt out by the subsequent fire, they were repaired and continue in service today.

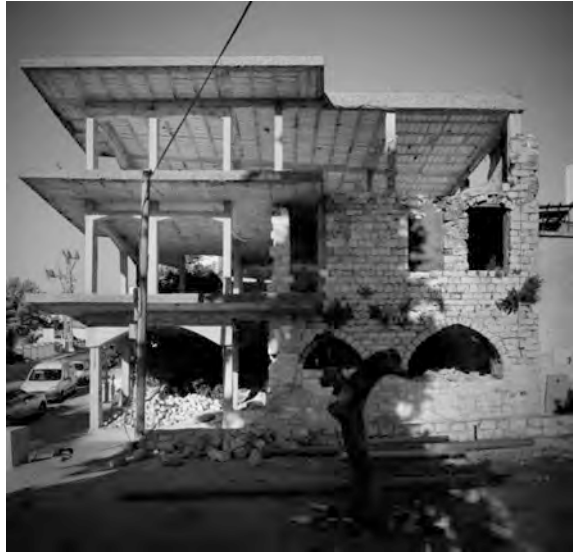
**Fig. 3.15** The interior of the historic structure of this Middle Eastern house has been demolished and is being replaced in RC, with the stone façade to be reconstructed around the new frame. This photo provides a graphic image of the difference between the open self-supporting framework of a reinforced concrete moment frame structure and a masonry solid wall structure. Photograph by © Randolph Langenbach

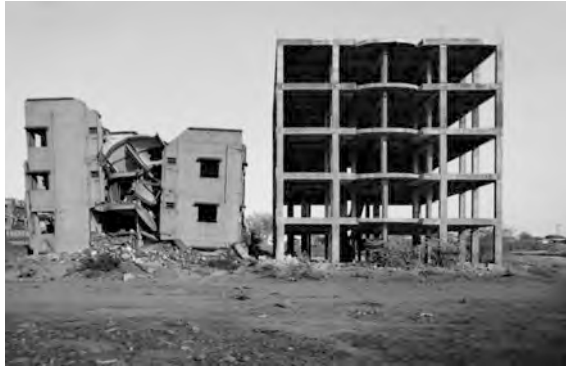
**Fig. 3.16** Two RC frame buildings in Bhuj, India after the 2001 Gujarat earthquake. The building on the left had been completed, while the frame only of an identical building had been completed on the right. The earthquake collapsed the one where the frame was restrained by the masonry infill walls, while the bare frame survived. Photograph by © Randolph Langenbach

The performance of *dhajji* and *hmuş* actually may provide insight into the better performance of the Haiti 19th century middle-class houses as well as large areas of the Haiti slum settlement houses. In my observations of the behavior of these systems in the Turkey earthquakes and the Kashmir and Gujarat earthquakes, the use of weak rather than strong mortars in combination with the timber framing allows the masonry to shift and slide early in the onset of earthquake shaking, rather than crack through the masonry units and fall out of the framework. The combination of the framework with the masonry thus is interactive, rather than one working against the other. “Frame action,” the independent working of the frame as a structural system, is neither what exists nor what is important. Although a framework of timbers is constructed, it is imbedded in the masonry wall and “works” in the engineering sense of the term together with the masonry in the wall (Figs. 3.16 and 3.17).

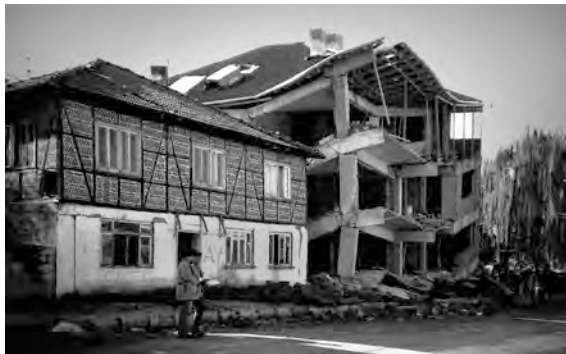
**Fig. 3.17** A collapsed RC building next to a surviving *hmuş* building in Turkey after the 1999 earthquakes showing the resilience of the timber frame with masonry infill compared to that of a new RC frame building of modest height next door. It is interesting to compare this view with Fig. 3.16, where the infill probably caused the collapse, while here the infill and timber frame worked well together. Photograph courtesy of Adem Doğangün

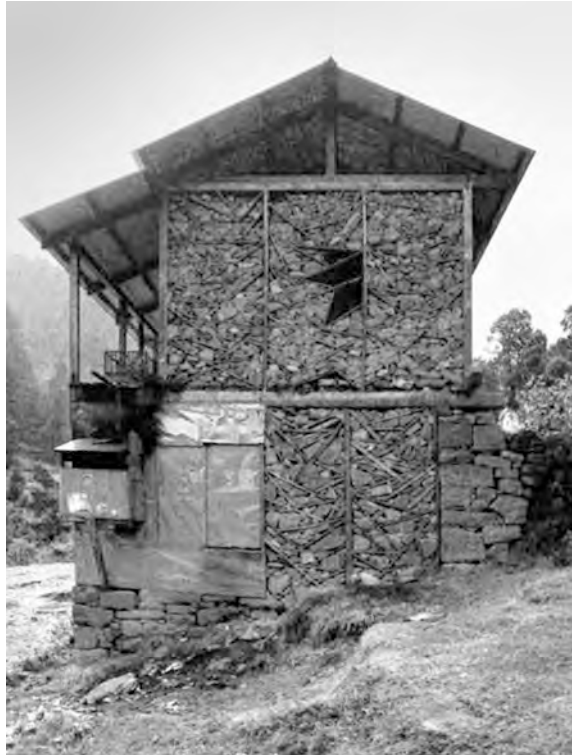
**Fig. 3.18** A rural general store building near Thub, Kashmir, Pakistan in the damage district after the 2005 earthquake. Photograph by © Randolph Langenbach

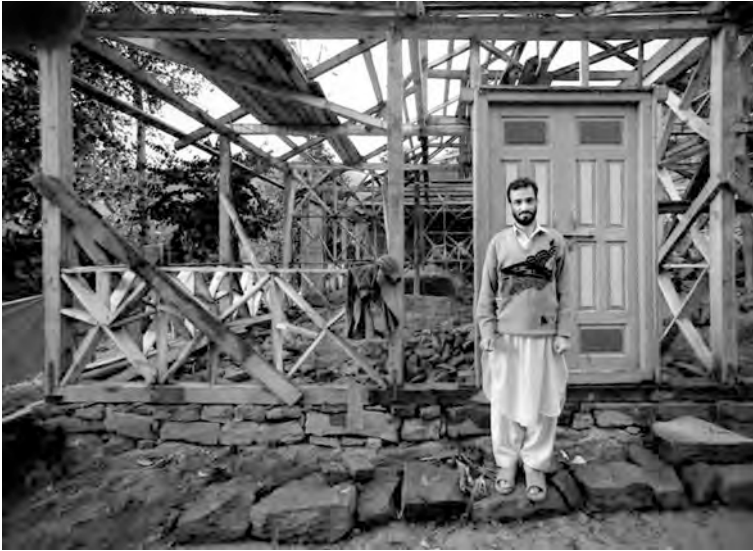
**Fig. 3.19** The owner standing in front of his house under construction showing the light timber frame of *dhajji* construction before the rubble stone masonry with mud mortar infilling. His unreinforced rubble stone house had collapsed in the earthquake and he and his neighbors proceeded to rebuild with *dhajji* when they saw that the only house to survive in the village was the only one of *dhajji* construction and that the one building of RC construction had also collapsed. Photograph by © Randolph Langenbach
