Historical Earthquake-Resistant Timber Frames in the Mediterranean Area

Chapter 3
Timber Frames and Solid Walls:
Earthquake Resilient Construction
from Roman Times to the Origins
of the Modern Skyscraper

Randolph Langenbach

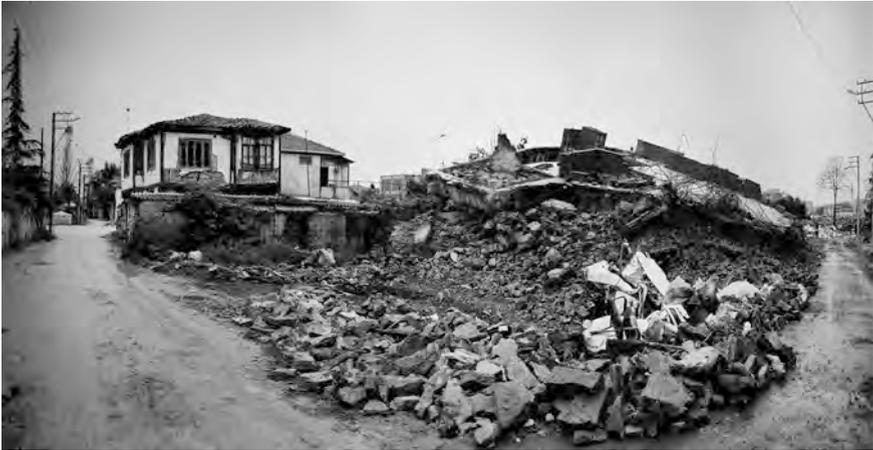
Fig. 3.1 A traditional *humuş* construction house still standing next to a row as far as one can see of reinforced concrete apartment buildings in Adapazari, Turkey after the 1999 Kocaeli earthquake. Photograph by © Randolph Langenbach

In November 2000, 1 year after two devastating earthquakes struck near the Sea of Marmara in Turkey, a conference was convened by UNESCO, ICOMOS and the Turkish Government in Istanbul, called “Earthquake-Safe, Lessons to be Learned from Traditional Construction” [1]. The 1999 earthquakes in Turkey, as well as more recent earthquakes worldwide, have demonstrated that in spite of all of the knowledge of seismology and earthquake engineering gained over the last century in the science and practice, the death toll in such events has continued to rise. It has become apparent that steel and concrete, even when built according to modern codes, have not been able to guarantee seismic safety (Fig. 3.1).

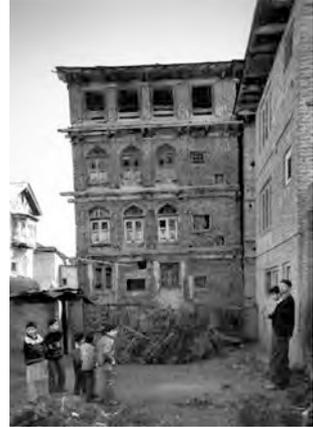
Fig. 3.2 Four story building of *taq* construction in Srinagar, Kashmir, India. The timbers are on the inside and outside face of the wall. Photograph by © Randolph Langenbach

These buildings were observed almost a century earlier by Arthur Neve, a British visitor to Kashmir, when he witnessed the 1885 Kashmir earthquake: “*Part of the Palace and some other massive old buildings collapsed ... [but] it was remarkable how few houses fell The general construction in the city of Srinagar is suitable for an earthquake country; wood is freely used, and well jointed; clay is employed instead of mortar, and gives a somewhat elastic bonding to the bricks, which are often arranged in thick square pillars, with thinner filling in. If well built in this style the whole house, even if three or four stories high, sways together, whereas more heavy rigid buildings would split and fall*” [2] (Figs. 3.2, 3.3 and 3.4).

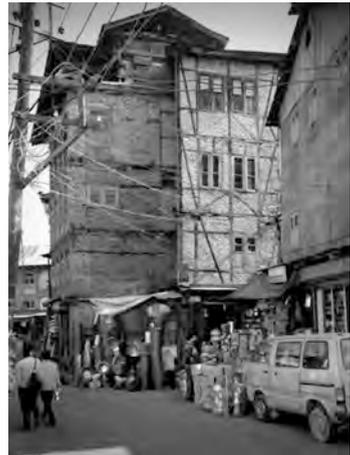
Fig. 3.3 Buildings in Srinagar, Kashmir. The building on the left is of *taq* construction, and on the right is of *dhajji dewari* construction. Photograph by © Randolph Langenbach

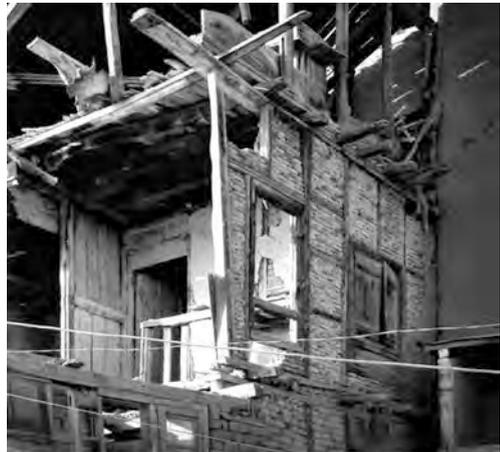
Fig. 3.4 A partially demolished *dhajji dewari* building showing timber frame with typical single layer of infill masonry construction. Photograph by © Randolph Langenbach

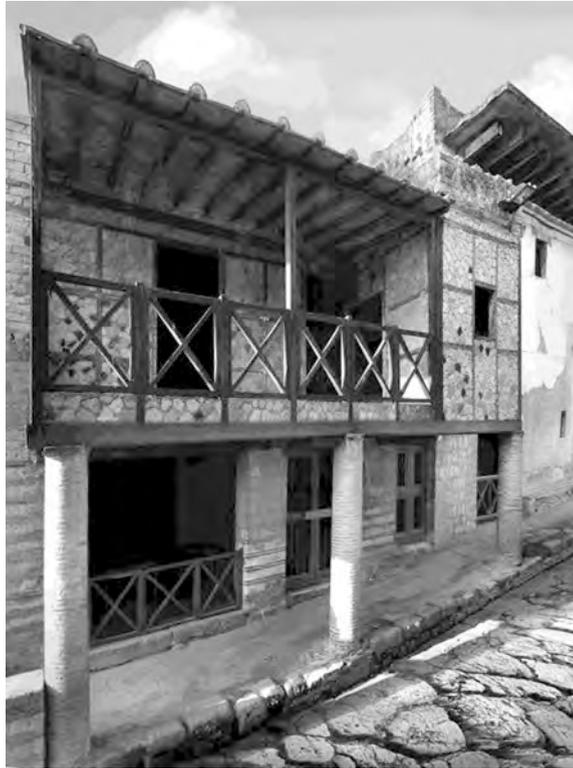
Fig. 3.5 A building in the ancient Roman town of Herculaneum uncovered after having been buried in the eruption of Vesuvius showing an example of timber frame with masonry infill that is thought to have been called Opus Craticium. Photograph by © Randolph Langenbach

The origin of both types of timber-laced masonry systems dates as far back as the ancient world. The palaces at Knossos have been identified as having possessed timber lacing of both the horizontal and the infill frame variety [5]. This suggests that timber-laced masonry construction dates back to as early as 1500 to 2000 B.C. Evidence of infill-frame construction in ancient Rome emerged when archaeologists dug up the port town of Herculaneum that had been buried in a hot pyroclastic flow from Mount Vesuvius in 79 A.D. They found an entire two story half-timber house and interior walls in other houses believed by the archaeologists to be examples of what Vitruvius has called *Opus Craticium*. After the fall of Rome, infill-frame construction became widespread throughout Europe. Timber-with-brick-infill vernacular construction is documented to have first appeared in Turkey as early as the eighth century [6] (Figs. 3.5 and 3.6).

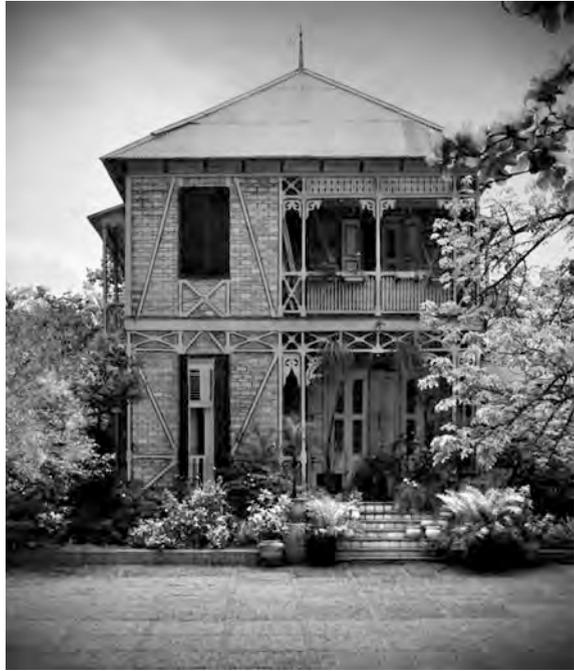
Fig. 3.6 A single family middle class house of colombage timber frame with single layer infill masonry construction near downtown Port-au-Prince photographed after the 2010 earthquake. This house was in the heart of the damage district with collapsed reinforced concrete buildings nearby. Photograph by © Randolph Langenbach

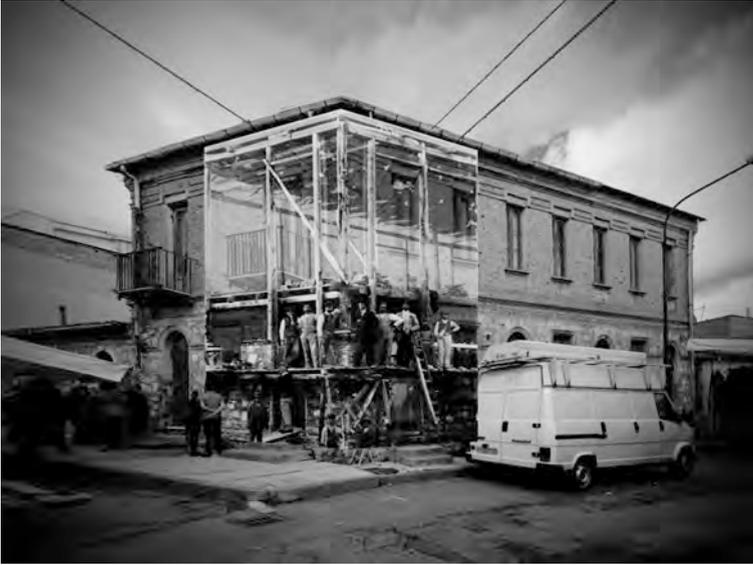
Fig. 3.7 An early 20th century building in Mileto, Calabria, Italy constructed with a baraccata timber frame embedded on the inside face of the wall, with a photo of it taken during its construction. *Photo courtesy of the owner*

addition by my own former academic colleague, Stephen Tobriner [10]. Rather than commenting on or attempting to add to this considerable work, I wish here to focus on a particular document written more than 80 years ago in English by an American engineer, John Ripley Freeman, who undertook a remarkably comprehensive study of earthquake damage and earthquake resistant construction around the world [11]. His section on Italian earthquakes makes up 75 pages of his 900-page book, and early on in his treatise on Italy, he states “Italy, more than any other country, was the early home of scientific research of many kinds, and in its great engineering schools of today, offspring of its ancient universities, the sacred flame of learning still burns brightly” [11, p. 564] (Figs. 3.7 and 3.8).

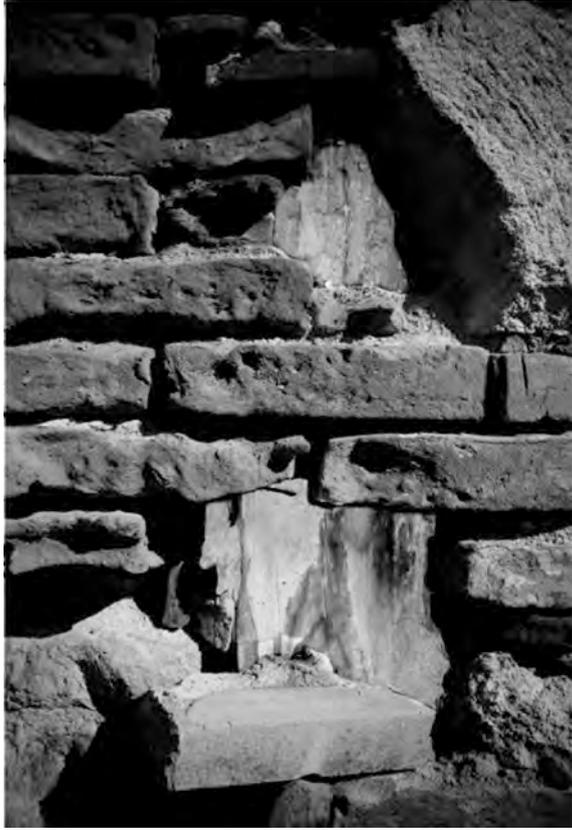
Fig. 3.8 A vertical column of the timber frame in the building in Fig. 3.7 showing through holes in the brickwork. Photograph by © Randolph Langenbach

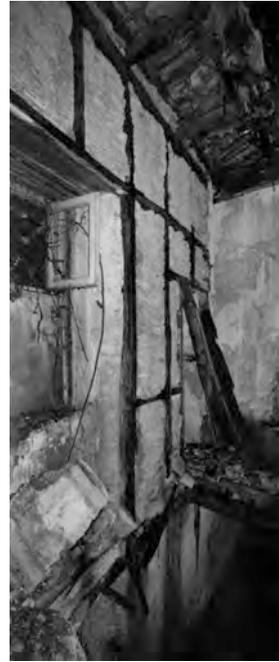
Fig. 3.9 Side view of exterior wall showing the thickness of masonry in the Bishop's House in Mileto, Calabria, Italy constructed after the 1783 earthquake showing *casa baraccata* framework embedded in the inside face of the masonry wall. The house has been abandoned for many years. Photograph by © Randolph Langenbach

Noting the report’s reference to “*cases where materials were lacking for a more nearly perfect system of construction*”, it is interesting to speculate on what, in 1909, the committee members may have been referring to. The report on the 1908 earthquake stated that “*the greatest resistance was presented by houses of one or two stories in height, constructed of the best brick masonry and resting on rock or firm soil,*” but the sub-committee on the 1905 earthquake made an interesting observation about a new form of construction—reinforced concrete stating that “*... four structures of reinforced concrete in Messina, which remained wholly unharmed*” which “*the sub-committee cited as examples of the capabilities of this material when properly used*” [11, p. 568] (Figs. 3.9, 3.10 and 3.11).

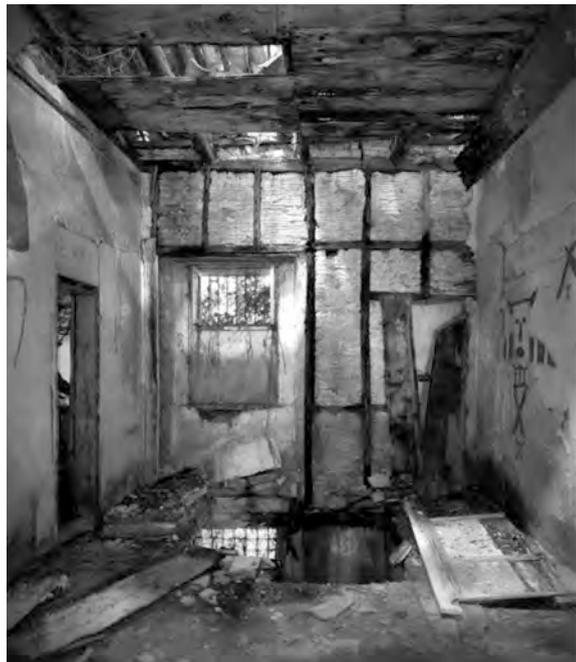
Fig. 3.10 Interior elevation view of the same wall as shown in Fig. 3.9 of the embedded *casa baraccata* framework in the Bishop's House in Mileto, Calabria, Italy. Photograph by © Randolph Langenbach

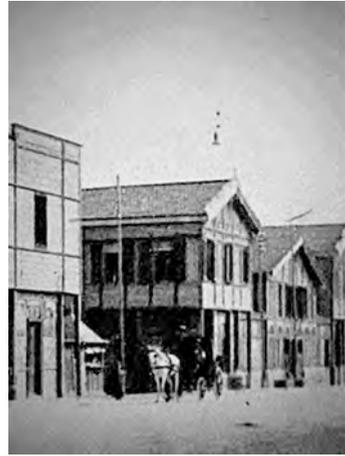
Fig. 3.11 This view of Messina as rebuilt after 1908 was identified by Freeman as “built under the new building laws.” In the caption to the image, Freeman states “In some [buildings] the framework is concealed, and in others [such as these shown] it is revealed and made an architectural feature” [11, p. 562] Photograph by © Randolph Langenbach

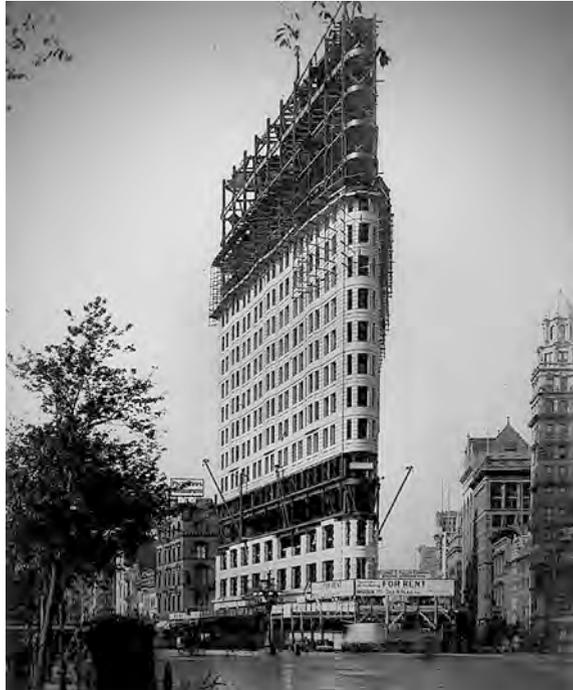
Fig. 3.12 Flatiron Building in New York City under construction in 1902 showing the heavy stone masonry façade resting on the steel frame. The upper walls were constructed separately probably to ensure the weight is bearing on the frame rather than the lower masonry walls. U.S. Library of Congress Photograph

An interesting fact about the historical development of the modern skeleton frame construction and portal frame analysis at the late 19th and early 20th centuries is that thick masonry infill and cladding was very much an accepted part of early steel and RC building construction, even though it was then, as now, not considered in the engineering calculations for lateral resistance. This is made clear by the author of one of the first textbooks on the subject of skeleton frame construction, Joseph Freitag when in both the 1895 and 1901 editions, he writes that “*‘Skeleton Construction’ ... suggests a skeleton or simple framework of beams and columns, dependent largely for its efficiency upon the exterior and interior [masonry] walls and partitions which serve to brace the structure, and which render the skeleton efficient, much as the muscles and covering of the human skeleton ... make possible the effective service of the component bones While the steel frame is more or less reinforced by the weight and stiffening effects of the [masonry infill], still no definite or even approximate values can be given to such items, except their purely static resistance or weight*” [13] (Figs. 3.12 and 3.13).

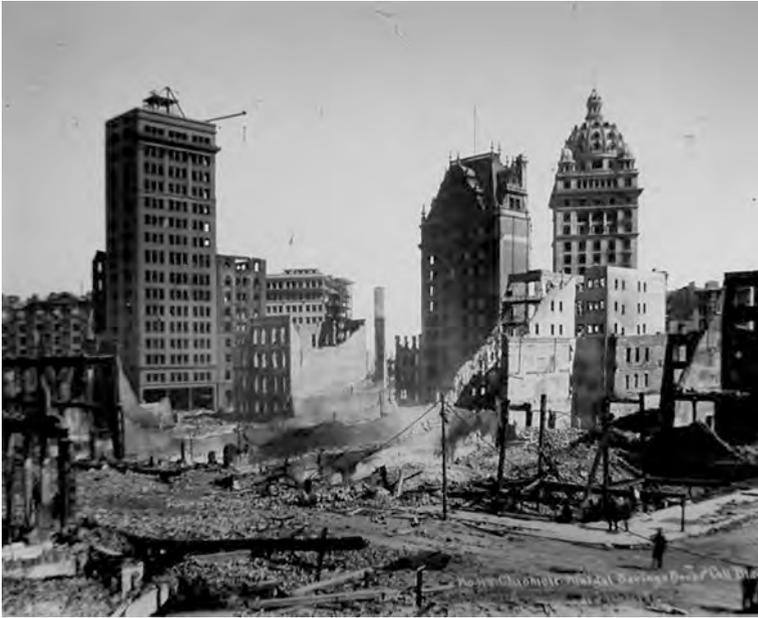
Fig. 3.13 View of San Francisco after the 1906 earthquake and fire. The three tall buildings visible in this view were burned out by the fire that followed the earthquake, but all three were in good enough condition despite this to be repaired, and they are still extant today. Photograph courtesy Bancroft Library, U.C.Berkeley

It was only a little over two decades after the construction of the first skeleton frame “skyscraper” in Chicago, the 10 story Home Insurance Co. Building by William Le Baron Jenney, that the 1906 earthquake in San Francisco put skeleton frame buildings—even some done by the same architects as those in Chicago—to the test. As it turned out, they passed that test remarkably well. Indeed, one must ask why these first generation steel skeleton skyscrapers in San Francisco remained standing with undamaged frames and repairable damage to the masonry walls, when so many frames with infill masonry buildings have been collapsed by earthquakes a century later. As clearly stated by Freitag, it was not the frame alone, but the masonry in partnership with the frame that was responsible. Many of these buildings are now more than 100 years old, and despite having been burnt out by the subsequent fire, they were repaired and continue in service today.

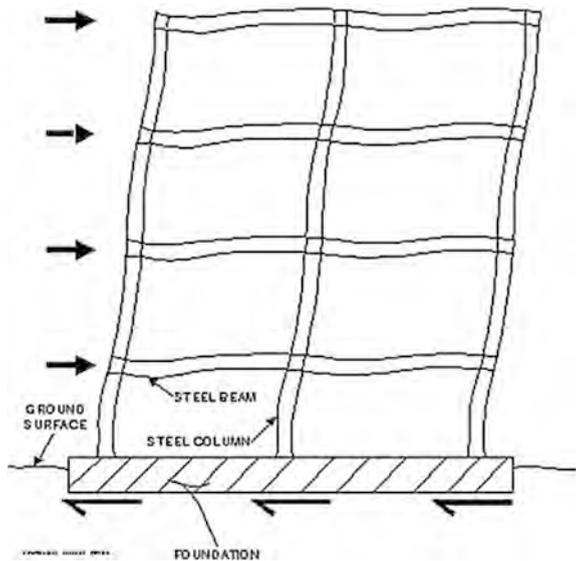
Fig. 3.14 “Frame action” of a moment frame shown here with the uniform elastic bending of the framing members unimpeded by the effects of infill walls

In most parts of the world today, the enclosure and partition walls are most often of weak, but stiff brittle masonry. This has not been considered a problem for wind, as the system together with the masonry was designed to remain elastic, and the addition of the masonry simply made it stiffer and thus likely to be more resistant. Design-level earthquakes though were another matter because a building's structural system is expected to deflect into the nonlinear range. In other words, structural damage is expected to occur. Because these walls are considered by the design engineers to be “non-structural,” these infill masonry walls are often not themselves designed to resist the lateral forces of an earthquake. Thus, their impact on the overall deformation of the building is not properly considered, especially after the point where some infill walls in the lower stories of the frame have broken, while others above continue to resist the deformation of the frame (Fig. 3.14).

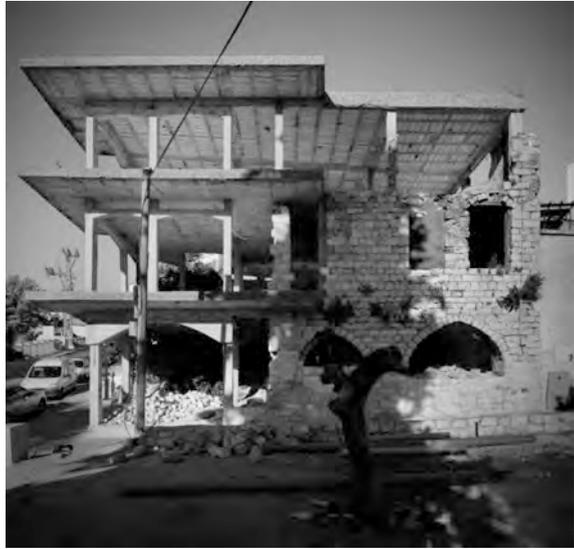
Fig. 3.15 The interior of the historic structure of this Middle Eastern house has been demolished and is being replaced in RC, with the stone façade to be reconstructed around the new frame. This photo provides a graphic image of the difference between the open self-supporting framework of a reinforced concrete moment frame structure and a masonry solid wall structure. Photograph by © Randolph Langenbach

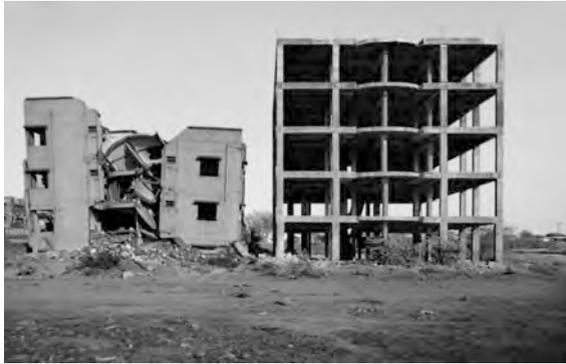
Fig. 3.16 Two RC frame buildings in Bhuj, India after the 2001 Gujarat earthquake. The building on the left had been completed, while the frame only of an identical building had been completed on the right. The earthquake collapsed the one where the frame was restrained by the masonry infill walls, while the bare frame survived. Photograph by © Randolph Langenbach

The performance of *dhajji* and *hmuş* actually may provide insight into the better performance of the Haiti 19th century middle-class houses as well as large areas of the Haiti slum settlement houses. In my observations of the behavior of these systems in the Turkey earthquakes and the Kashmir and Gujarat earthquakes, the use of weak rather than strong mortars in combination with the timber framing allows the masonry to shift and slide early in the onset of earthquake shaking, rather than crack through the masonry units and fall out of the framework. The combination of the framework with the masonry thus is interactive, rather than one working against the other. “Frame action,” the independent working of the frame as a structural system, is neither what exists nor what is important. Although a framework of timbers is constructed, it is imbedded in the masonry wall and “works” in the engineering sense of the term together with the masonry in the wall (Figs. 3.16 and 3.17).

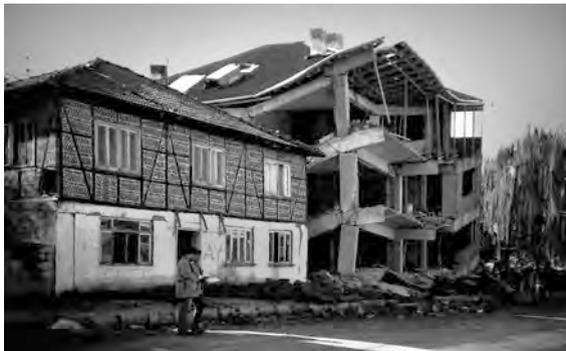
Fig. 3.17 A collapsed RC building next to a surviving *hmuş* building in Turkey after the 1999 earthquakes showing the resilience of the timber frame with masonry infill compared to that of a new RC frame building of modest height next door. It is interesting to compare this view with Fig. 3.16, where the infill probably caused the collapse, while here the infill and timber frame worked well together. Photograph courtesy of Adem Doğangün

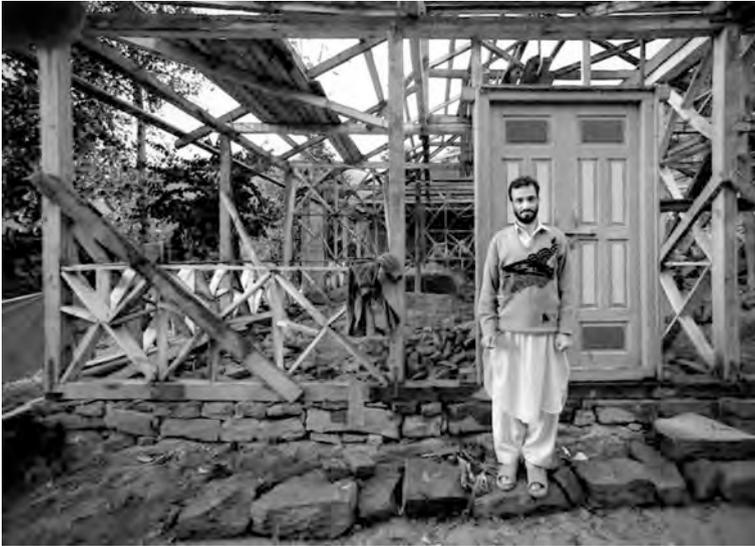
Fig. 3.19 The owner standing in front of his house under construction showing the light timber frame of *dhajji* construction before the rubble stone masonry with mud mortar infilling. His unreinforced rubble stone house had collapsed in the earthquake and he and his neighbors proceeded to rebuild with *dhajji* when they saw that the only house to survive in the village was the only one of *dhajji* construction and that the one building of RC construction had also collapsed. Photograph by © Randolph Langenbach
