## **TIMBER 2.0: RESILIENCE AND VULNERABILITY OF WOOD CONSTRUCTION IN EARTHQUAKES AND FIRES**

**Randolph Langenbach \***

**Keywords:** Turkish House, Timber Frame, Stud Frame, *hımış*, *hatil*, half-timber, nails, earthquake, fire.

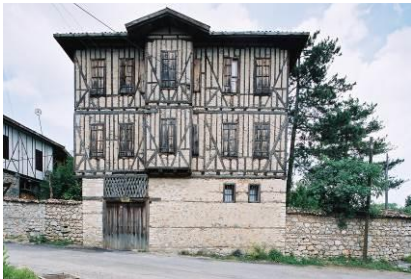
**Figure 1:** house with *hımış* on the 1<sup>st</sup> and 2<sup>nd</sup> floors, and *hatil* on the ground floor in Safranbolu.

The second is a timber frame with masonry infill known in Turkey as *hımış*, (in English called “half-timber”). Here, the masonry is usually a single “wythe” or layer, often with the bricks laid at angles to fit between the studs, or alternatively if stone is used, random rubble set into thick layers of mortar. Depending on the locale the mortar is commonly a lime mortar, but in some rural areas a mud mortar may be used. In *hımış*, the combined timber and masonry wall is only as thick as the timbers – meaning only plus or minus 12cm (5 inches), and thus, when one considers how thin the walls are it seems counterintuitive that this system would be safe and resilient in large earthquakes - but the frame confines the masonry making it an integral part of the structural system. From a structural engineering standpoint, trying to calculate this structure is ultimately frustrating because it comes in many variations, all of which are non-engineered and thus based on intuition rather than rules or codes. (Figure 1)

The third timber structural system most resembles construction as is common in the USA and Canada – 100% timber with closely spaced studs and joists covered on the exterior with sawn wood cladding and on the interior with lath and plaster over a hollow wall.[3] (Figure 2&3+18-20+24-26) Except for wood-abundant countries such as the U.S. and Canada, buildings built entirely of wood are quite rare. Turkish *hımış* construction has thinner walls than masonry bearing-wall buildings, and is thus easier and more economical to construct. It also serves as overburden weight on masonry walls below for earthquake resistance. (Figure 1)

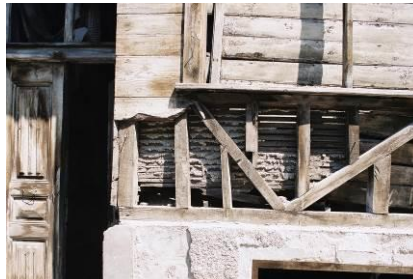
**Figure 2:** Stud framing typical in central Istanbul without infill masonry.

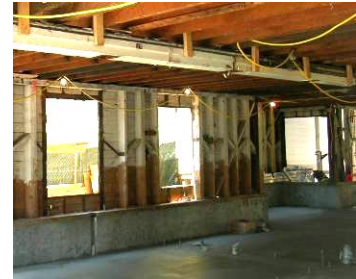
**Figure 3:** San Francisco 19<sup>th</sup> century house with timber framing exposed.

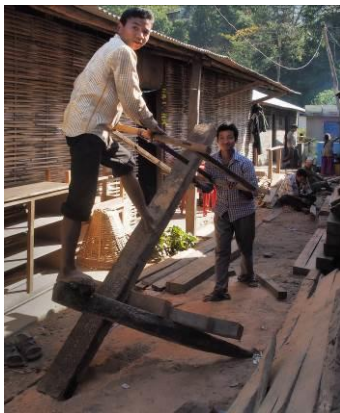
**Figure 4:** Hand cutting timber planks in Nepal, 2016. **Figure 5:** *Colombage* (Half-timber) house with almost no damage from the 2010 earthquake in Haiti. **Figure 6:** Half-timber 3 story house with almost no damage in 2001 earthquake in Ahmedabad, Gujarat.

working with wood siding was elusive. The saws that did exist made the precision cutting of the lightweight framework possible, but cutting of a massive number of boards to cover the walls remained impractical. (Figure 4) Returning to the second typology, *himiş* construction is a variation on a shared construction tradition that has existed through history in many parts of the world, from Elizabethan England to 19th Century Central and South America. In Britain, for example, it would be referred to as “half-timbered,” in Germany as “*Fachwerk*,” in France and Haiti as “*colombage*” (which did well in the 2010 Haiti quake, as seen for example in Figure 5), in Kashmir, India as “*dhajji-dewari*,” and in El Salvador as “*bahareque*.”[4] Ancient Roman examples have been unearthed in Herculaneum, several involving interior partitions, but one involving an entire two-story row house.[5] The palaces at Knossos have been identified as having possessed timber lacing of both the horizontal and the infill frame variety. This history sets the date of what can be reasonably described as timber-laced masonry construction back to as early as 1500 to 2000 BC.[6]

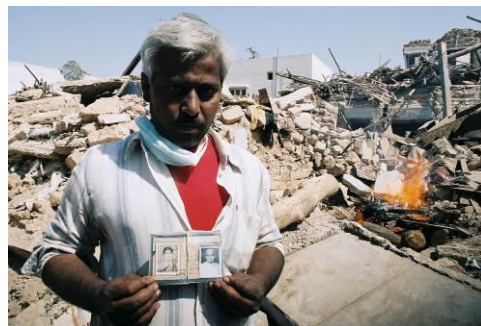
**Figure 7:** URM stone house in Bhuj after 2001 Gujarat earthquake. **Figure 8:** This man survived but his mother didn't, and he is cremating her, and holds her picture. **Figure 9:** Another view of the ruins of both stone houses and concrete houses in Bhuj.

Observing the places where this method did not become a predominant building type supports this hypothesis. For example, in India, the Gujarat earthquake of 2001 revealed that the Mughal city of Ahmedabad in its historic walled city core had similar timber-laced construction (Figure 6), while the historically Hindu city-states of Bhuj (Figures 7-9), Anjar, Morvi, and Jamnagar did not share this construction tradition. In the 2001 earthquake the Hindu cities were devastated, while in Ahmedabad the occupied and maintained houses in the Walled City survived with very little or no damage. As proof that Ahmedabad was also well within the damage district, many reinforced concrete buildings surrounding the city collapsed.[7]

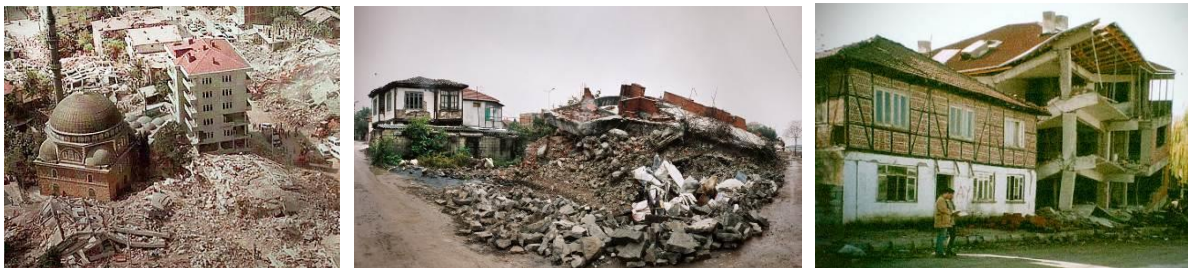
**1999 EQ photos: Figure 10:** Mosque and minaret still standing in Gölcük with collapsed RC buildings around it. (Al Jazeera) **Figure 11:** *Hımsı* house next to an entire row of collapsed RC buildings in Adapazari. **Figure 12:** *Hımsı* house next to destroyed RC building. (Adem Doğançün)

We now return to Turkey, not for ancient or medieval history but because of two catastrophic earthquakes that occurred in 1999. The first of these, the Mw 7.6 Kocaeli (or Marmara or İzmit) earthquake, was on August 17, 1999, followed on November 12<sup>th</sup> by the Mw 7.2 Düzce earthquake. The first quake caused approximately 20,000 fatalities, and the second added another 1,000. Views of collapsed buildings were all over the news at that time, but little was broadcast about timber-laced masonry buildings. For unreinforced masonry, there was the arresting aerial photograph taken in Adapazari showing a stone mosque standing with all of its minarets intact, completely surrounded by reinforced concrete (RC) buildings that had pancake collapsed. (Figure 10)

I knew that construction techniques existed in Turkey that were similar to those I had documented in Kashmir, but I did not know if such buildings existed in the 1999 earthquake affected cities. When I spoke to a returning reconnaissance team member I asked if he had seen any timber with infill masonry buildings, and he said he did see some and they were still standing. Then when I asked if he had taken any photos of them, he replied: “no.” Despite the fact that they might hold evidence of a key to resilience in this and future quakes, the vernacular buildings were to him neither relevant nor of value. It was at that moment that I decided that I must go to Turkey to explore this situation more fully. Thus my research on traditional timber-laced masonry construction moved from a study in the British Library about the 1885 earthquake in Kashmir to a view of the damage in 1999 from under a hard hat. (Figure 11)

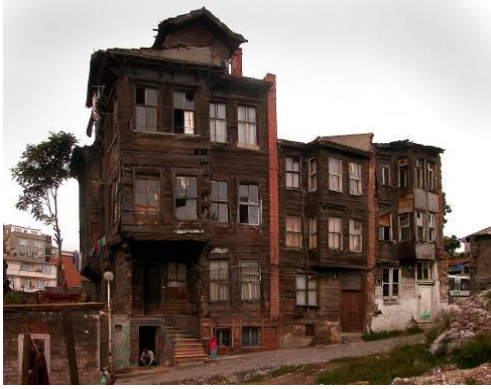
**Figure 17:** Houses with firewalls.

The “*Hocapaşa* Fire was preceded by only nine years in 1856 by a fire in Aksaray, and followed by another in 1870 called the Pera Fire, both of which were also influential on the future town planning in Istanbul.[21] After the Pera fire, brick and stone construction became mandatory in certain zones in 1875, and in other secondary zones timber was occasionally allowed, provided that masonry firewalls were constructed between the wooden buildings.[22] Because masonry was more costly than timber, this served to make reconstruction unaffordable for many except in certain areas. (Figure 17)

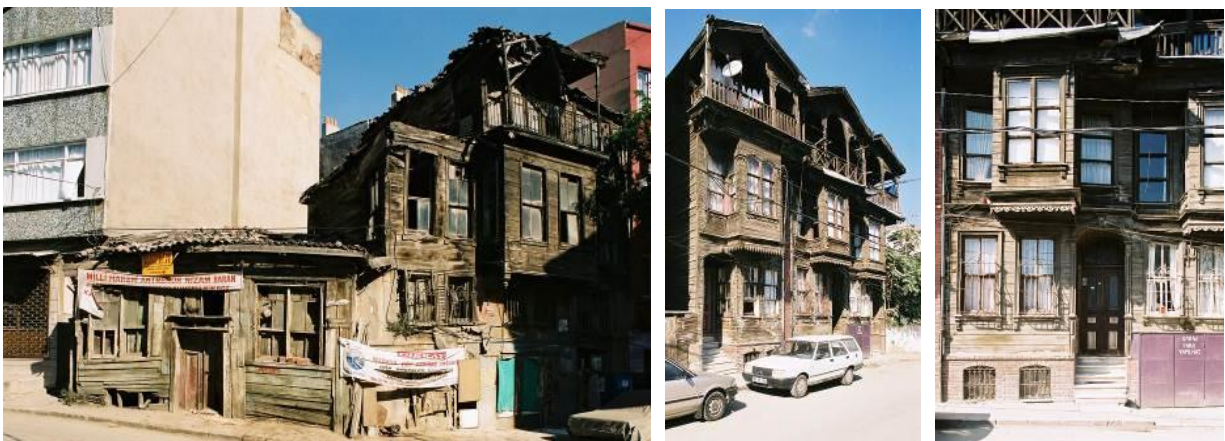
**Figure 18, Figure 19, Figure 20:** Deteriorated wooden houses in Sultanahmet, Istanbul, with modern concrete apartment house visible to the left in #18.

Over the course of the last century the wooden houses of Istanbul have gradually fallen into disrepair, even as many were still lived in, but usually by tenants without an interest in their maintenance. Many have been demolished and replaced with stone and concrete apartment houses under a process which has come to be called “*yap-sat*” (build-sell) where an owner sells his property to a builder-developer, who then builds a condominium form of ownership apartment house and the previous owner is given one of the units as compensation for the sale of the property. (Figures 18-20)

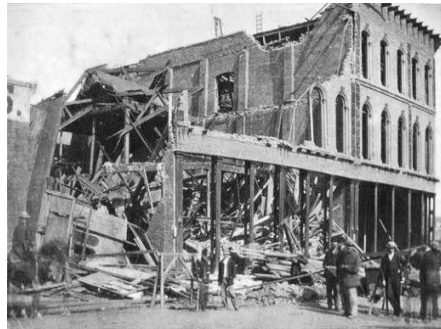
**Figure 22:** 1868 EQ. (Bancroft)

More recently, in an article published in 2016, Jack Boatwright, a geophysicist at the USGS states that his research has shown that *“The 1868 quake was twice as big as the standing model we had of it.”* The San Jose Mercury newspaper the day after the quake reported *“buildings and trees seemed to pitch about like ships in a storm at sea,”*[27] and Mark Twain’s commentary on his own experience of the 1865 earthquake is one of the most informative and graphic descriptions of experiencing an earthquake ever written.[28] Thus in this case, the effect of these was not unlike that of the earthquake in Istanbul of 1509 – and like that earthquake, they encouraged a continuation of what was already the widespread construction of multi-story stud-framed wooden buildings. (Figures 21-23)

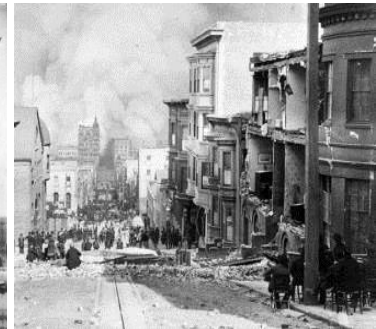
**Figure 23:** 1906 EQ. (Genthe)

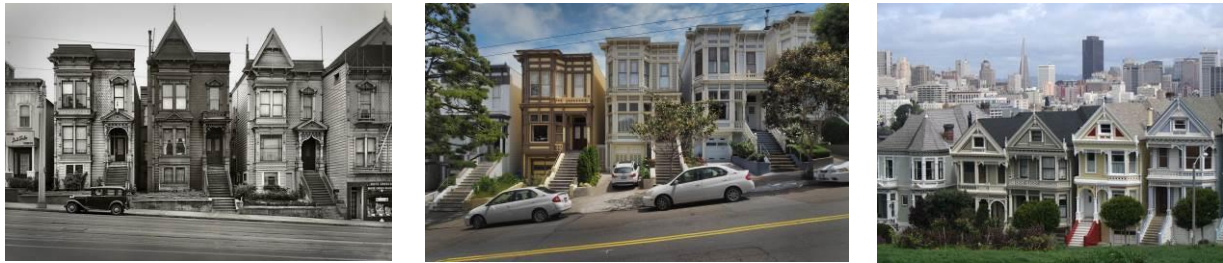
**Figure 24, 25:** San Francisco Victorians, 1940 (HABS), and today. **26:** The “Painted Ladies” (B. Mittal)

For San Francisco its time would come, and it came following another earthquake that caused as many as 50 to 60 fires to break out. It was the Great Earthquake of 1906. The fires coalesced into several great fires that burned for days, consuming the entire central business district plus the most of the splendid wooden mansions on Nob Hill as well as other residential areas on the eastern edge of the city. But, wait! Isn't San Francisco famous for its wooden Victorian houses today? (Figures 24-26)

This is where it gets interesting, because these now famous wooden houses did survive the fires. There were, of course, an equal or greater number of wooden buildings that burned, but a large part of the destroyed area was the central business district with brick and stone buildings with interior wood floors, some of which were even equipped with fire shutters. However, what makes this particular fire remarkable is that not only did it get into the brick buildings which then were left as collapsing shells; it also burned out every downtown highrise building of fireproof construction. These were first generation skyscrapers of skeleton steel frame construction with brick floors of jack-arch construction, a structural technology that had its first origins in Chicago only two decades before. Despite their fireproof construction, it was the contents of the buildings that were flammable – just as occurred in the World Trade Center buildings in New York on 9/11 almost 100 years later. Despite the best efforts of the fire department the fire could not be stopped from getting into the buildings. Interestingly, despite the fact that they had suffered both earthquake damage and were completely burnt out, most of these buildings were repaired and many are still extant today, over a century later.[30]

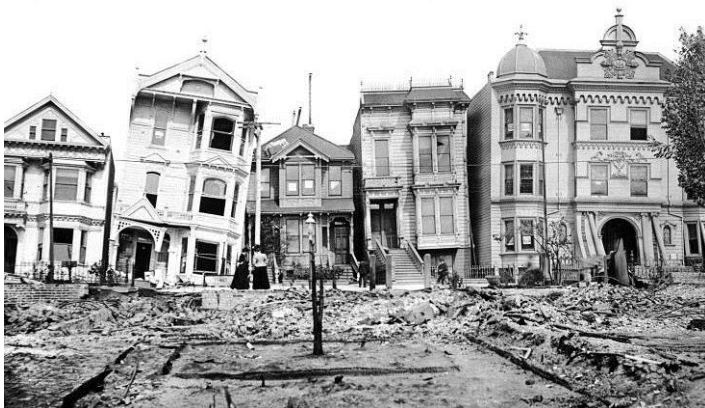
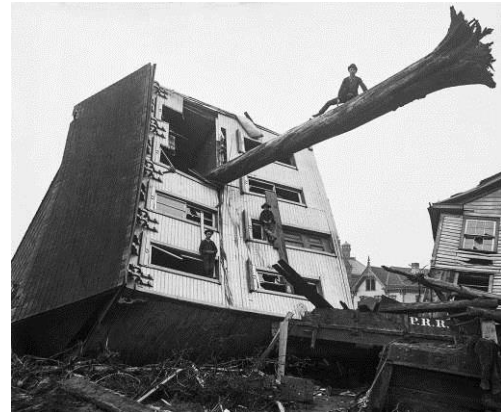
**Figure 29:** Wooden houses on Howard street, only one of which remains still centered on its foundation. Most interesting is that they managed to hold the line against the fire with these houses facing ones burning. (The Atlantic, 4/11/16) **Figure 30:** John Shultz House after the 1889 Johnstown dam burst, a remarkable visual testament to the resilience of 19<sup>th</sup> century stud frame construction. (Bettmann/Getty Images)

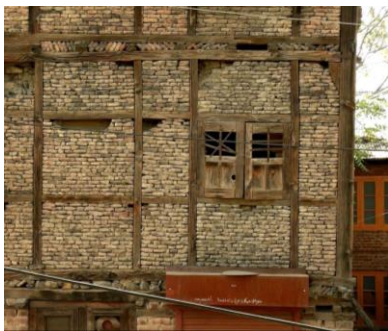
**Figure 31:** Srinagar, Kashmir *dhajji* structure without diagonals

Now, as traditional and vernacular forms of construction have gained increasing interest by students and professors alike, a number of engineering papers indicate that the masonry infill is largely missing from the engineering analysis except as dead weight. There is, for example, much emphasis on the need for diagonal timbers within the frame to act as lateral braces. In actual practice, there are many traditional infill frame structures - for example in the Vale of Kashmir and in Pakistan – which do not have diagonals, but which have proven to be as resilient as the others in the 2005 earthquake. This was also true with some *himis* buildings in Turkey during the 1999 earthquakes. (Figure 31)

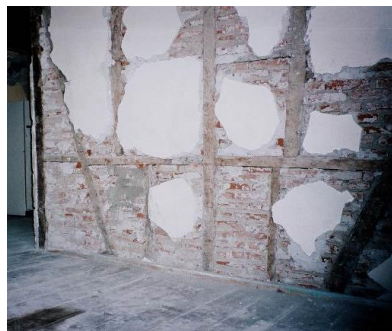
**Figure 32:** House in Düzce, Turkey after 1999 EQ, showing the ‘working’ of *himis* wall

In recent decades, engineers have struggled to figure out a way to analyze and do calculations on reinforced concrete frames with infill masonry, and one of the important methodologies that has been developed is to include what is now called the “*equivalent diagonal strut.*” This is the compression strut that occurs as the building’s frame deforms and transfers compression load onto the infill masonry. In an earthquake, this causes the characteristic “X” cracks. However, one almost never sees an “X” crack in a *himis* or *dhajji* structure. This means that there is a very important and beneficial difference between the traditional infill

systems, and the infill walls found in modern concrete frame buildings. (Figures 32 & 33) The most counterintuitive difference is that the mortar in traditional construction is most often either mud or weak lime mortar, in contrast to cement mortar used in modern RC construction. The second is that the infill panels are much smaller than those found in modern RC structures. This is linked to a need to rediscover what had been traditional knowledge, not unlike what was observed after the 1885 earthquake in Srinagar by Arthur Neve, in the quote referenced above: “...wood is freely used, and well jointed; clay is employed instead of mortar, and gives a somewhat elastic bonding to the bricks, .... If well built in this style the whole house, even if three or four stories high, sways together, whereas more heavy rigid buildings would split and fall.”[32]

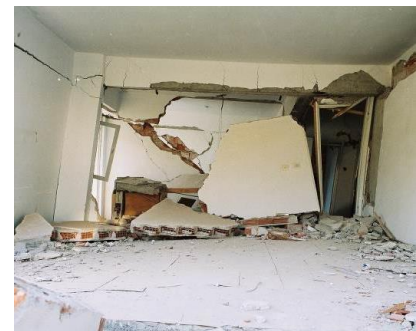
**Figure 33:** Collapsed RC building in 1999 showing shear failure of hollow clay tile infill wall.
