## INTEGRITY OF STRUCTURE: The Armature of our Architectural Heritage

Randolph Langenbach

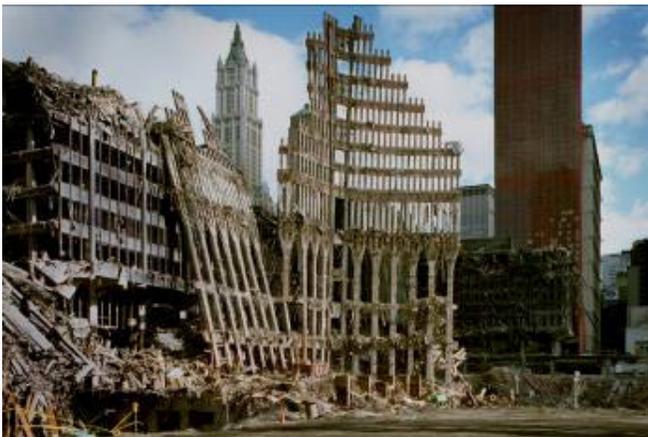
**Figure 1:** Ruins of World Trade Center North Tower façade with the Woolworth Building in the distance. Originally the tallest in the world, with the demise of the Twin Towers, the 1913 Woolworth Building has again resumed its status as the tallest building in Lower Manhattan.

Of course, intellectually, the collapse made sense. How could any building stand up to the fiery crash of a large fully loaded commercial airplane? In fact they withstood that force – only to suddenly collapse an hour later into an indefinable pile of debris – except for the evocative Gothic style ruin of the broken facade of each tower. (Figure 1)

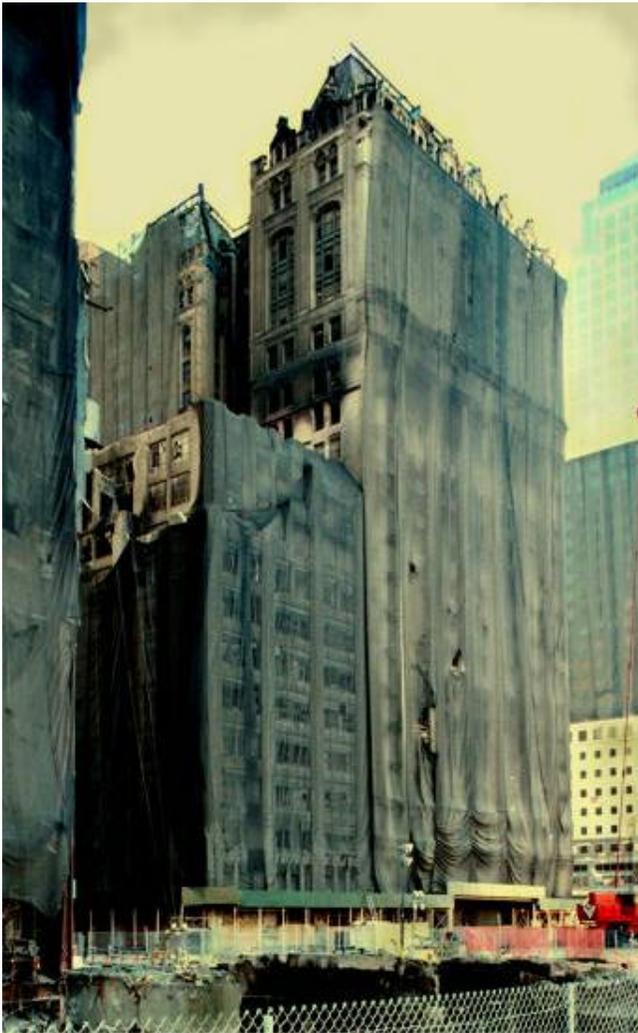
**Figure 2:** An enshrouded and burned out 90 West Street after the collapse of the World Trade Towers opposite.

On one side of the World Trade Center complex stood a much older building that was also almost completely burned out. It was not just older; it was more than half a century older. At the time it was constructed, at 28 stories, it was one of the tallest buildings in the world of its day. (Figure 2)

A year after the collapse of the towers, the interior of 90 West Street is a burned out ruin. Almost every floor suffered extensive fire damage, and some became sufficiently hot to soften the steel columns. This building stands as evidence of how far the burning debris was catapulted into the surrounding area. However, unlike all of the other burned out buildings, not only did it not collapse, as did Seven World Trade Center, *its structural system was only slightly damaged.* That system, which consists of hollow clay tile and riveted steel, proved to be more durable and capable of avoiding the destructive warping of the steel joists and columns that occurred in the massive group of 1960's seven-story buildings that surrounded the towers.

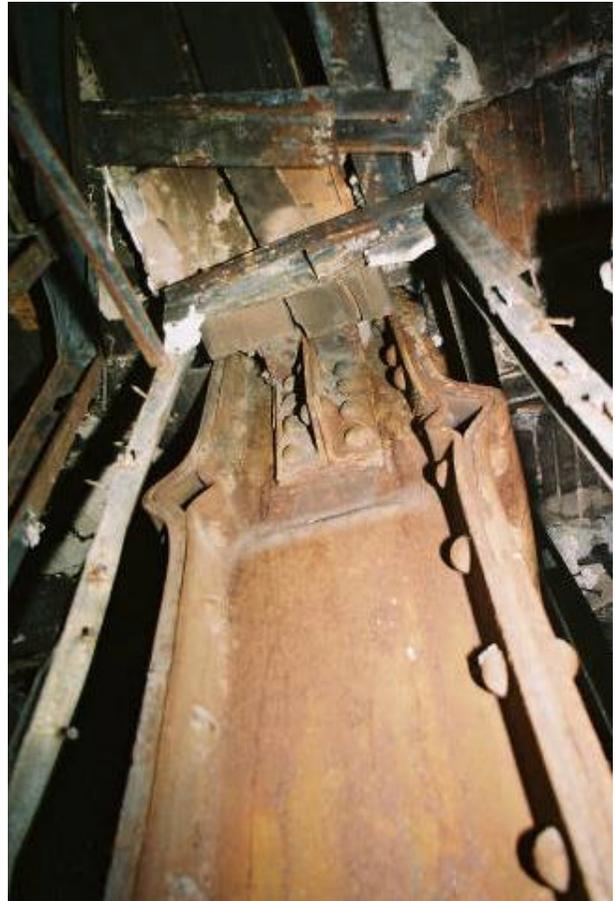
**Figure 3:** Buckled riveted steel column, 90 West Street

Only a few columns were slightly buckled, (Figure 3) a testament to the fact that even though the fires were

hot, the onset of collapse was arrested (most probably by the rivets) just as it had been for many similarly constructed high-rise buildings which were thoroughly burned out in the San Francisco Earthquake and Fire of 1906 almost a century earlier.

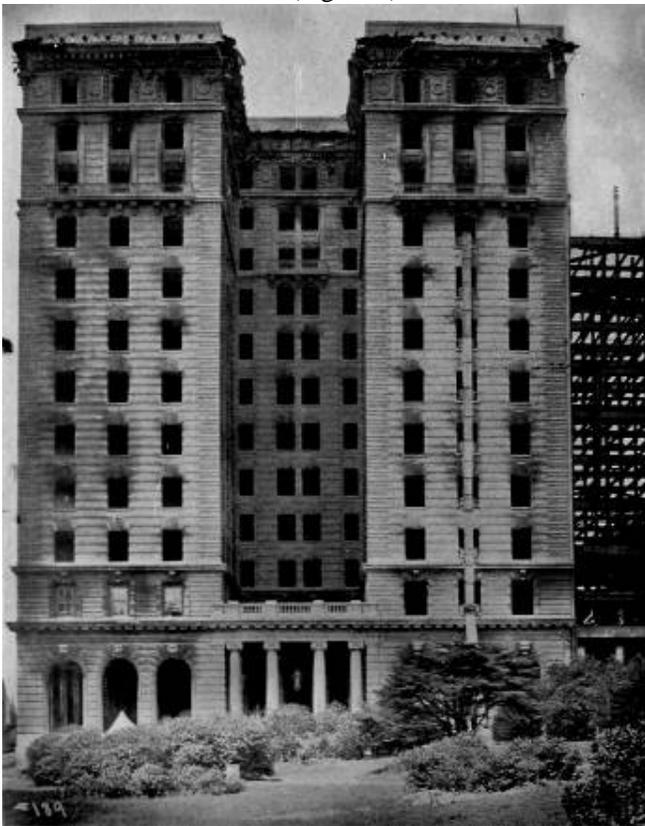
**Figure 4:** Burned hulk of the St. Francis Hotel in 1906. This steel frame in this building came through the fire in almost perfect condition. (FROM: A.L.A.Himmelwright, CE, The San Francisco Earthquake and Fire, The Roebling Construction Company, NY, 1906, p175.)

This building stands as a testament to the resilience of the now archaic structural and fireproofing system of the building's structure. It also stands as a remarkable present-day chance to study what happened in San Francisco to the cluster of early high-rise buildings that existed in that city when the great 1906 earthquake and fire ravaged the entire downtown area, destroying all in its path except the high-rise buildings of similar construction as 90 West Street. It is even more remarkable to take note of the fact that almost all of the buildings in San Francisco in 1906 of this type were repaired after they were both damaged in the earthquake and completely burned out. Most of these repaired turn-of-the-century buildings are still extant today, almost a century later. Few people today are even aware that when they stay in the luxurious stately Fairmont Hotel or the equally impressive St. Francis Hotel that they are in the restored interiors of what had been burned out hulks in 1906. (Figure 4)

The detailed reports on the performance of the burned-out San Francisco buildings show that their performance in the extremely hot fires, although far from perfect, was in many cases good enough to allow the buildings to be restored. In fact, it was the 1906 earthquake and fire that demonstrated some of the problems with hollow clay tile fireproofing, as it was knocked off of the steel framing by expanding steel plumbing pipes, or cracked by the earthquake, but the earlier steel structural systems of riveted steel members, rather than welded rolled wide flange beams and columns of today, proved to be remarkably stable even where the tile had fallen away. As a result, these badly damaged buildings could be repaired.

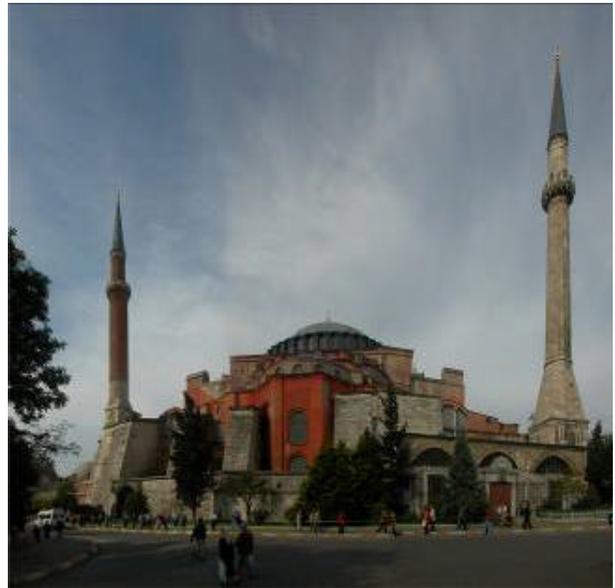
**Figure 5:** Exterior of the eastern side of Hagia Sophia. This view shows the many large buttresses added over the centuries to support the original church. (To be able to illustrate this view in a single image, two wide-angle photographs have been joined together.)

life span of the World Trade Center towers, yet an earthquake collapsed part of the dome in 557. In the rebuilding process, the shape of the dome was changed, making it more stable, and the great buttresses were built, wiping out the original Justinian period exterior design with its late classical portico. (Figure 5)

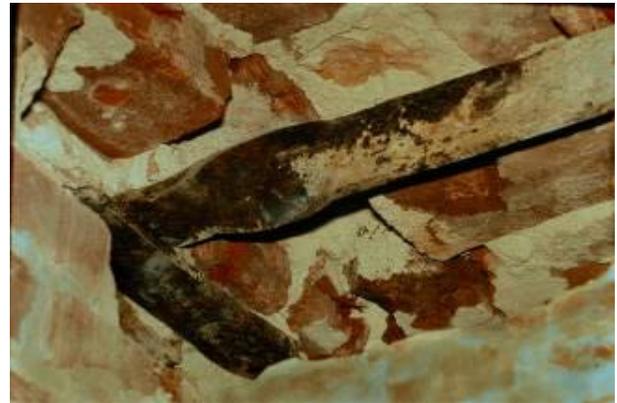
**Figure 6A:** Bond iron inside the brick exterior wall of South Hall exposed during construction work.

When the walls were opened up to install reinforced concrete pilasters before the new reinforced shotcrete wall was sprayed over the surface of the historic masonry, it was discovered “bond iron” – a system of wrought iron bars that tied the building together above and below the windows on every level – was imbedded in the brick masonry. (Figure 6A) In addition, the beams and joists were anchored to the walls with iron ties that were imbedded into the walls so that they would be hidden on the exterior. (Figure 6B)

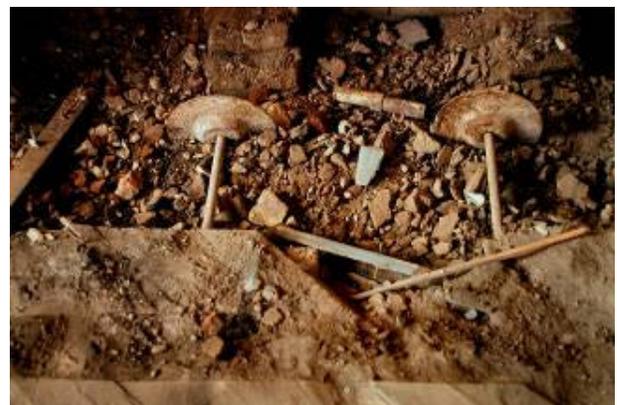
**Figure 6B:** Dog anchors in South Hall walls exposed by construction work.

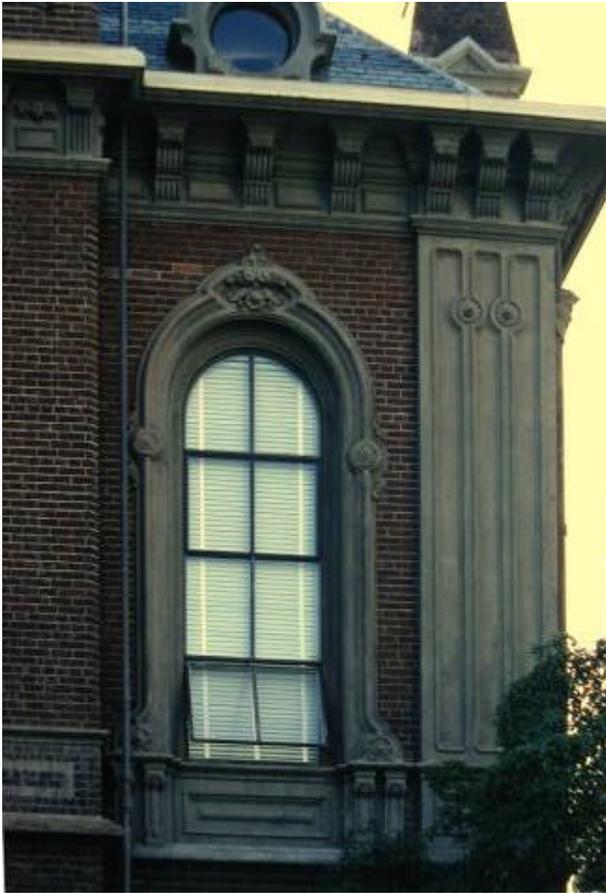
**Figure 6C:** Exterior of South Hall showing large ornamental cast iron corner bracket. The bond iron in the brick walls terminates at the large bosses.

Huge story-high ornamental cast iron plates that were attached to the corners of the building should have provided a clue to what was inside. (Figure 6C) The large bosses on these plates proved to be the nuts that held the ends of the bond iron straps that ran from corner to corner through the length of every wall. Ironically, there was historical evidence in the University's own records of the existence of this reinforcing, but historical research was not included as part of the design phase of the project and thus this remarkable historic anti-seismic structural system was revealed only so that it could be destroyed in order to construct a modern-day version of the same thing.

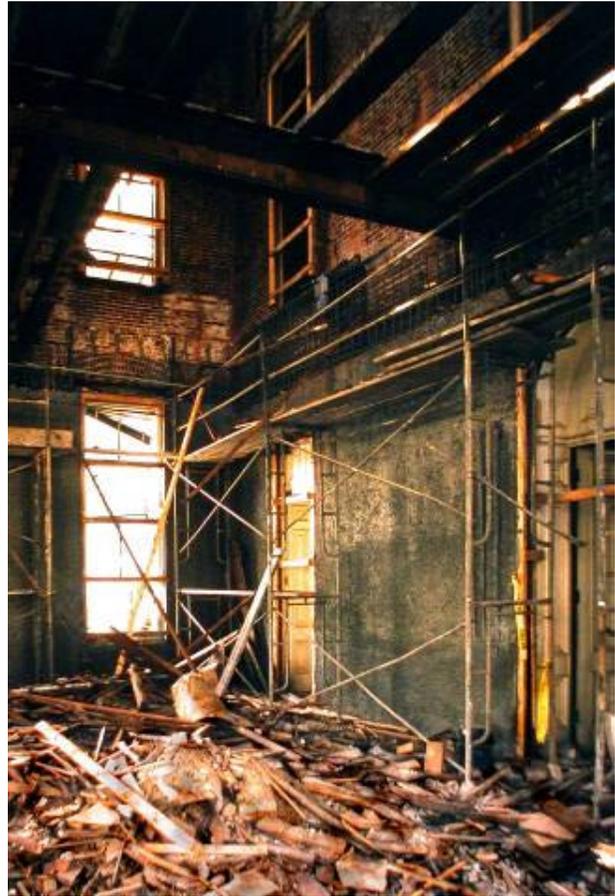
**Figure 7:** Interior walls of South Hall being covered by steel and shotcrete.

The tragedy of this project is that, once discovered, nothing was done either to (1) adapt the modern retrofit project to either preserve or to take advantage of the original system, or (2) accurately document it for the historical record of a nineteenth century earthquake resistant building technology. In the process of installing the new system, the iron rods were all cut and destroyed. The brick structure was encased in a tomb of concrete shotcrete, a material that is impossible to remove or replace. The destruction of this record of historic technology is thus a loss of an important historical engineering artifact. (Figure 7)
