**SURVEY REPORT ON NORTHERN KASHMIR EARTHQUAKE OF  
OCTOBER 8, 2005  
FROM THE INDIAN KASHMIR SIDE OF THE LINE OF CONTROL**

**By Randolph Langenbach**

Building Conservation Consultant, Oakland, California

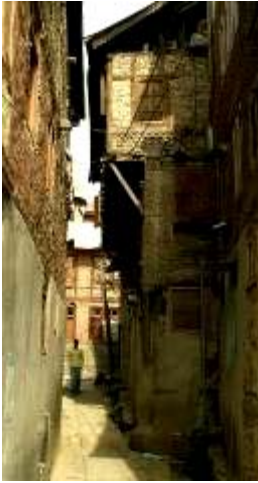
A tour of a portion of the historic center of Baramula brought to our attention that this area contains many well preserved examples of traditional Kashmiri architecture, both of the *Taq* (timber laced masonry bearing wall) and *Dhajji Dewari* (timber frame with infill masonry) construction. (Figures 11 & 12). No other buildings seen in the approximately 5 block area inspected had any significant damage. Other damage in this area was limited to the falling out of minor amounts of brickwork and one case of pounding damage. Across the river, one building was seen to have lost its masonry gable, a condition that may have been repeated a number of times. On the whole, however, the damage was not widespread enough from which to draw conclusions on which buildings were weak and which were more robust. The one conclusion that may be drawn from the building with the collapsed wall is that it may have experienced a greater resonance with the earthquake because of its height, and this resonance proved to be capable of precipitating the out of plane collapse of the wall. There was no evidence of ties between the floors and the collapsed masonry wall.

Figure 11: Narrow lane in Baramula Old City with Dhajji Dewari top floor construction.

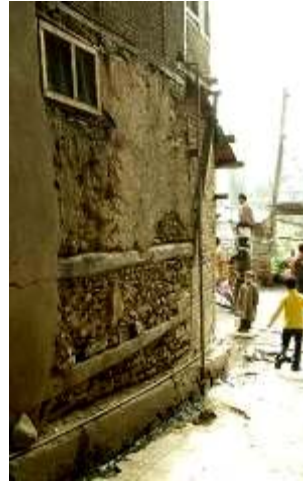
Figure 12: Timber lacing in URM wall of house in Baramula.

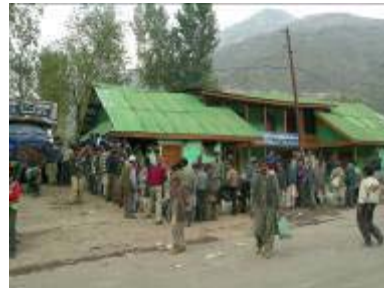
What was notable was that in Uri, although the damage was heavy and pervasive, it was insufficient to shut down the normal life and business of the town. Many of the shops and offices were functioning, even in buildings that had sustained damage. [Figure 35] The kind of damage that had disrupted what would have been thought to be the more substantial buildings of the Government complex was rare in the market town. Walls were cracked and breached in some buildings, with some collapses, but most buildings were either totally of timber, or had Dhajji Dewari walls that remained intact. [Figure 36] Those buildings of rubble stone without timber lacing suffered similar failures to those in the government complex. In many of these, the stone was laid in mud mortar without bond courses. [Figure 33 & 37]

Figure 35: In Uri, this and many other shops were open and in active use in wooden buildings, or even some partially damaged masonry buildings.
