**SURVEY REPORT ON NORTHERN KASHMIR EARTHQUAKE OF  
OCTOBER 8, 2005  
FROM THE INDIAN KASHMIR SIDE OF THE LINE OF CONTROL**

**By Randolph Langenbach**

This report is from observations made from a trip into the Indian side of Kashmir from October 24 to 29, 2005, including a trip into the damage district as far as Uri on October 25. This survey is limited to observations made along state highway 1A from Srinagar to Baramula and Uri. This survey of the damage was facilitated by the Archaeological Survey of India, and included visits to four historical monuments and archeological sites on this route that are under their jurisdiction. The trip to the damage district also included visits to the historic city of Baramula, to Uri, and several villages in the same region.

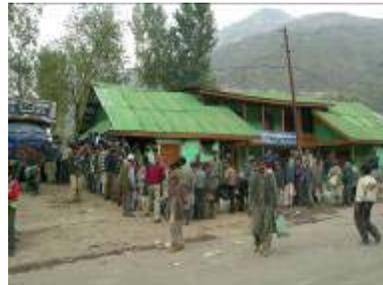
What was notable was that in Uri, although the damage was heavy and pervasive, it was insufficient to shut down the normal life and business of the town. Many of the shops and offices were functioning, even in buildings that had sustained damage. [Figure 35] The kind of damage that had disrupted what would have been thought to be the more substantial buildings of the Government complex was rare in the market town. Walls were cracked and breached in some buildings, with some collapses, but most buildings were either totally of timber, or had Dhajji Dewari walls that remained intact. [Figure 36] Those buildings of rubble stone without timber lacing suffered similar failures to those in the government complex. In many of these, the stone was laid in mud mortar without bond courses. [Figure 33 & 37]

Figure 35: In Uri, this and many other shops were open and in active use in wooden buildings, or even some partially damaged masonry buildings.
