Rubble Stone Walls and Reinforced Concrete Frames: Heritage Structures Reveal the Hidden Truth about Risk and Resilience during the Haiti Earthquake

Randolph Langenbach

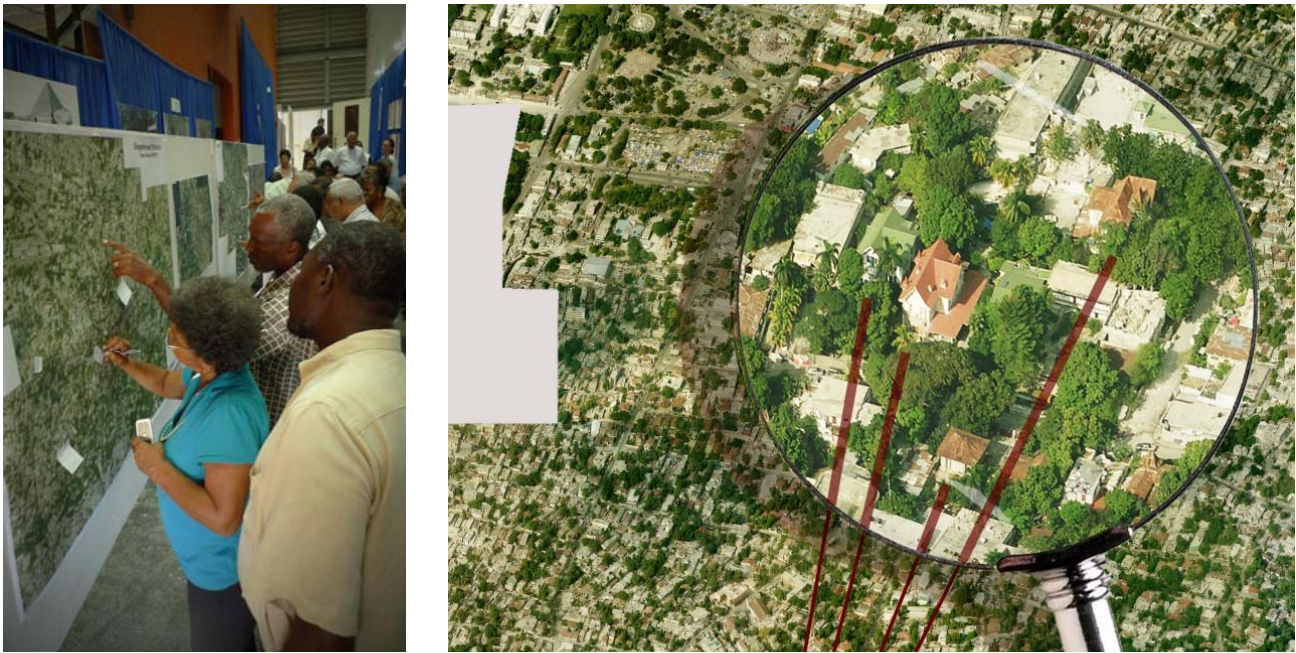
Figure 2. Left: April 2010 Exhibition at FOKAL in Haiti of murals of the Gingerbread District made from Pictometry images. Right: View showing the Gingerbread houses picked out of the aerial images by their distinctive architecture. The National Palace, which collapsed, is visible in the upper left.
