# Better than Steel? (Part 2): Tall Wooden Factories and the Invention of “Slow-burning” Heavy Timber Construction

Randolph Langenbach  
*Conservationtech Consulting*  
Oakland, California, USA

**ABSTRACT:** This paper continues the historical analysis of tall wooden buildings started in the author’s ICSA2010 Keynote paper, *Better than Steel? The use of timber for large and tall buildings from Ancient Times until the Present* (Langenbach 2010)

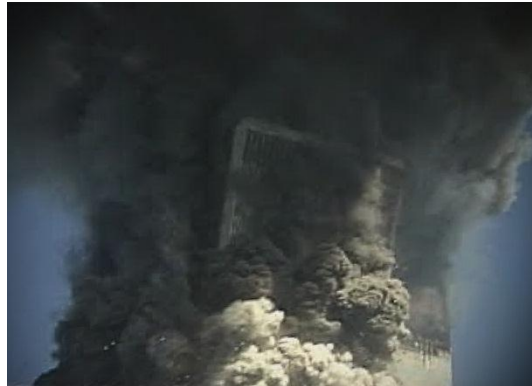
Figure 2. Onset of collapse of World Trade Center South Tower. Photo: Still image from private video of unknown source.

tained blazes, buildings have collapsed. That is the condition that the analysts determined was the case for the World Trade Center towers, where the shredded airplane and subsequent explosion stripped off much of the protective fireproofing. (Figure 2) This also included Tower #7, which was damaged only from the debris falling from the other two.

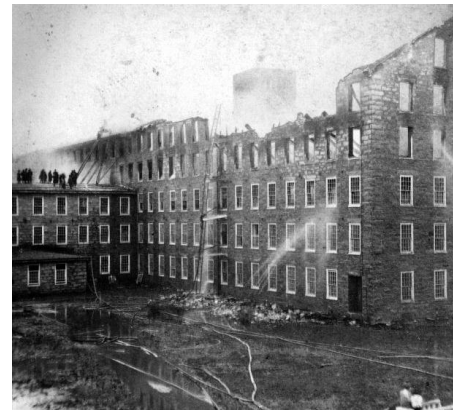
Figure 6. Granite Mill #1 with top two floors burnt out in 1874, showing that the fire was prevented from spreading to lower floors. Photo: (ATHM web).

Serious fires still did occur, as was shown by the Granite Mill #1 fire in Fall River with the graphic engraving in Harpers of the millworkers jumping to their deaths, skirts wafting up in the wind. The effects of events like that helped to speed the elimination of gable roofs in favor of beam-and-plank flat roofs, but that very same fire demonstrates the effectiveness of the beam-and-plank floor system by showing that the fire did not destroy the building below the floor where it started. The mill was rebuilt with a flat roof, but the unburnt floors visible in Figure 6 above were kept and repaired, rather than replaced.

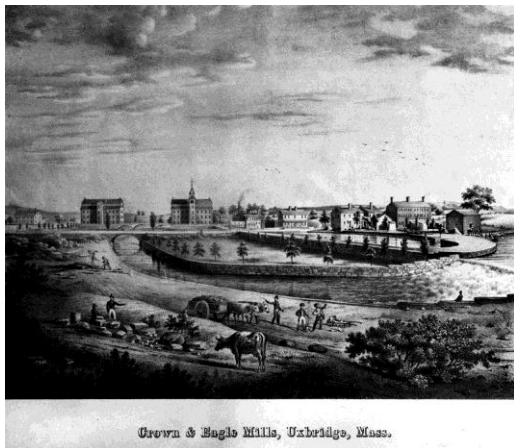
Figure 7. Ca.1830 view by James Kidder of the Crown and Eagle Mills, North Uxbridge, MA. The 1825 Crown Mill was constructed with joists, and the 1827 Eagle Mill was constructed with beam-and-plank floors. *Photo of print from Library of Congress HABS collections.*

Moving forward to the first years after independence and the War of 1812, entrepreneurs in New England began to invest in the fledgling textile industry. As agriculture moved to more fertile lands further west, this industry soon became the economic driver of the region. Despite the wars, there was an increasingly close communication between the early industrialists in England and those of New England, as the British saw their American colleagues as valued customers for their products. The first mills were clustered in New England and around Philadelphia. They had to be clustered because of the need to tap the water power directly at locations of waterfalls, or “privileges” as they were known at that time – a term which indicated the particular value of such locations as sources of power for water wheels and later for turbines, and eventually then for electrical power. The characteristics of the tapping and delivery of power in that age is important to the subject of this paper because the need to build tall multi-story structures is its result. The mill with all of its machines had to be close to the river, with water supplied by a canal to the waterwheels and turbines that were connected to the machines by shafts and leather belts. (Figure 7 & 8)

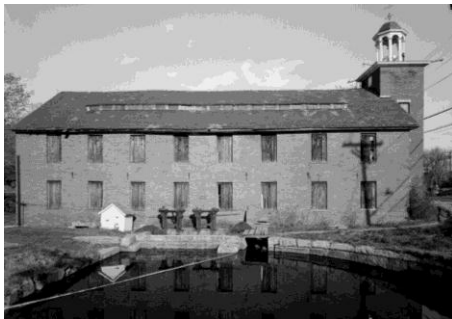
Figure 9. Harris Mill #1, Harrisville, N.H. in 1969. *Photos by Jack Boucher for HABS.*

Most of the 19<sup>th</sup> century mills were of masonry on the exterior, but the American mills, as well as many British mills, had timber floors. The construction was first a direct derivation of the heavy timber construction used for houses and commercial buildings – with heavy timber beams supporting joists which were nearly square in cross-section and mortised into the beams 18 inches to 2 feet apart (45 to 60 cm) on center. The floor itself consisted of two layers of 1 inch (2.5 cm) sawn planks, often laid with a layer of mortar in between the layers to resist the downward spread of fire. This timber construction was resting in pockets in the ma-

sonry walls, with iron rods with plates installed to hold the beams to the walls. These rods kept the vibrations of the machines from shaking the buildings apart. (Figure 9, 10, 11)

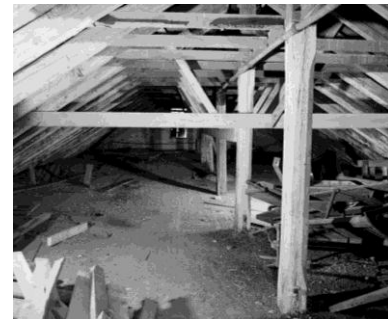
Figure 11. Interior of attic story showing characteristic fire-prone light frame gable roof construction.

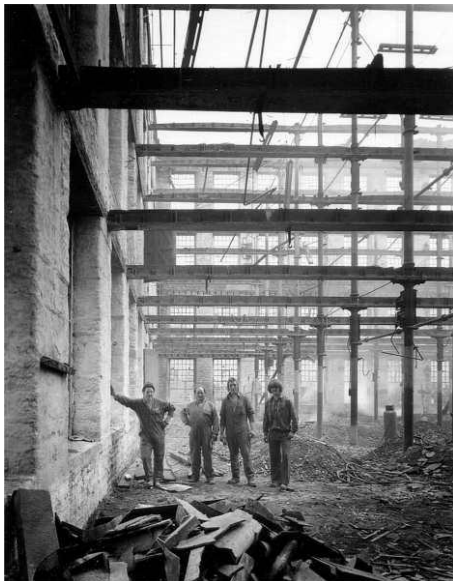
Figure 12. Mill under demolition in 1969 in West Riding area of Yorkshire, England showing iron frame with joist pockets visible on beams for wooden joists. Photo © by author.

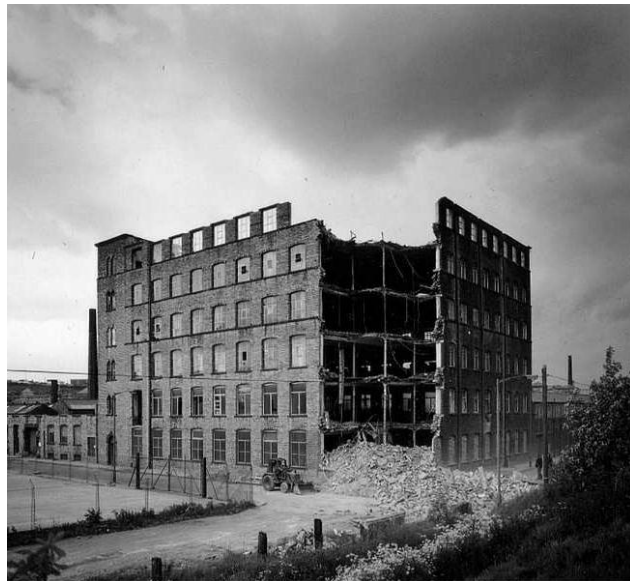
Figure 13. Mill under demolition in 1969 in Huddersfield, Yorkshire, England showing 'fireproof' iron frame with masonry jack-arch construction. Photo © by author.

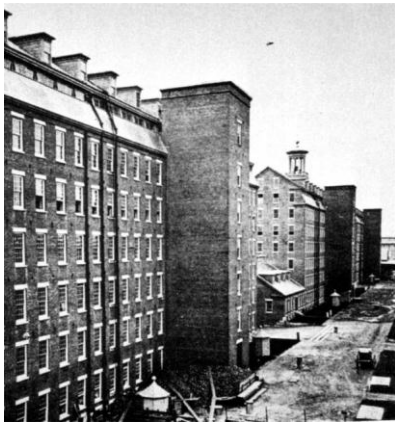
Figure 14. The ca. 1845 Bay State Mills in Lawrence MA. These mills, 9 stories including the two floor levels in the gambrel roof, may have been the tallest U.S. 19<sup>th</sup> century mills ever constructed. They were demolished only 36 years after they were built. Late 19<sup>th</sup> century mills were not so high in part because of inability to reach this height with hoses and ladders. In the 20<sup>th</sup> century, the height limit was restricted to 65 feet (20 meters). *Photo from (Langenbach 1981)*

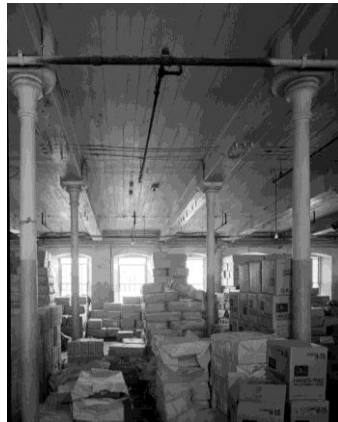
Figure 15. Interior of Stark Mill #2, Amoskeag Millyard, Manchester, N.H. showing beam-and-plank “*slow-burning*” construction, ca. 1840, before the term “*slow-burning*” was coined. This view shows an example of this system with a finished wood board ceiling nailed directly to the planks, with the 1” thick boards nailed crossways to the planks, parallel to the beams. *Photo by the author for HABS.*

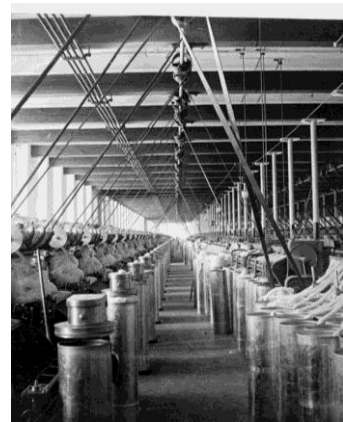
Figure 16. View of Carding Machine Room in the Jefferson Mill, Amoskeag Millyard. This view is of a mill ca. 1880, and shows beam and plank “*slow-burning*” construction. *HABS copy photo.*

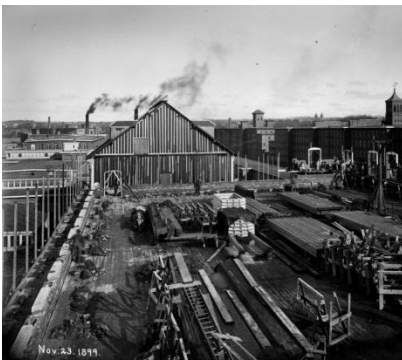
Figure 17. Reconstruction of Amoskeag Mill #4 and #5, 1899. This shows the last of the gable roofed mills in the Amoskeag Millyard being replaced with an updated mill that is wider than, but not as high as, the earlier mills. *HABS copy photo.*

The structural improvement and cost savings can be explained because of a number of advantages. With the elimination of the joists, the mortising of the beams for joist pockets was no longer necessary. These pockets weaken the beam without significantly reducing its weight, so their elimination improved the strength and stiffness of the main beams significantly. Also, the joists themselves are subject to splitting if they were notched to fit into the joist mortises. In addition, because the handiwork of the notching of the beams and shaping and placing of the joists was no longer needed, the speed and ease of construction must have improved dramatically. However, for this beam-and-plank system to be viable, the cutting, planing, and cutting the groove in the 2 ½" to 3" thick pine planks itself had to be industrialized so that the already cut, planed and dressed timbers could be delivered to the site together with the wood splines ready to install (Candee 1989). (Figure 17 & 18)

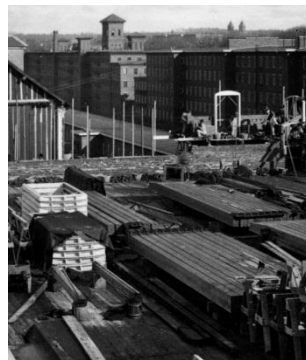
Figure 18. Detail of #17 showing the sawn and dressed heavy timber beams with cast iron seats already attached ready for erection. *HABS copy photo.* (Most copy photos from *Manchester Historic*

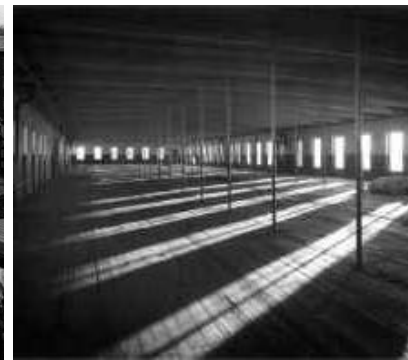
Figure 19. Interior of Stark Mill #3, Amoskeag Millyard, the day before it was demolished under "Urban Renewal". This shows the "slow-burning" heavy timber flat roof that was retrofitted onto this building after the earlier gable roof was removed. *Photo © by the author.*

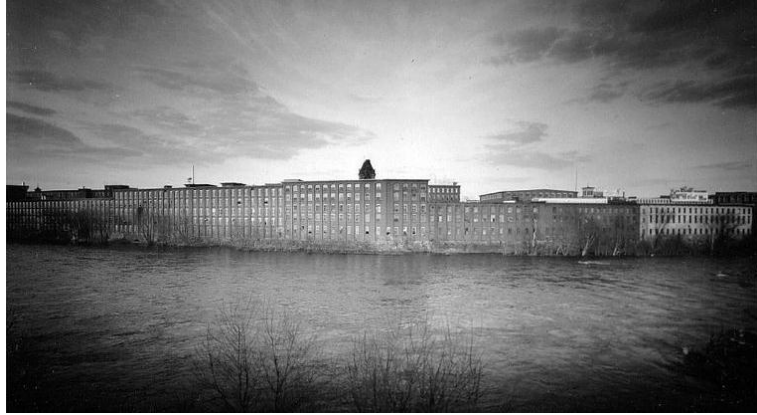
Figure 21. The southern end of the Amoskeag Millyard from across the Merrimack River. The original millyard had many separate “Lowell style” gable-roofed mills, but during the 2<sup>nd</sup> half of the 19<sup>th</sup> century, with improved firefighting equipment and full ‘slow-burning’ construction, the later buildings were joined together with internal firewalls. *Photo © taken in 1968 by the author.*

It was also in the latter half of the nineteenth century that the large cotton mill complexes in New England began to merge into continuous buildings with internal firewalls replacing the rows of individual mill buildings that had characterized the first phase. These great complexes in Lowell, and Lawrence, Massachusetts, and Manchester and Nashua, New Hampshire, and Biddeford and Lewiston, Maine became dramatic and impressive examples of the urban design potential of large cities of the industrial era. (Figure 20 & 21)

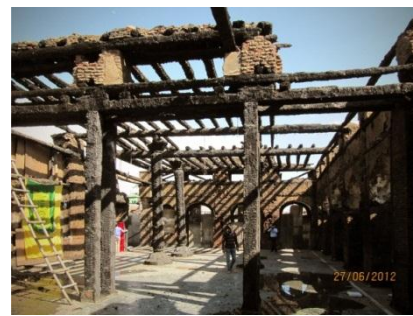
Figure 24. View of the fire and a view of the same space as in #24 after the fire destroyed the entire interior, leaving the heavy timbers charred but structurally sound. Needless to say, the loss of the artistic ornamental interior is a tragedy. The columns in the distance are two of those seen in the center of figure 23. Photo (center) *Kashmir Monitor*, (right) *Hakim Sameer for INTACH*.

For example, the absence of firewalls with functional automatic fire doors in both the Bhutan and Indian Kashmir buildings was particularly tragic as they could so easily have been installed. Ironically, in the case of the Kashmir building, when the fire was extinguished the heavy timber structure of the building was still extant – and even found to be of sufficient strength to allow its reuse in a restoration, although I have been informed that this will not be done (Hakim 2012). The timbers remained sound through the long hot blaze because of the insulating effect of the charring of the exposed surfaces of the beams. As the oversized beams char, the charred surface serves to protect the wood beneath, and prevent the total consumption of the timber in the blaze. (Figure 24)

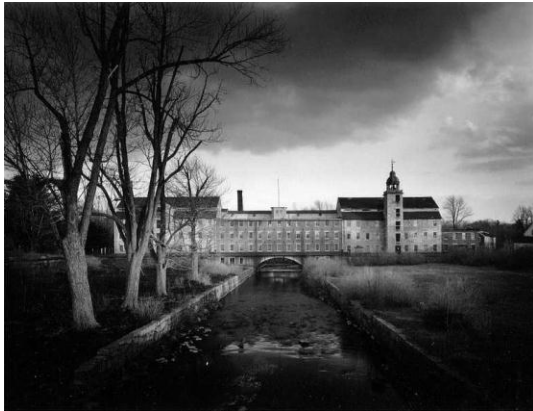
Figure 34. Crown and Eagle Mills, North Uxbridge, MA. in 1968. (see also Figure #7 & #8) Photo © by the author.

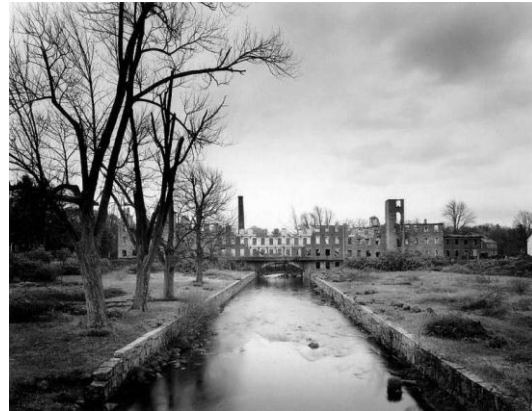
Figure 35. View of the Crown and Eagle Mills after vandals lit the vacant mill on fire in 1975. The ruins were subsequently rebuilt with modern materials as senior housing. The bell tower was not restored. Photo © by the author.

When the sprinklers were turned off, and the standpipes are broken, as was so often the case when one-by-one, the textile companies went out of business and the mills were abandoned, many have been burned, often from fires lit by vandals or vagrants. The saddest loss of such a mill I have seen is the complete destruction in 1975 of the Crown and Eagle Mills, which had already been recognized by the mid-20<sup>th</sup> century as the most beautiful of all of the New England mills, just as it had been so honored when it was constructed a century and a half earlier. It was unused at the time, with sprinklers turned off, but for half a century, it had been carefully preserved by its last owner – until vandals succeeded in burning it down. (Figure 35. Also shown in Figure 7 & 8).

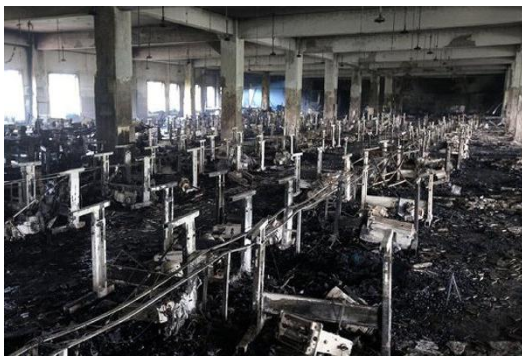
Figure 36. The Tazreen Fashions Factory, Bangladesh after the fire that killed 112 people. It appears from this image that the concrete structure was not even scorched, indicating that it was a flash fire that killed the people who could not get out. *Photo Abir Abdullah/European Press Photo Agency.*
